Investigation of Air Distribution System Leakage and It's Impact in Central Florida Homes

Final Report

FSEC-CR-397-91
January 31, 1991

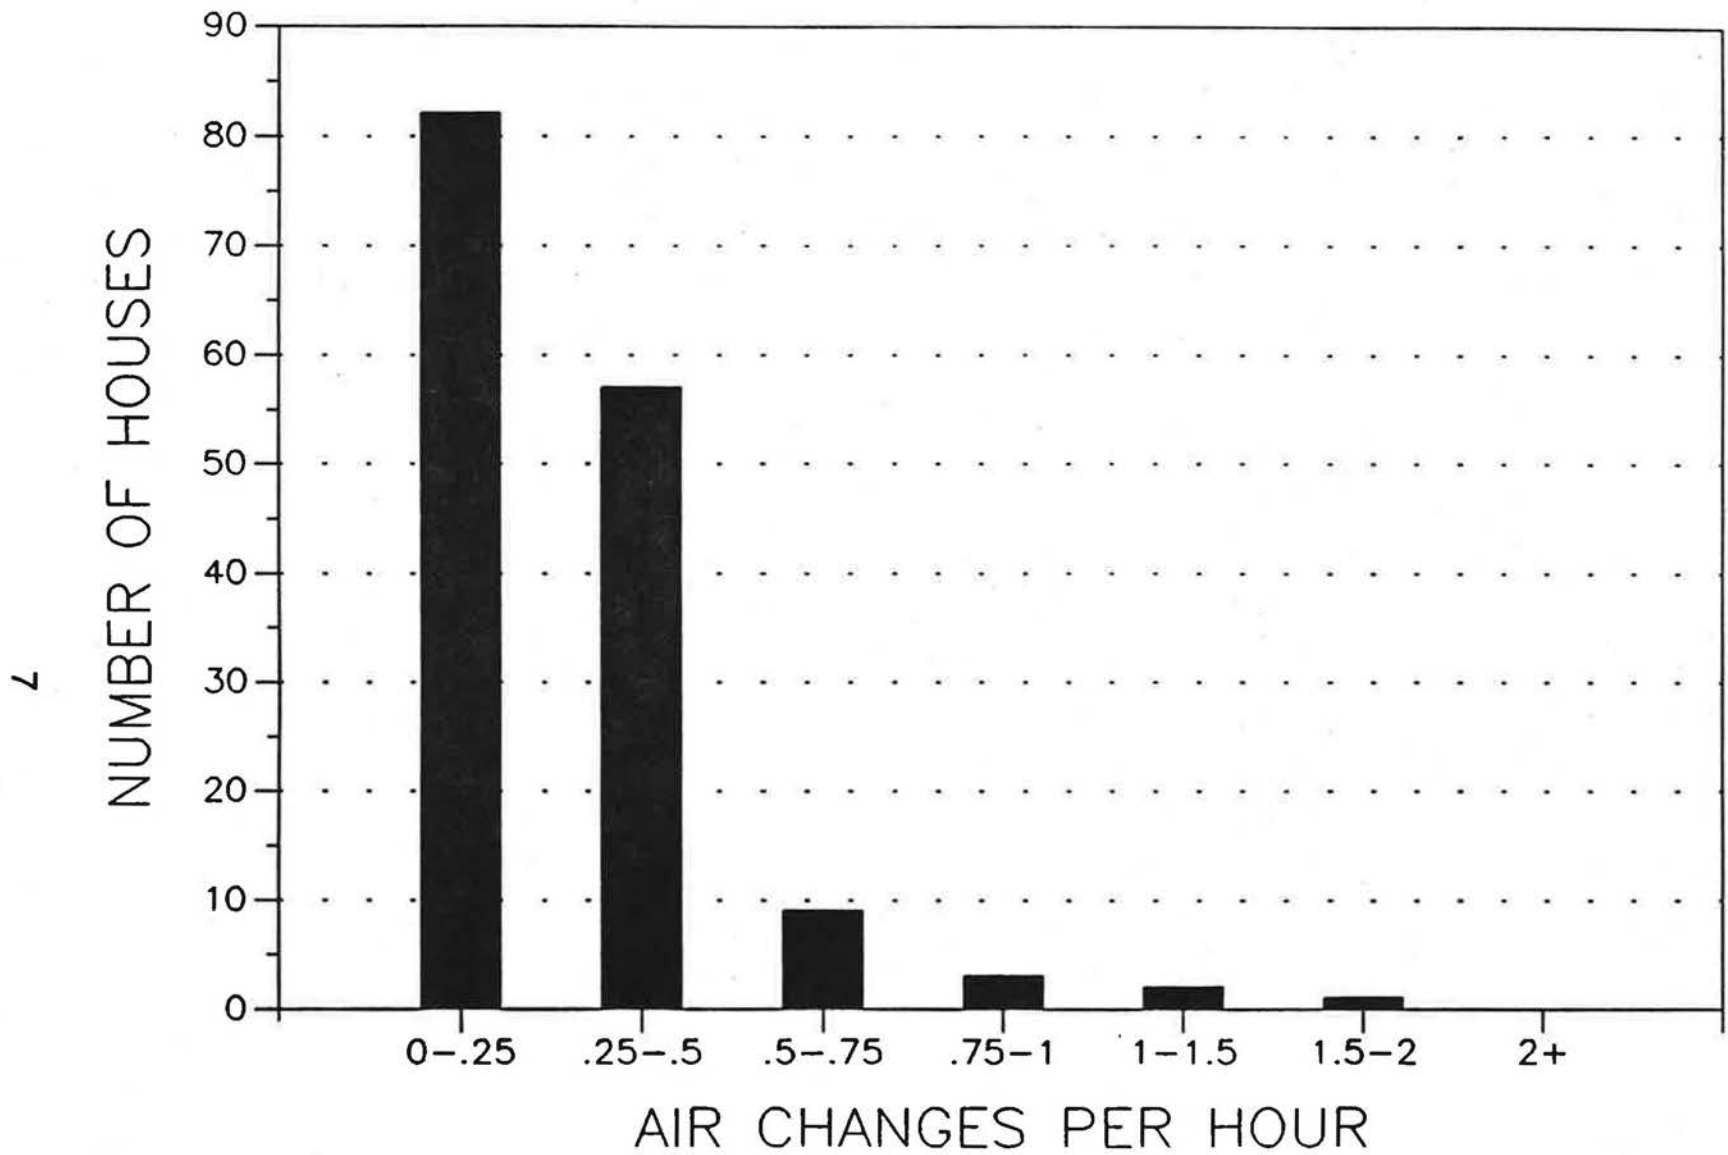
Figure 1. Tracer gas infiltration rates in 154 homes with the air handler off. Average = 0.28.

Figure 2. Tracer gas infiltration rates in 156 homes with the air handler on. Average = 0.91.

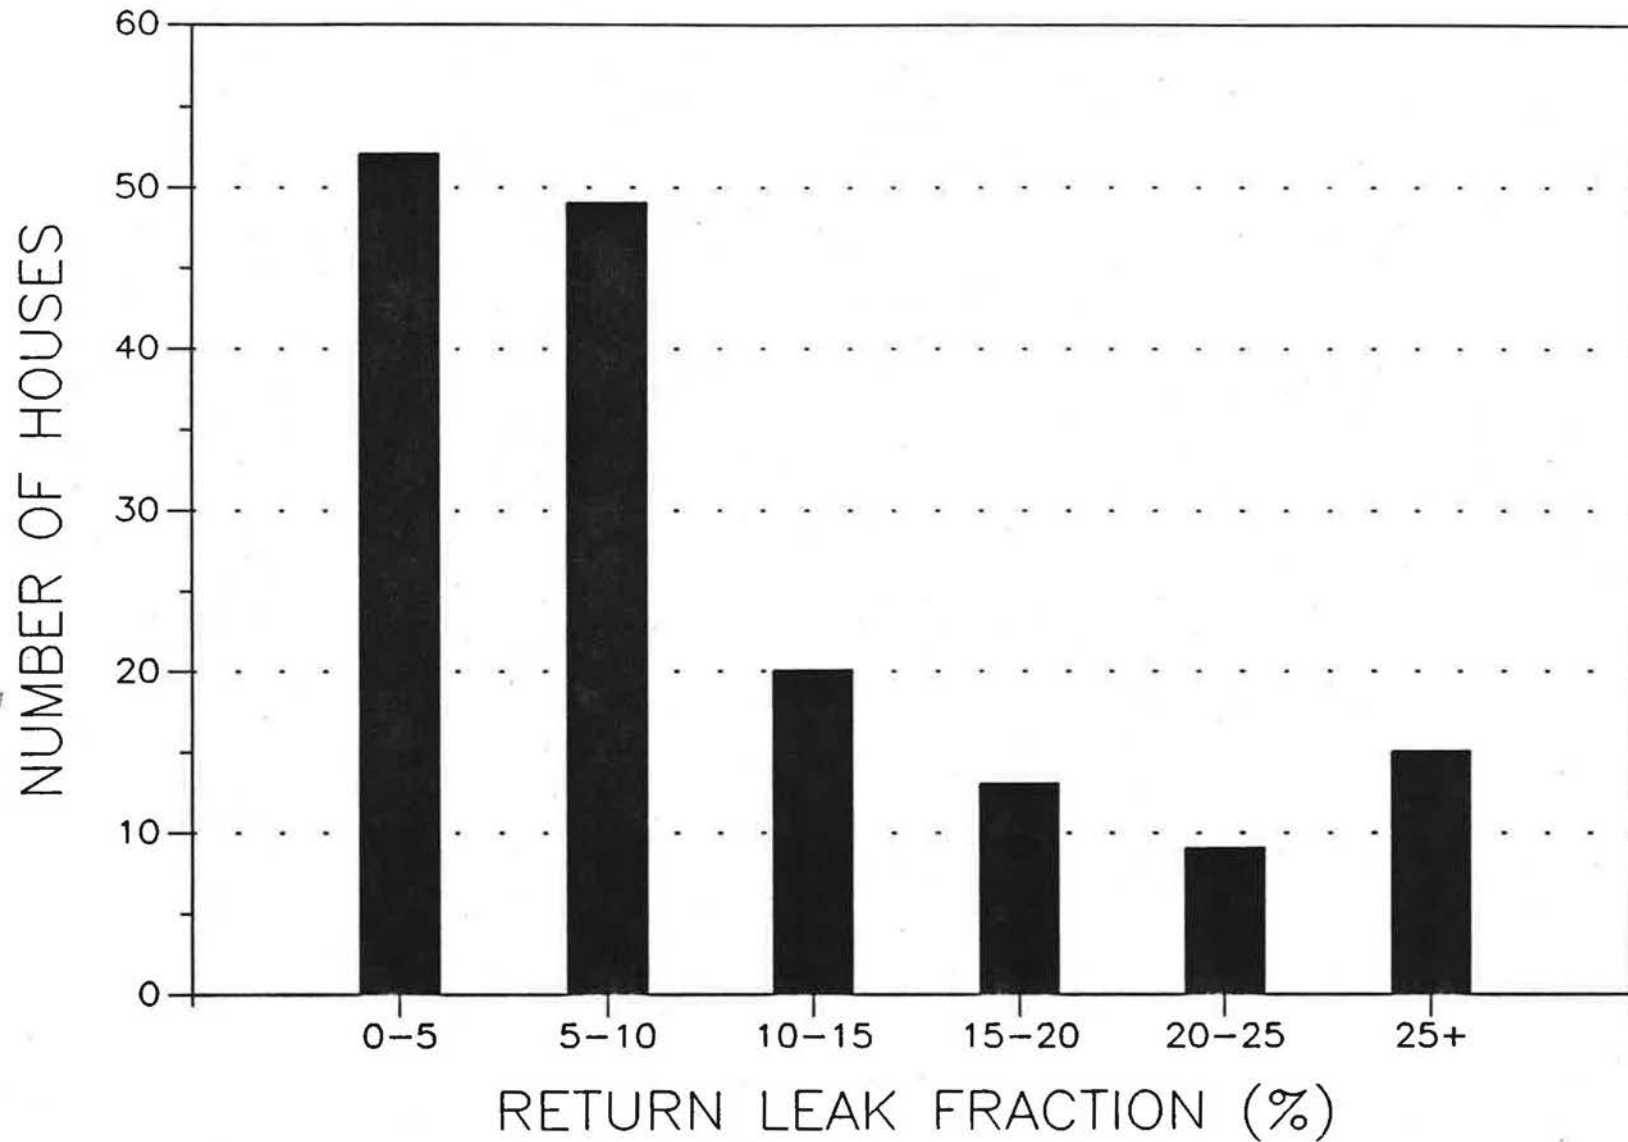
Return leaks were found to be dominant in the majority of homes based on visual inspection. Tracer gas tests were used to determine the size of return leaks. The return leak fraction (RLF) was measured in each home with the AH operating (Figure 4). Sixty-seven percent were found to have return leaks equal to or greater than 5% of the AH total air flow. Thirty-six percent have greater than 10% RLF. The average for 160 homes was 10.7% RLF.

Figure 4. **Return leak fraction (RLF) in 158 homes measured by tracer gas dilution. Average = 10.7%.**

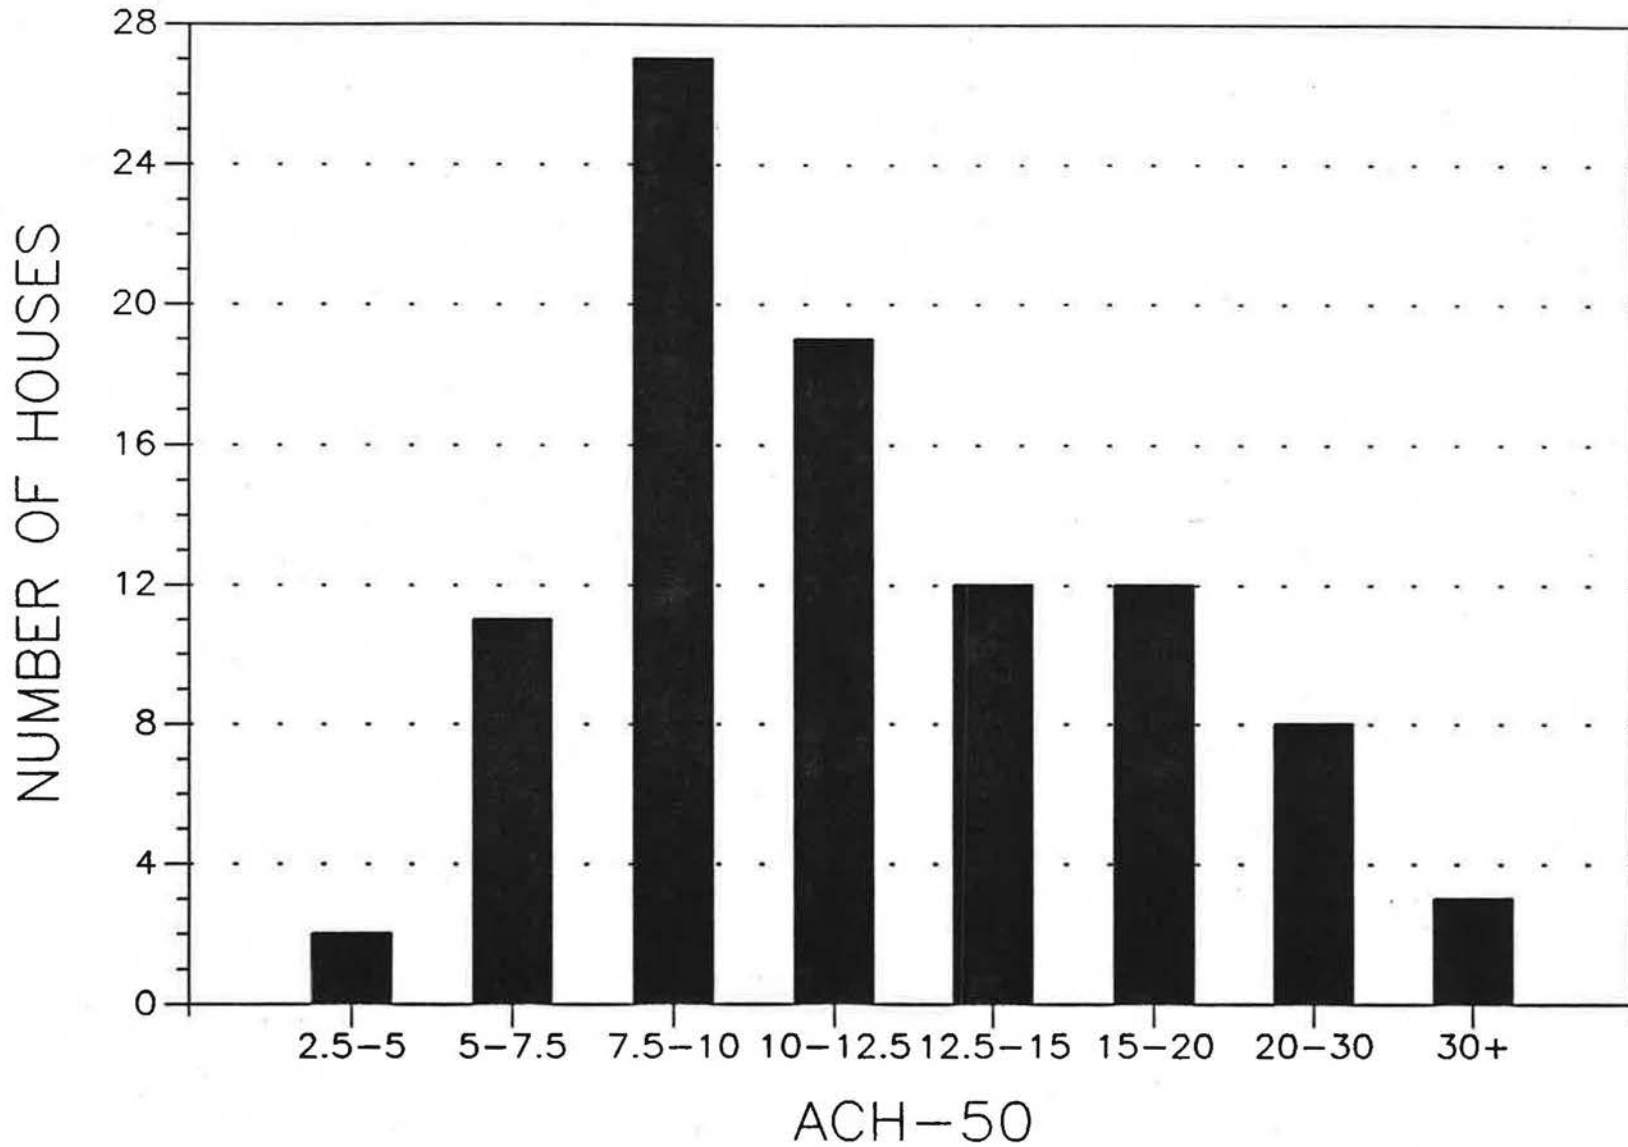
Figure 5. House airtightness (ACH50) measured by blower door in 99 Florida homes. Average = 12.7 ACH50.

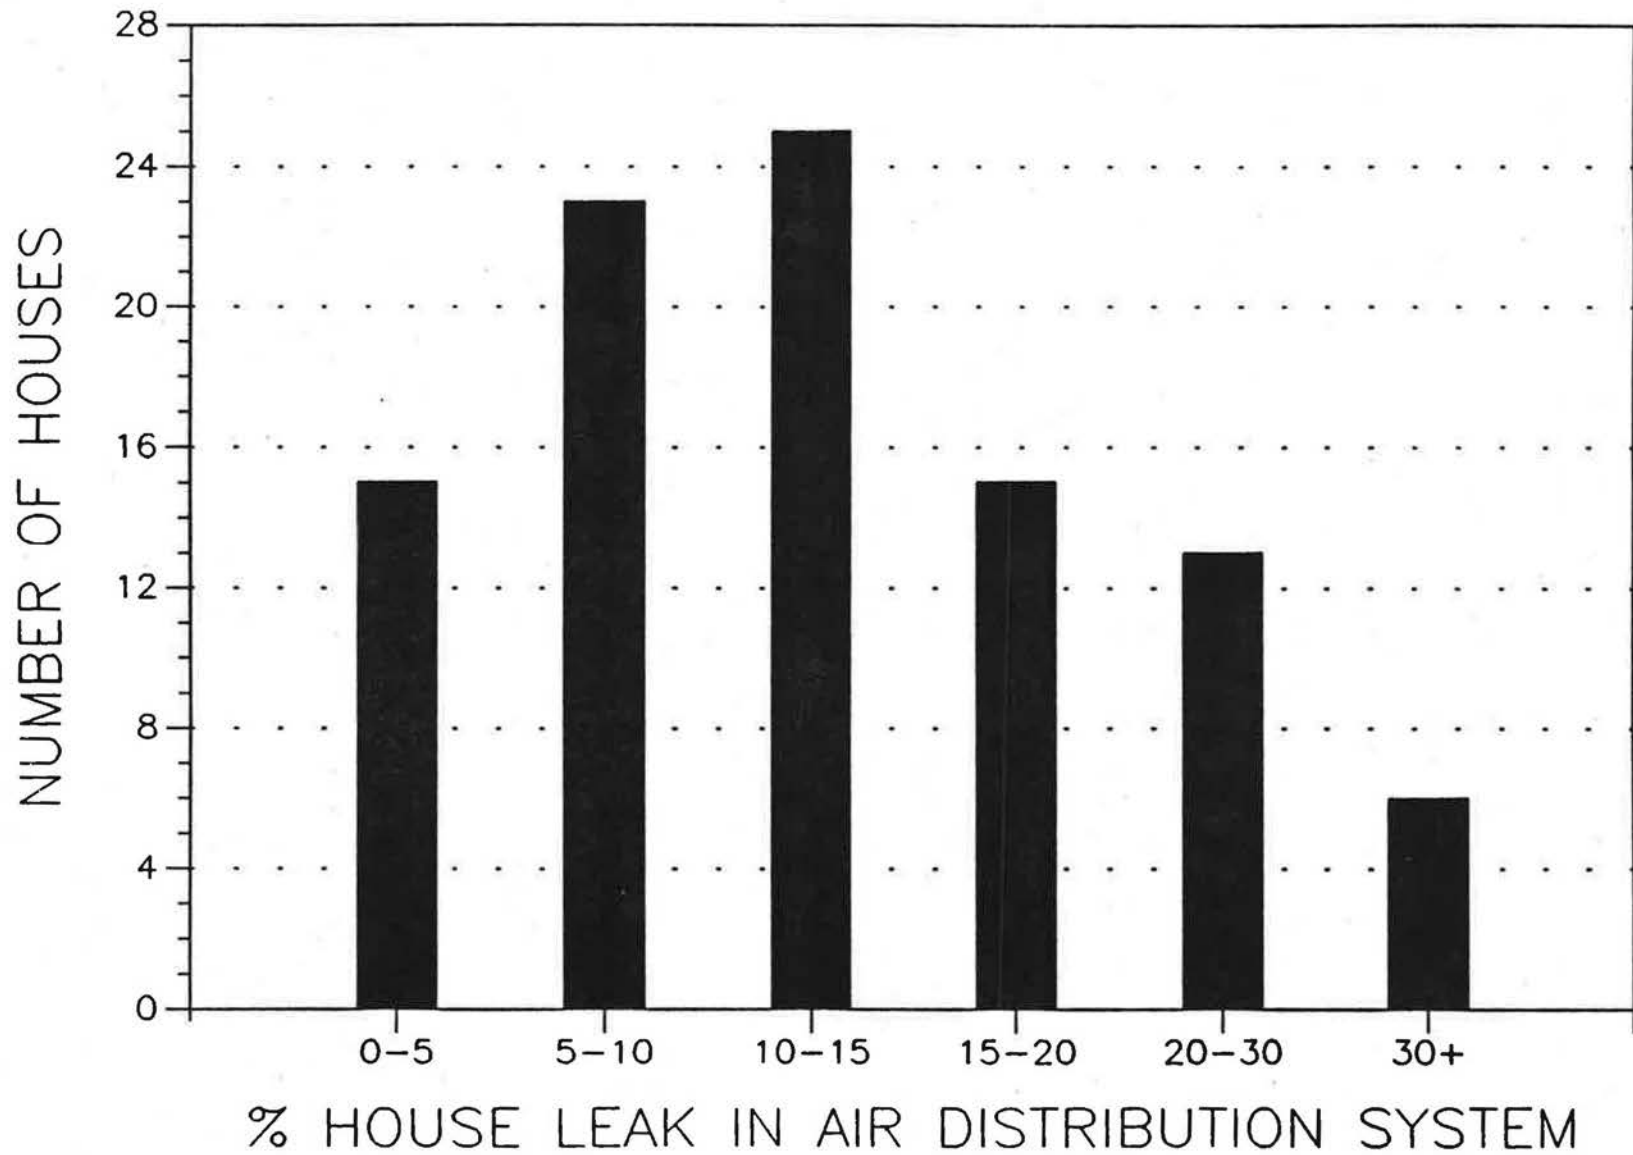
Figure 6. Percent of house air leakage at 50 pascals which is located in the air distribution system of 95 homes, determined by blower door. Average = 12.7%

than 1% of the volume of the house, it is remarkable that it contains such a large proportion of the leak area of the house. This indicates significant problems in ADS construction which must be addressed.

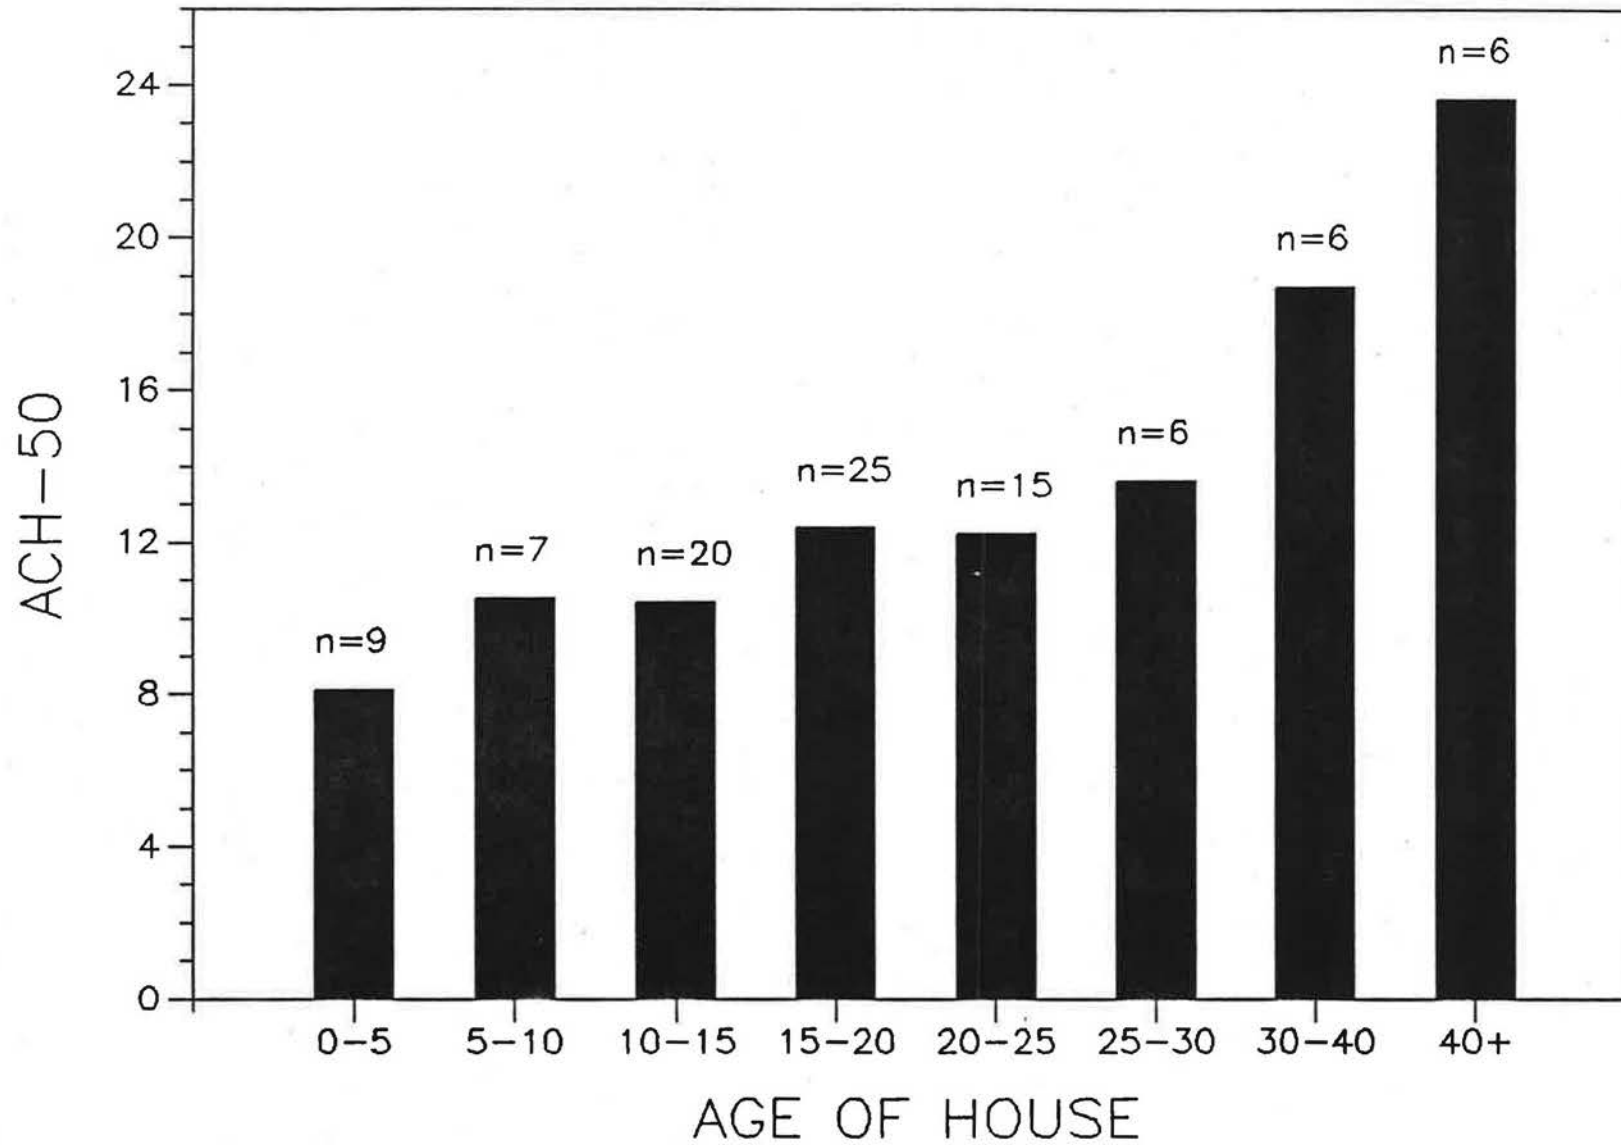
Blower door tests indicate that house airtightness is a function of age (Figure 7). Older homes are leakier. Homes built in the last 10 years have ACH50 of about 8 while those over 20 years old have an average ACH50 of about 16.

Figure 7. House airtightness (ACH50) as a function of age, measured by blower door in 95 Florida homes. Average = 12.7 ACH50.

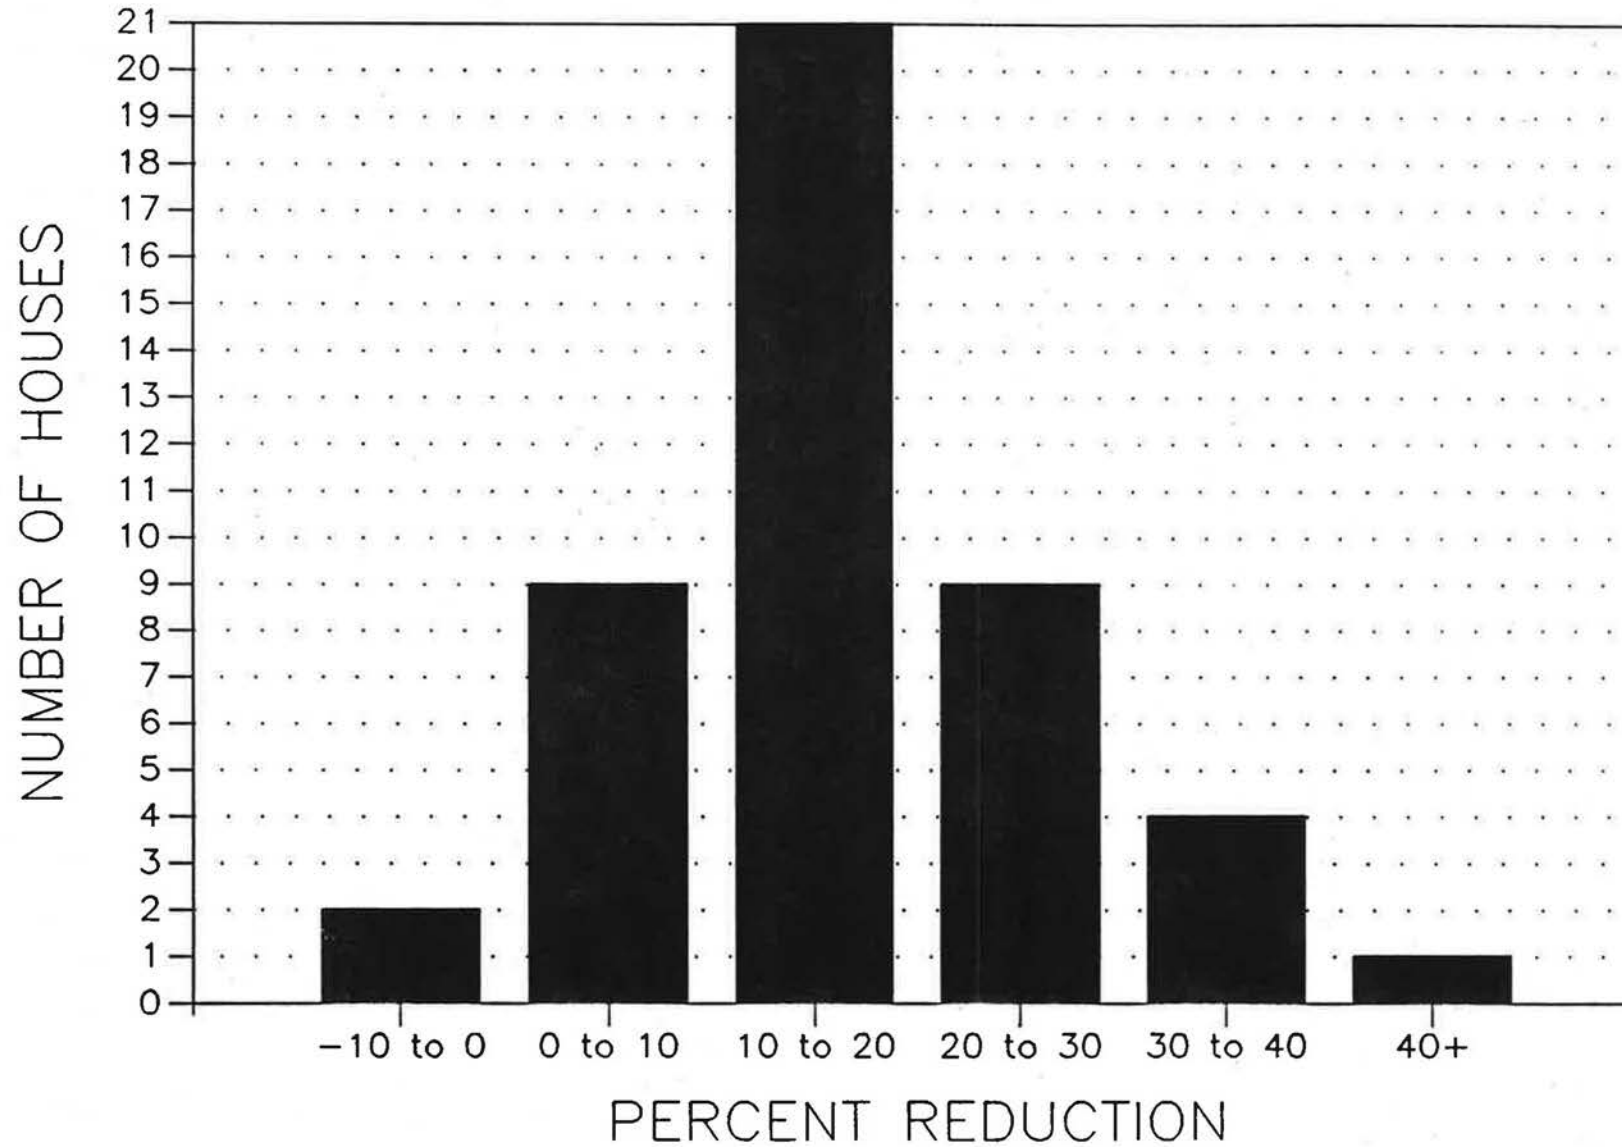
Figure 8. Reduction in cooling energy use resulting from repair of air distribution system leaks in 46 homes. Average reduction = 17.4%.

In eight homes, energy savings were less than five percent. These cases were examined to see why savings were low. In two instances, energy savings were small because the initial duct leakage was small. Therefore, small energy savings were expected. In one, repairs reduced a 7% return leak to 3.3%, and energy use was reduced 4.2%. In another, which had almost no duct leakage (achon = 0.35 and RLF = 4%), energy savings was 2.0%.

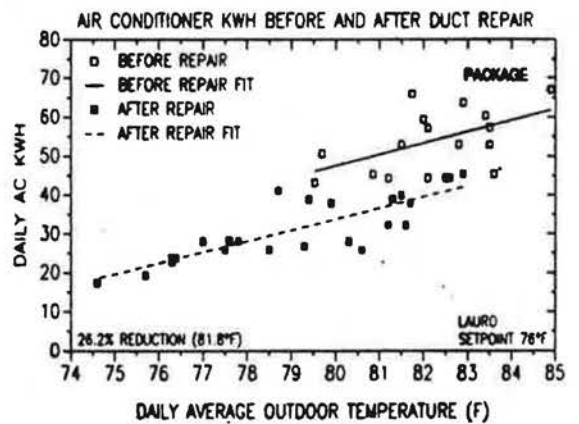
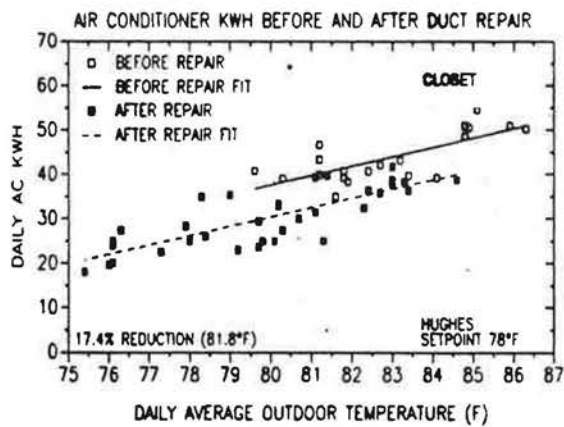
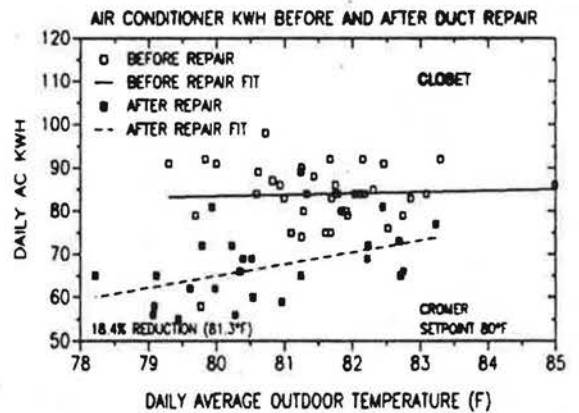
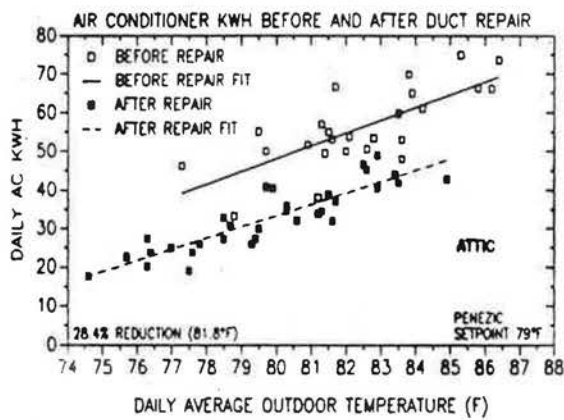
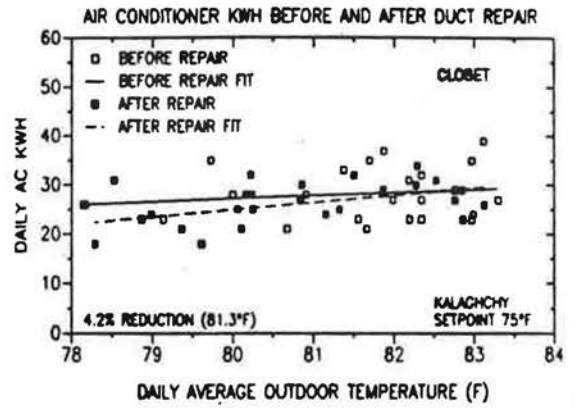
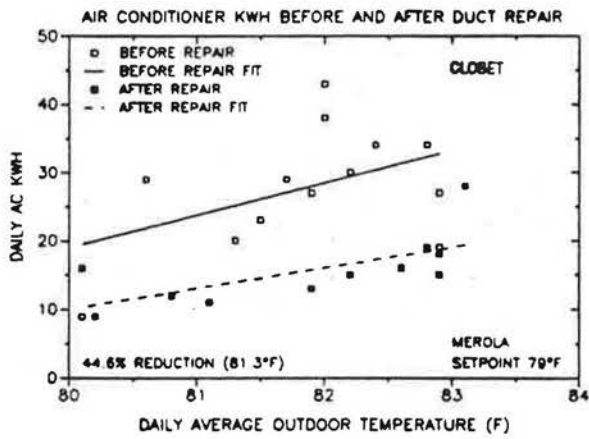
Figure 9.   Measured cooling energy use before and after repair of air distribution system leaks in six Florida homes. (Source: Cummings, Tooley, Moyer, and Dunsmore, 1990)

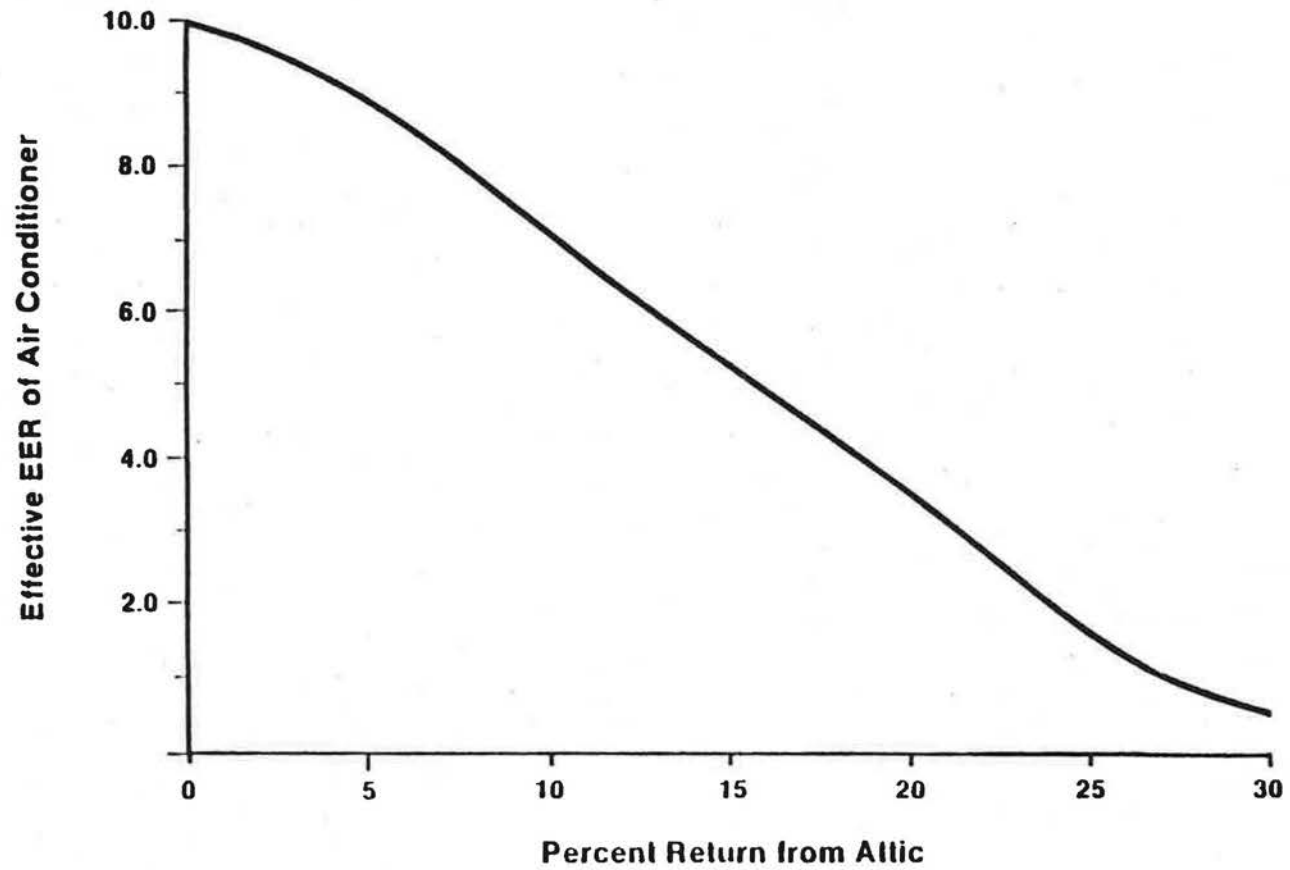
Figure 12 shows the impact of return duct leaks from the attic upon AC energy efficiency ratio (EER). Since the utility's summer peak occurs at about 5 P.M., when the attic is likely to be 120°F and have a dewpoint temperature of about 85°F, a 15% return leak can reduce the effective capacity and EER of the system by 45%. A 30% return leak can completely overwhelm the capacity of the system, causing the temperature in the house to rise. The total increased electrical demand in many homes is limited by the capacity of the air conditioner. If air conditioner capacity were unlimited, the peak demand impact of duct leaks on the summer peak would be much larger.

Figure 12.   Degradation in air conditioner efficiency (Energy Efficiency Ratio) when various sized return leaks draw hot air from the attic, assuming the room is 78°F and attic air is 120°F.

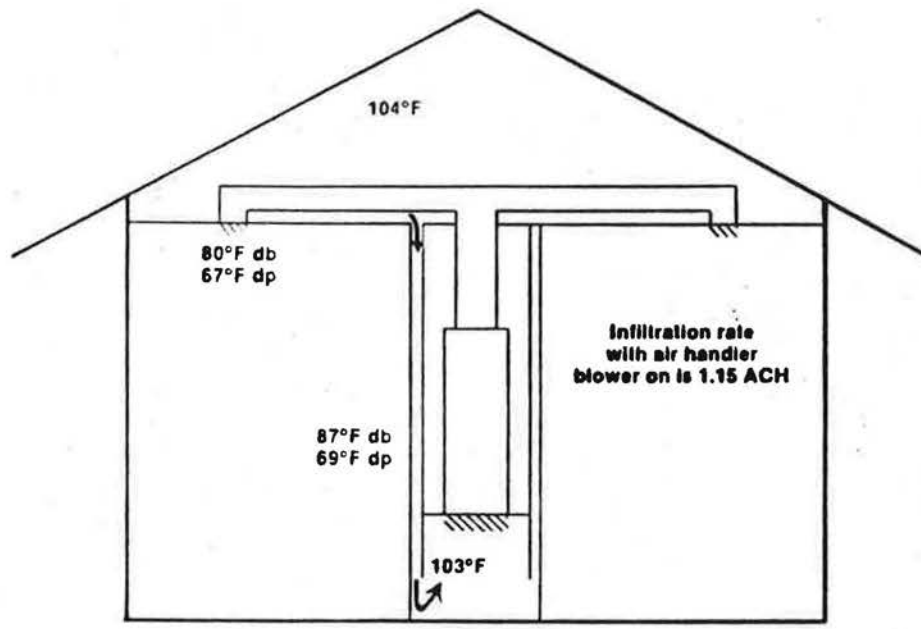
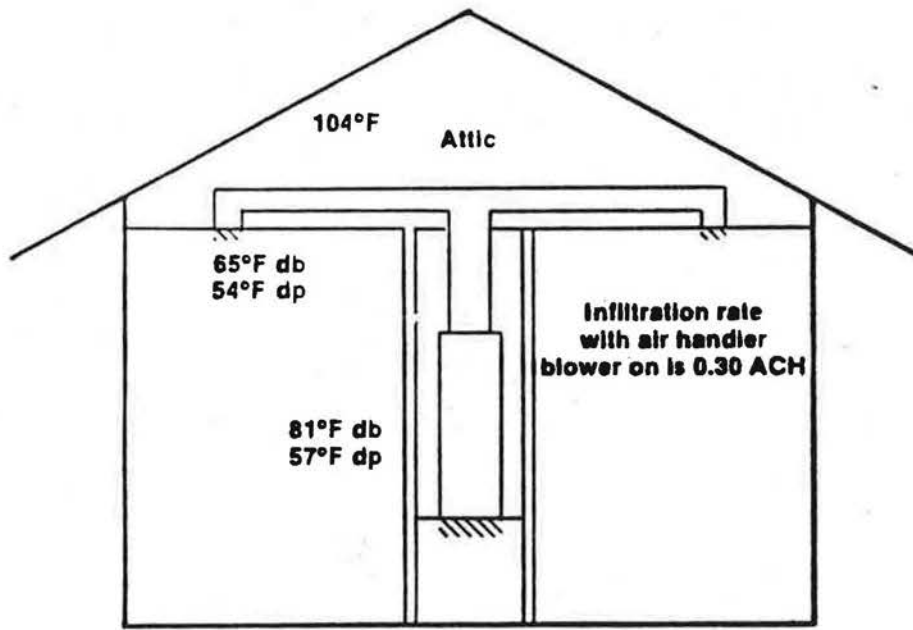
Duct leak impacts on demand are illustrated in Figure 13. Measured infiltration and air conditioner performance are shown before and after repair of a 30% return leak. The infiltration rate with the air handler operating decreased nearly 75% from 1.15 ach to 0.30 ach as a result of the repairs. Temperature drop from return (measured in the room at the register) to supply increased from 7°F to 16°F, indicating a 130% increase in net, sensible cooling capacity. Put another way, air conditioner capacity and efficiency were reduced by about 55% as a result of drawing 104°F attic air into the return air stream. It is interesting to note that the room temperature was 87°F before repair, even though the air conditioner was running continuously, because the capacity of the air conditioner was insufficient to maintain the setpoint. Afterwards, the house could be easily cooled with the air conditioner cycling normally.

Figure 13.   Impact of a 30% return leak from the attic upon the house infiltration
rate and air conditioner performance. Air distribution system leaks
increase infiltration by a factor of four and reduce sensible cooling
capacity by 56%.
