NBS BUILDING SCIENCE SERIES 102

# The Thermal Performance of a Two-Bedroom Mobile Home

U.S. DEPARTMENT OF COMMERCE • NATIONAL BUREAU OF STANDARDS

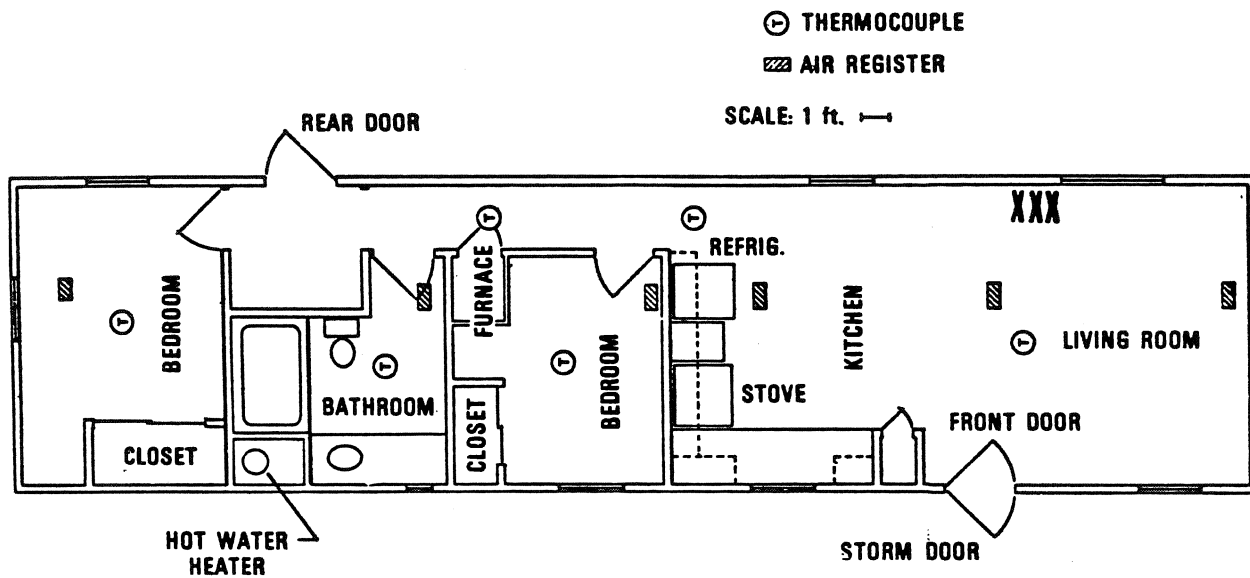
To test this hypothesis and evaluate various corrective techniques, a series of changes were made in the wall construction and the resulting thermal profiles were observed. All of these changes were made in one location as identified in figure 30.

FIGURE 30. Location of thermographic investigation of wall performance denoted by X.

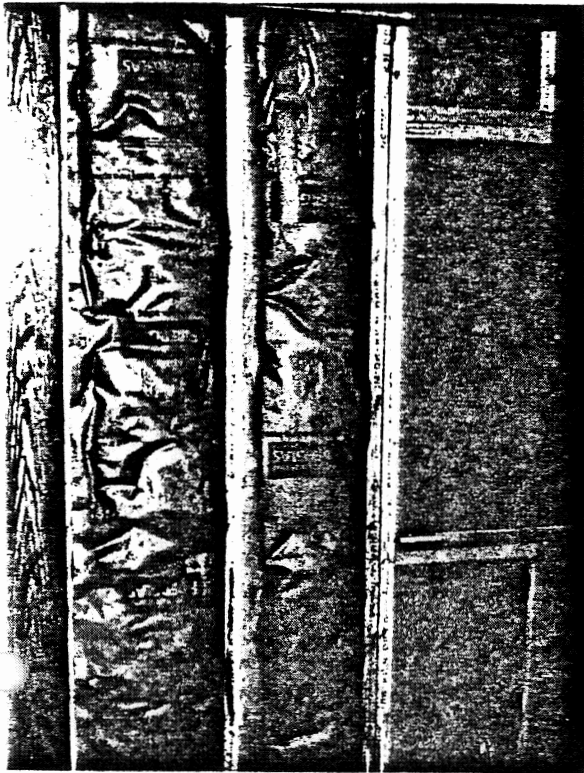
In both cases, thermographic and thermocouple observations revealed that the cold streaks were substantially eliminated with full batts. Without neat, mechanically-attached placement, some streaks did occur along the studs where the insulation was wrinkled due to stuffing the stapling flanges of the vapor barrier into the stud space, allowing air passage (see fig. 37). With neat attachment, cold streaking was eliminated and surface temperatures were very even, as shown in figure 38. As changes were made in the insulating system, inside-surface temperatures were recorded with the thermocouples located at A and B as shown in figure 39. These temperatures are shown in table 4.

FIGURE 35. Inside of mobile home wall with paneling removed. Original R-7 batt insulation has been replaced with R-11 batt. Insulation friction fit.

An alternative way to stop air movement within wall cavities and subsequent siphoning of heat to the outside would logically be to fill the cavity with insulation to remove locations where air could move. This theory was tested by removing the original insulation (R-7) and replacing with an R-11 full thick batt. This technique was evaluated with insulation installed by friction fit (fig. 35) and with the insulation stapled neatly to the faced of the wood studs (fig. 36).

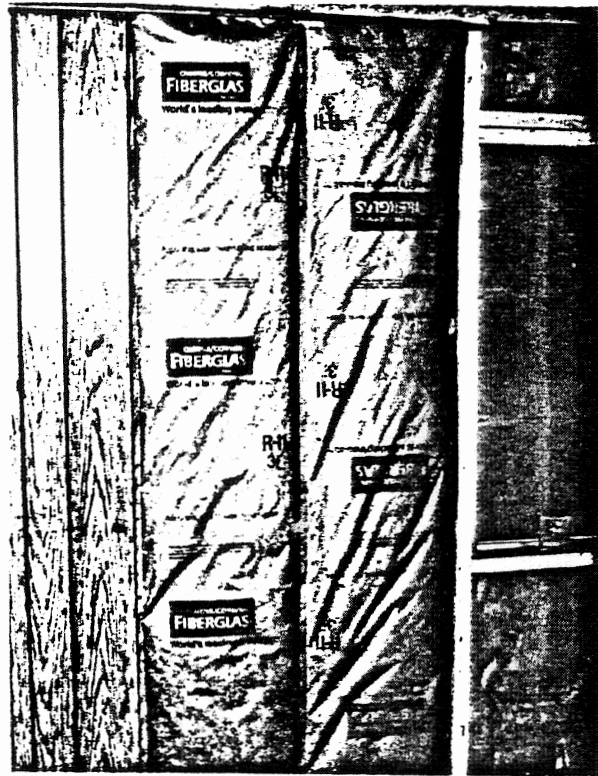
FIGURE 36. Same as figure 35 but with R-11 batt stapled neatly in place.

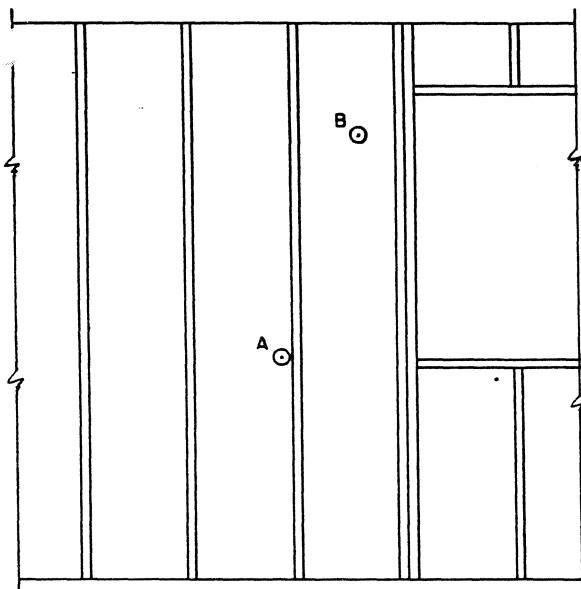
sharp as shown in figure 29. See table 4 for surface temperatures at locations A and B of figure 39. Location A is a spot where temperatures were lowest, and location B is the warmest temperature.

FIGURE 39. Thermocouple locations on inside of wall paneling. Temperature readings shown on table 4.

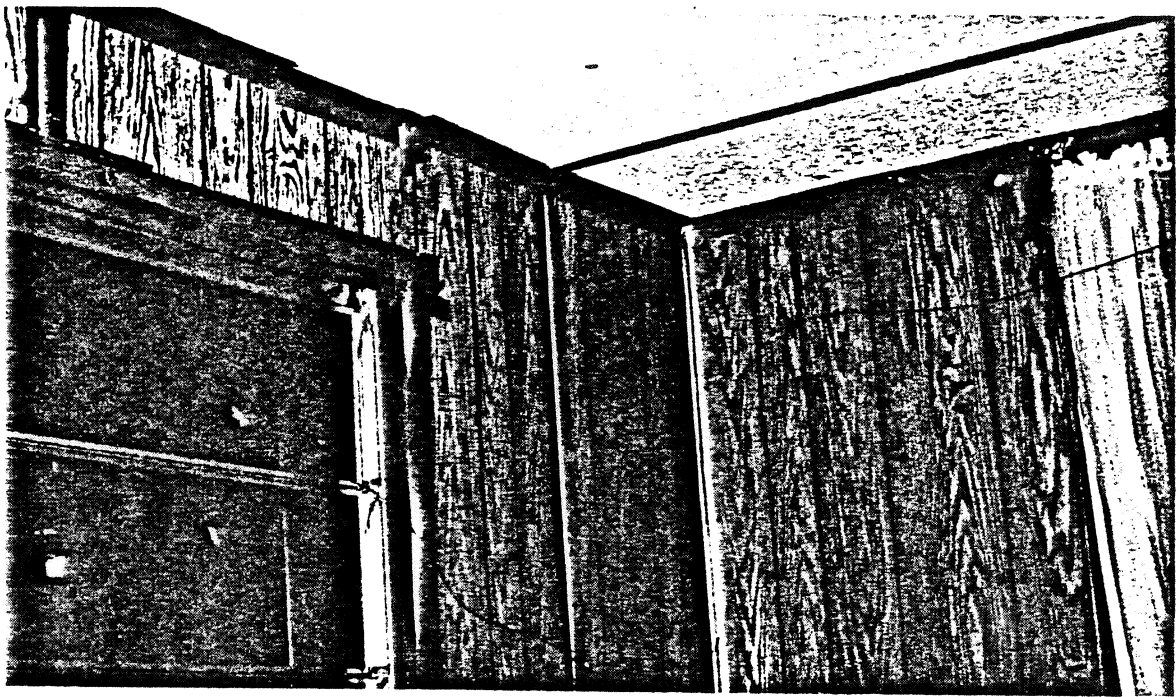
FIGURE 45. Panel side joints, wall corner joint, ceiling wall joints and window sealed with duct tape.

The sealing process was accomplished with aluminized duct tape. Figures 45 through 47 show examples of sealing of suspected air leaks.
