# Assessment of durability of airtightness by means of repeated testing of 4 passive houses

Jiří Novák<sup>\*1</sup>

*1 Czech Technical University  
Faculty of Civil Engineering  
Thákurova 7*

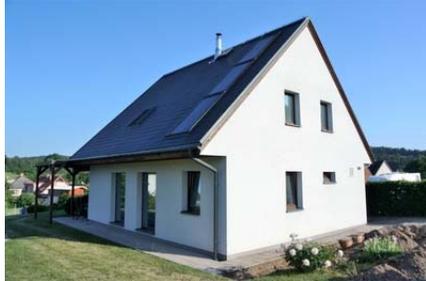
Figure 3 The building A in 2018

The airtightness of the building A has deteriorated over the 11 years - the  $n_{50}$  value rose from  $0.51 h^{-1}$  in 2007 to  $0.71 h^{-1}$  in 2016. The  $n_{50}$  value increased mostly in the first 3 years, between 2007 and 2010 (from  $0.51$  to  $0.67 h^{-1}$ ). It is not clear whether the difference between the test results from 2007 and 2010 is due to the effect of ageing or rather to different building preparation (sealed attic hatch). Between 2010 and 2016 the  $n_{50}$  value increased slightly, but the differences between the test results are lower than the uncertainty. Between 2016 and 2018 the  $n_{50}$  value increased suddenly and significantly. A defect or accelerated degradation of the attic hatch gaskets are very likely causes of this change as shows the result of the second test carried out in 2018 with sealed attic hatch.

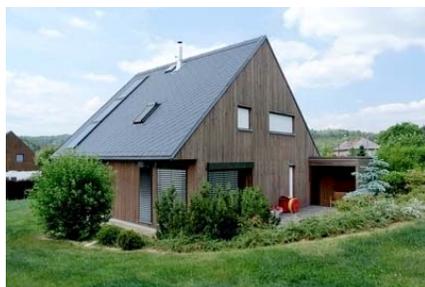
Figure 5 The building B in 2018

The building was commissioned in 2007. At that moment, the household equipment and furniture which are usually fastened to the building structure and involve a risk of a damage of the air barrier system, were not installed (fitted kitchen, cupboards). In 2016, the building was partly refurbished and furnished:

- the internal cladding of the 1<sup>st</sup> floor walls was removed as well as the 1<sup>st</sup> floor flooring
- the connection of bitumen sheets of the slab on the ground to the PE foil air/vapour barrier of the 1<sup>st</sup> floor walls was repaired and sealed again

- the new flooring of the 1<sup>st</sup> floor and internal cladding of the 1<sup>st</sup> floor walls were installed
- the new fitted kitchen, cupboards and other pieces of furniture were installed

The quality of the execution was supervised, the presence of leakages was checked during the process. No other interventions to the air barrier system were made from 2007 to 2018.

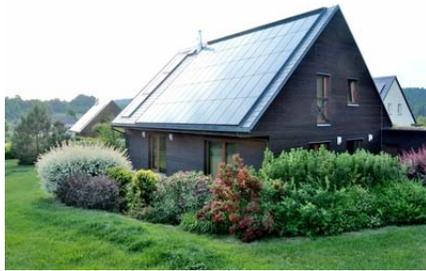
Figure 7 The building C in 2018

The building was commissioned and furnished in 2007. No information is available whether the installation of numerous pieces of furniture and household equipment was supervised or not. The caretaker reported an accident of sewage water system between 2007 and 2018. The repair of the damaged pipework required a partial disassembly of the external wall and involved interventions to the air barrier system. The repair was carried out urgently, without any special supervision.

The  $n_{50}$  value obtained in 2018 is substantially higher than in 2007. The most likely cause of this increase is neglected sealing of the air barrier layers during the repair of the sewage water system failure. An improperly sealed penetration the sewage water pipework (significant leakage path) was found in an accessible installation gap. Perhaps, similar leakage paths resulting from improper repair works remained undiscovered in inaccessible parts of the external wall as well.

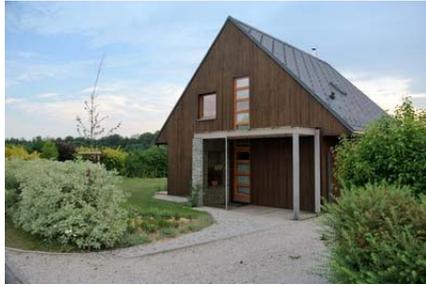
Figure 9 The building D in 2018

The building D (fig. 9) is an inhabited single-family house. Several years after the completion, the building changed the owner. Both families used the building in a typical way and without any special concern about the airtightness and its durability.

The building was tested only at the moment of commissioning in 2007 and in 2018. The tests were carried out in summer and spring respectively. The test result obtained in 2018 with the sealed attic hatch is only indicative. The test results are given in tab. 4 and fig. 10.
