Monitoring of the Building Envelope of a Heritage House A Case Study

Abstract

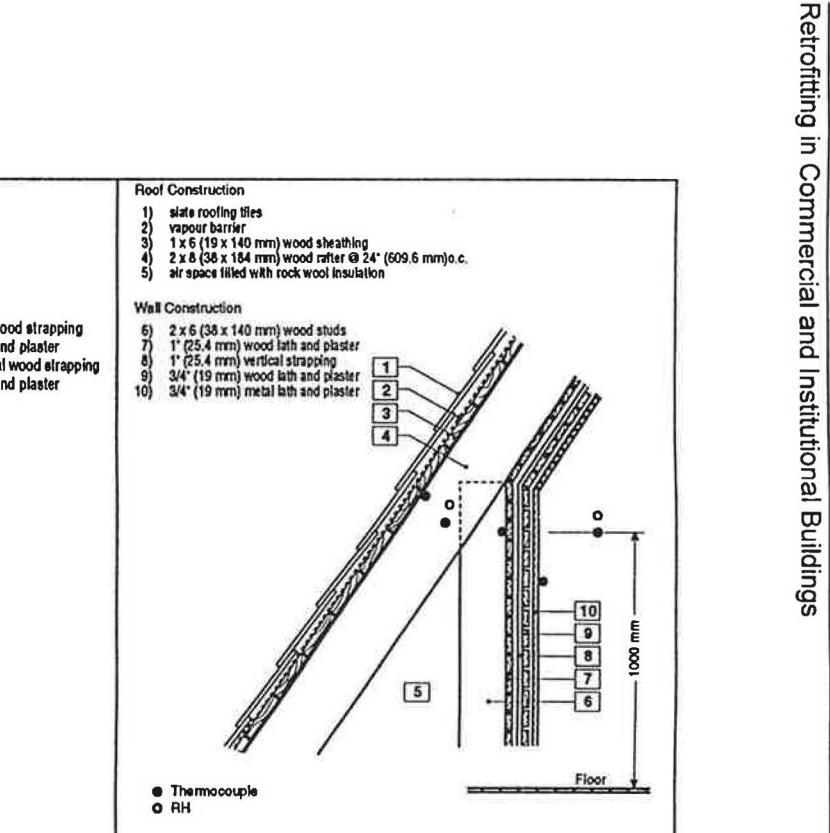
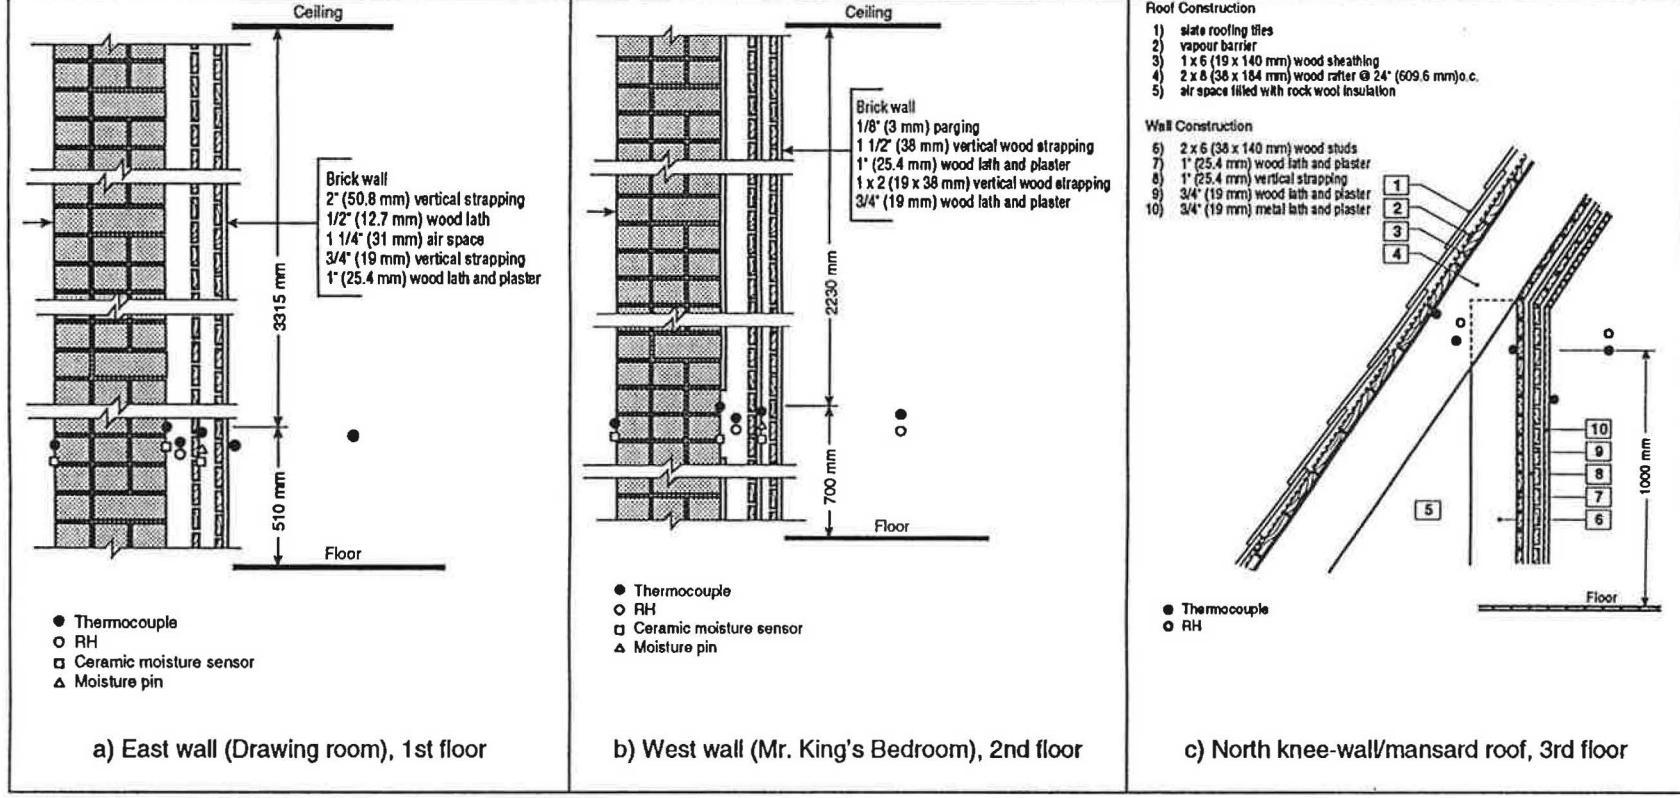
Figure 2: Sections through monitored walls on 1st, 2nd and 3rd floors showing instrumentation.

Four wall sections, the attic, two foyers, a window, and an outdoor location on the site were chosen to be instrumented. Figure 2 shows cross-sections of the walls monitored and the location of the instrumentation. The window selected was a leaded single-glazed metal frame casement window (glass 6 mm thick; the storm window was absent during the monitoring because of maintenance). The window is located in the east wall of the dining room on the first floor. The preliminary study showed severe condensation was possible on the same window. The wall sections instrumented were the east wall in the drawing room on the first floor, the north wall in the dining room on the first floor, the north wall in the dining room on the first floor, shows the locations monitored on the first and second floors.
