The Interactive Window System was a sterling effort by Colt International, aimed at developing an integrated and modular product for use in naturally ventilated buildings. Milton Park Ltd piloted the system in a passive solar building completed for Marston Book Services. How well has the building performed?

BY THE PROBE TEAM

PROBE

16: Marston Book Services

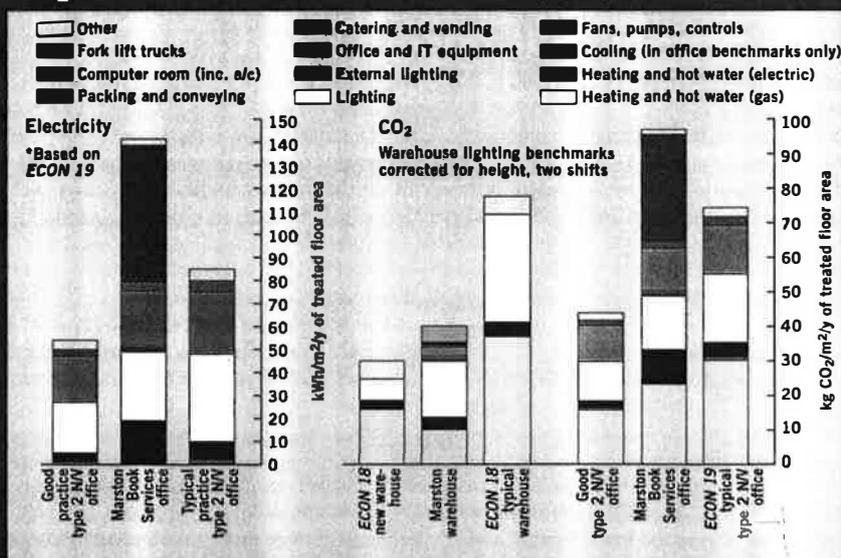
FIGURE 1: End-use energy breakdown at Marston Book Services. Conversion factors are gas: 0.2 kg CO₂/kWh and electricity: 0.52 kg CO₂/kWh. All electrical energy consumption is based on 1997 data. Although not shown, the electrical consumption of the warehouse (42 kWh/m² of footprint area, or 31 kWh/m² including the mezzanine) can be considered close to the 'improved' benchmark in ECON Guide 18.

At 6 kWh/m²/y of treated floor area, electricity for office hot water is close to the typical benchmark³ of 7 kWh/m² where water heating is electric (figure 1).

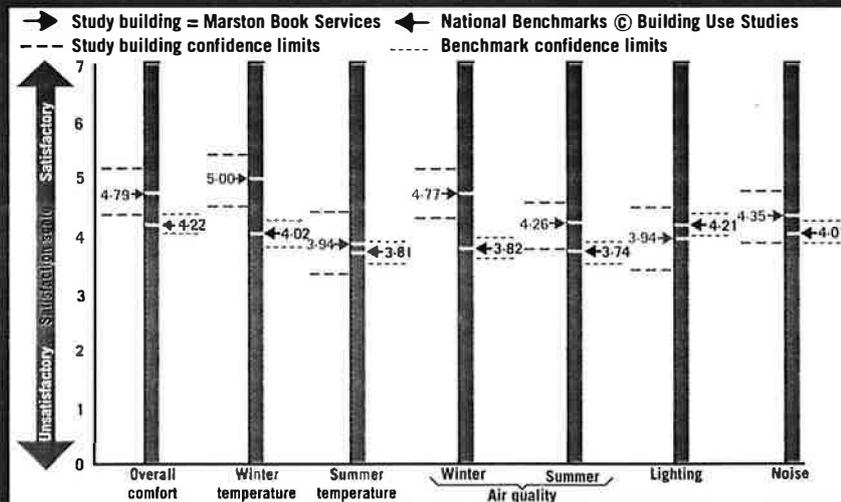
Building Use Studies (BUS) carried out a survey of all 55 office staff in 1997 (figures 2 and 3). 32% of the staff are male, compared with a 52% dataset average. 62% say they have window seats (norm: 64%). 47% are under 30 (norm: 35%). Almost all work standard hours, mostly at vdu for six hours or more each day.

FIGURE 2: Overall satisfaction with comfort conditions at Marston Book Services.

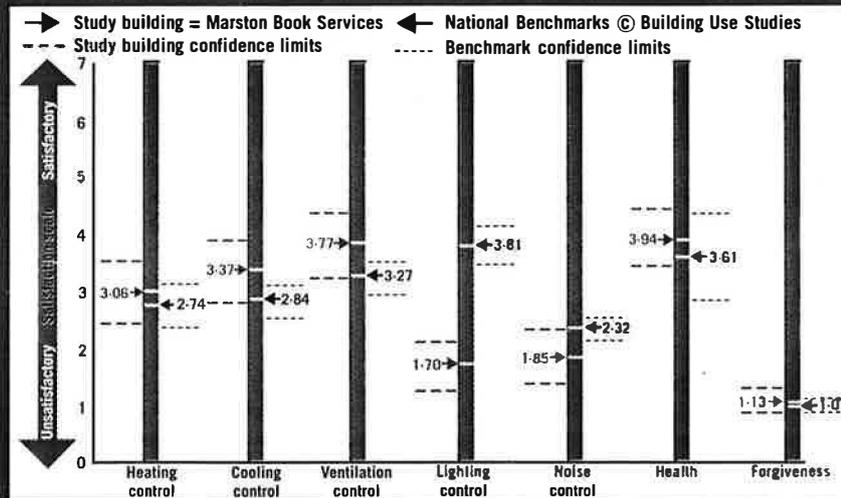
FIGURE 3: Occupant satisfaction with the building's health, management and control strategies.
