PROBE

18: Portland Building

The Portland Building is the fifth educational building to be surveyed by the PROBE Team, and the last in the current PROBE series of building investigations.

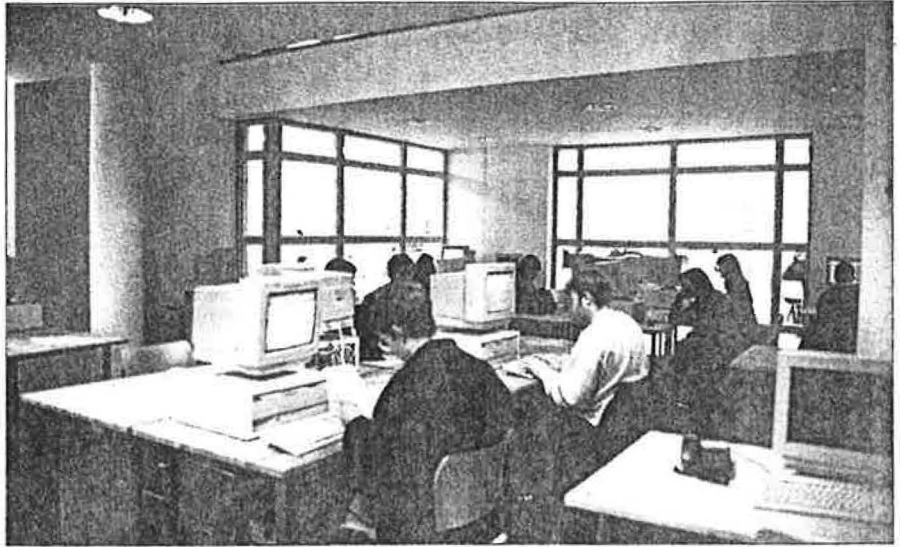
Despite glare from the artificial lighting, students' average perceived productivity at the Portland Building was very good. However, occupants tended to report that the building was "aesthetically appealing, but functionally poor".

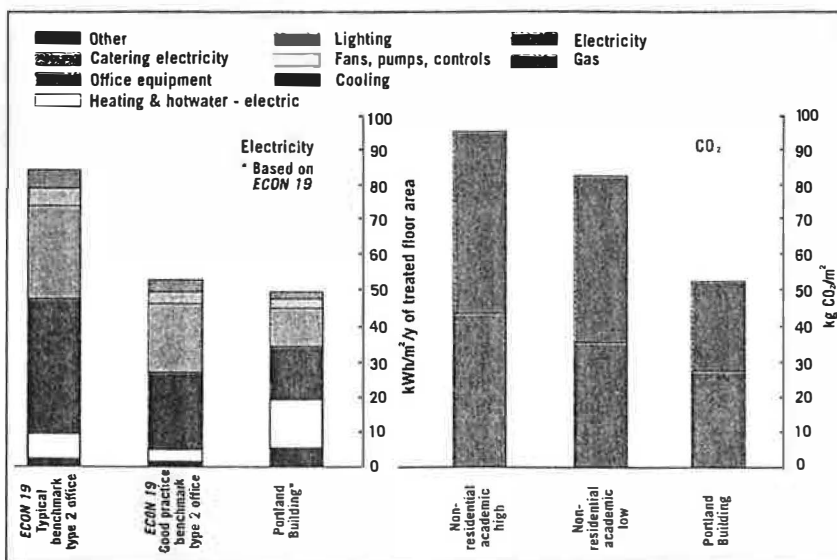
FIGURE 1: End-use energy breakdown at the Portland Building. The conversion factors are: gas – 0.2 kg CO₂/kWh and electricity – 0.52 kg CO₂/kWh. *Electricity use at the Portland Building was calculated from three weeks of monitoring of half-hourly data.

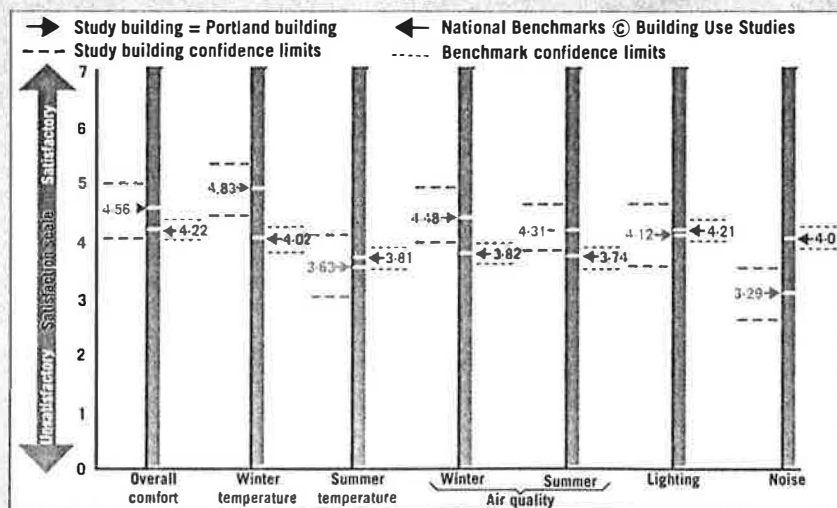
FIGURE 2: Overall satisfaction with comfort conditions at the Portland Building.

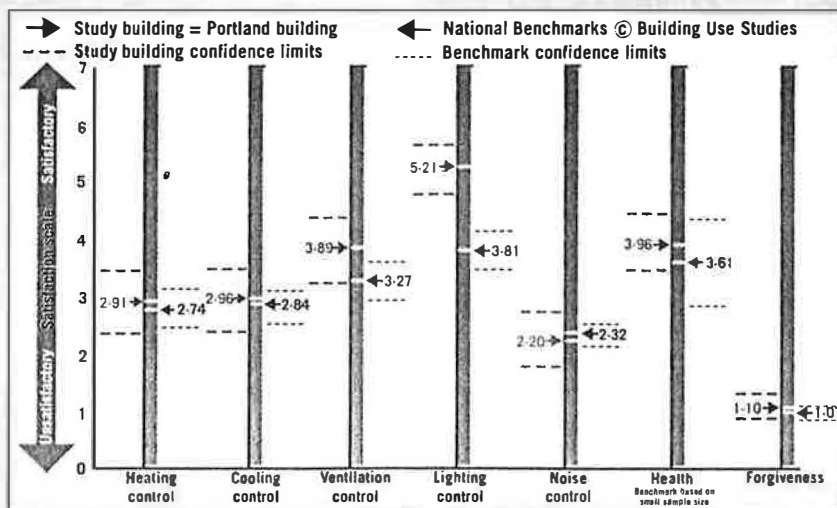
FIGURE 3: Occupant satisfaction with the building's health, management and control strategies.

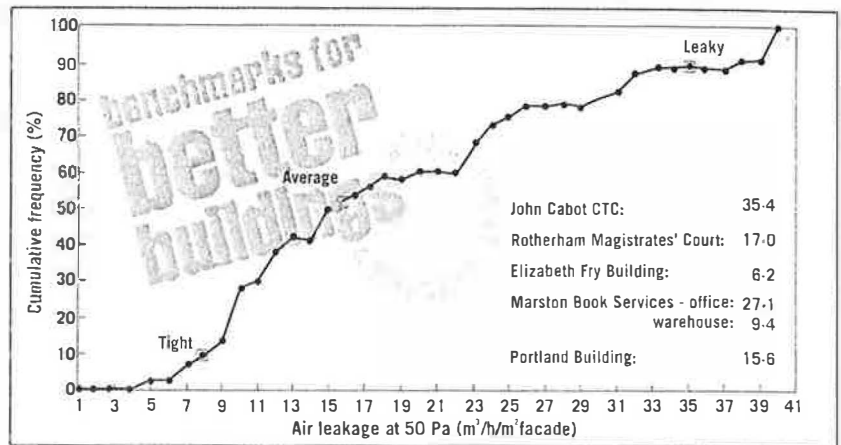
FIGURE 4: The air leakage data for the Portland Building, plotted on the BRE/BSRIA database.

The air leakage index (or Q-value) for the Portland Building was calculated to be 15.6 m³/h/m² of envelope area at a reference pressure of 50 Pa. This indicates that the building performs about average on the joint BRE/BSRIA database (figure 4). In the BRE's opinion, a tight non-domestic

The air leakage audit showed that the roof/wall junctions on the third floor were very leaky. The junctions between the RSJs and timber beams were also found to be very leaky, with large gaps visible. Air was detected coming from the ventilation towers, indicating that these structures were not airtight.

The windows were found to be generally quite good, with minimal air leakage through them. However, there was significant air leakage around the south-facing timber bay windows, especially along the floor joint. The stairwell windows were also found to be slightly leaky at the frame wall junction.

All of the external doors had significant air leakage through them. The fire doors on the ground floor in the small lecture theatre leaked badly, both at the bottom and along the right-hand sides.
