## field notes

# Solving a Chimney Moisture Problem

by Joe Ponessa

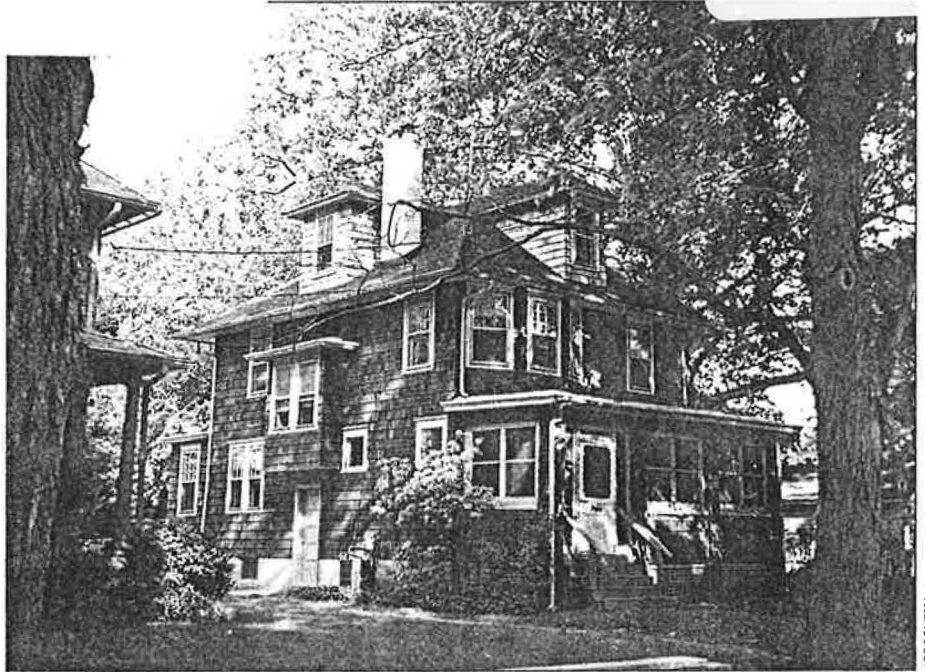
In September 1998, roofer Kevin Fischer, carpenter/painter Bill Coyle, and I were called to help out on an 80-year-old, three-story, wood frame house located in southern New Jersey. The house had a chimney-related moisture problem that had been worsening over a couple of years. Damage to the plaster-and-lath walls surrounding one corner of the chimney had first appeared on the second-floor ceiling and adjacent walls. By the time we got involved, damage had started to appear on the first-floor inside wall and ceiling near the chimney, under the area where damage had appeared on the second floor.

Wall damage that had appeared on the second floor around the chimney gradually worsened over time. It would reappear, even after the new roof was put on.
