Carbon Monoxide Exposure from a Vehicle in a Garage

Thomas H. Greiner, Ph.D., P.E.
Member ASHRAE

Charles V. Schwab, Ph.D.

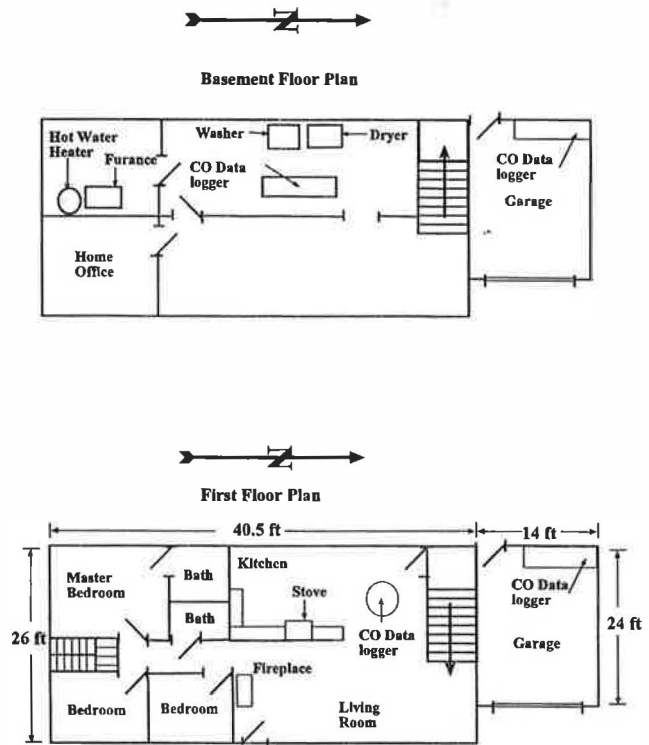
Figure 1 Floor plans of house and garage.

The standard procedure for pressure testing was followed (ASTM 1987; CGSB 1986). The house pressure testing was conducted by placing the blower door in the front door in the east wall shown in the first floor plan in Figure 1. This testing was conducting using natural conditions (no other devices operating), under various conditions using the furnace blower, and using exhaust fans in bathrooms. Analysis of the measured values was performed by supplied software (version 1992).

The garage pressure testing was conducted by placing the blower door in the exterior west door to the garage shown in

the first floor plan in Figure 1. This testing was conducted using natural conditions (no other devices operating).

The CO concentrations were measured in the house in the kitchen and basement. CO data loggers were placed on the kitchen table, as shown in the first floor plan of Figure 1, and on an exercise bench in the basement exercise room, as shown in the basement floor plan of Figure 1. The data loggers used are not temperature compensated, so they were calibrated at 70°F (21°C) and used inside the house, which was kept at 70°F (21°C). These units measure the CO concentrations with a resolution of 1 ppm and accuracy of ±3%.
