RESIDENTIAL COMBUSTION VENTING FAILURE

FINAL TECHNICAL REPORT

COUNTRY-WIDE SURVEY RESULTS

January, 1987

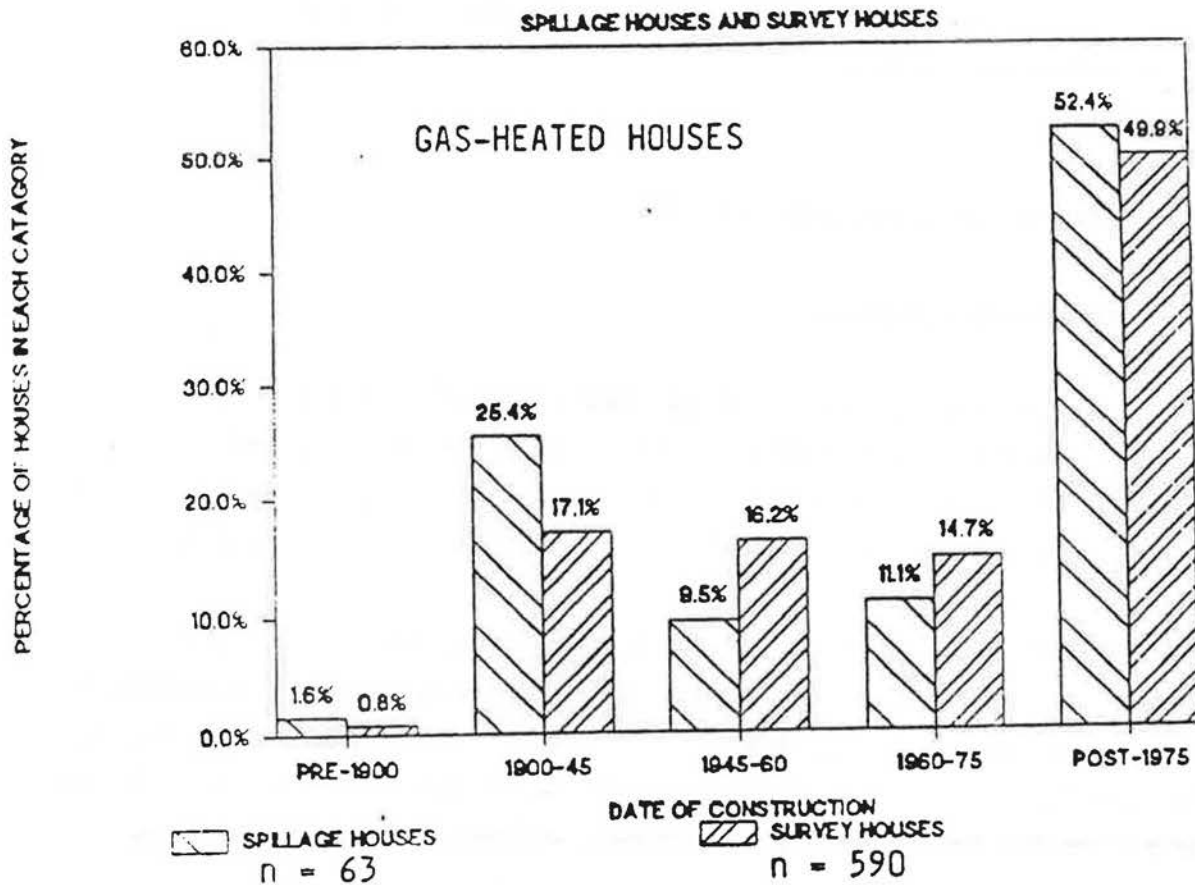
GRAPH 3: Distribution by Date of Construction

Graph 3 presents the distribution of spillage houses and survey houses by date of construction. Both the older and newer houses indicate higher than average spillage incidents. The strongest trend is towards increased problems in the pre-1945 houses, which may be related to chimney deterioration, liners, leaks, poor maintenance and fuel conversions. The higher incidence of spillage in the post-1975 houses is

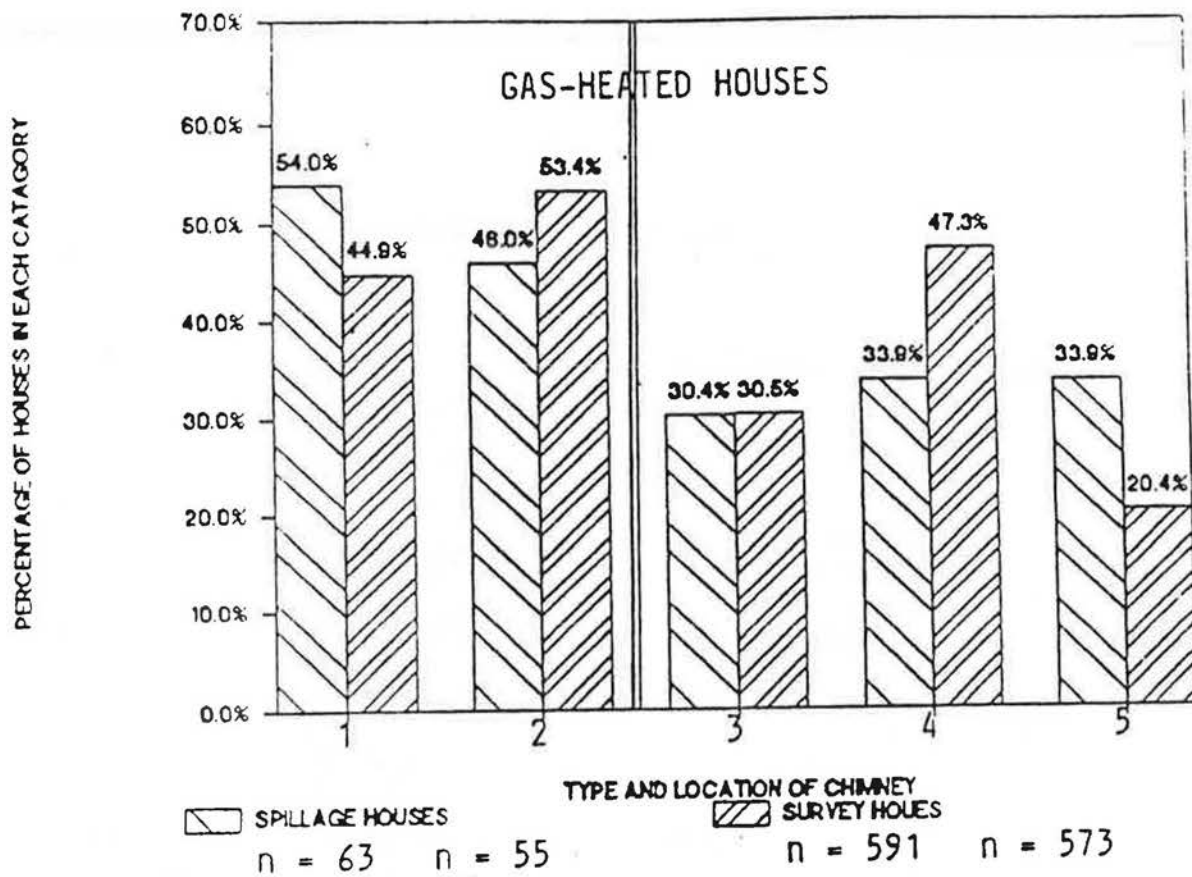
Graph 5 presents the distribution of survey spillage houses by the type and location of chimneys. There is a strong trend towards greater spillage problems with exterior chimneys, and with masonry chimneys with metal liners. Metal chimneys, on the other hand, have a much lower incidence of spillage problems in relation to the total number of houses. These trends are consistent with much of the field testing that had taken place prior to the survey, since exterior chimneys have been found to be cooler and less buoyant under some weather conditions, and to be in poorer repair due to blockages and leaks. The higher incidence of problems with lined masonry chimneys is surprising, but may be consistent with problems identified during the case study follow-up investigations, which found spillage occurring as a result of constrictions created by flexible liners, undersized liners, and rain caps.

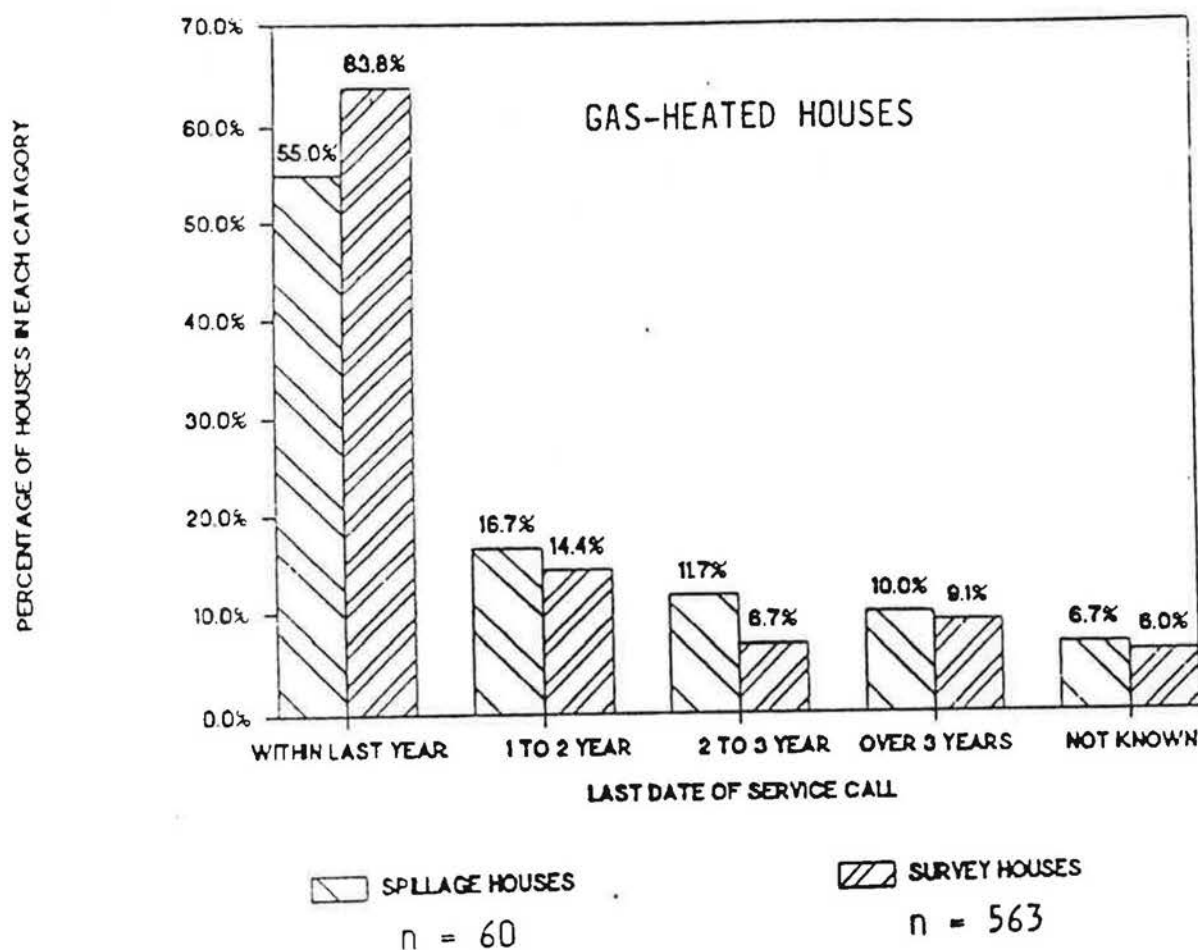
GRAPH 8: Distribution of Houses by Date of Last Service Call

Graph 8 presents the distribution of spillage in survey houses by the date of the last service call. Houses where the appliance has been serviced within the last year show a significantly lower proportion of spillage houses when compared to houses where the last service call was more than one year previous.

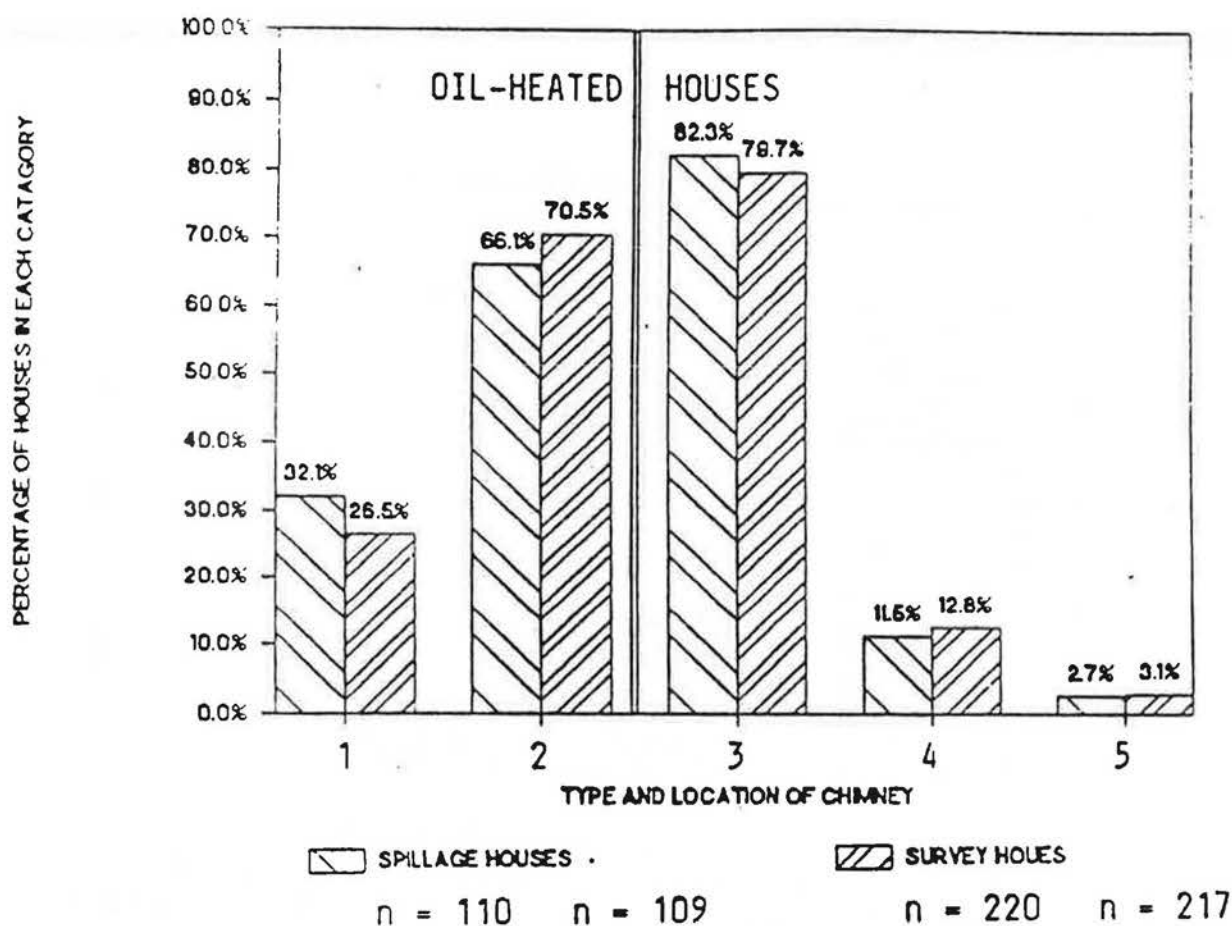
Graph 12 presents the distribution of oil-heated houses by type and location of chimney. Exterior chimneys appear more likely to experience spillage problems than interior chimneys. Masonry chimneys appear more likely to have problems than metal chimneys, although the variations are not great.

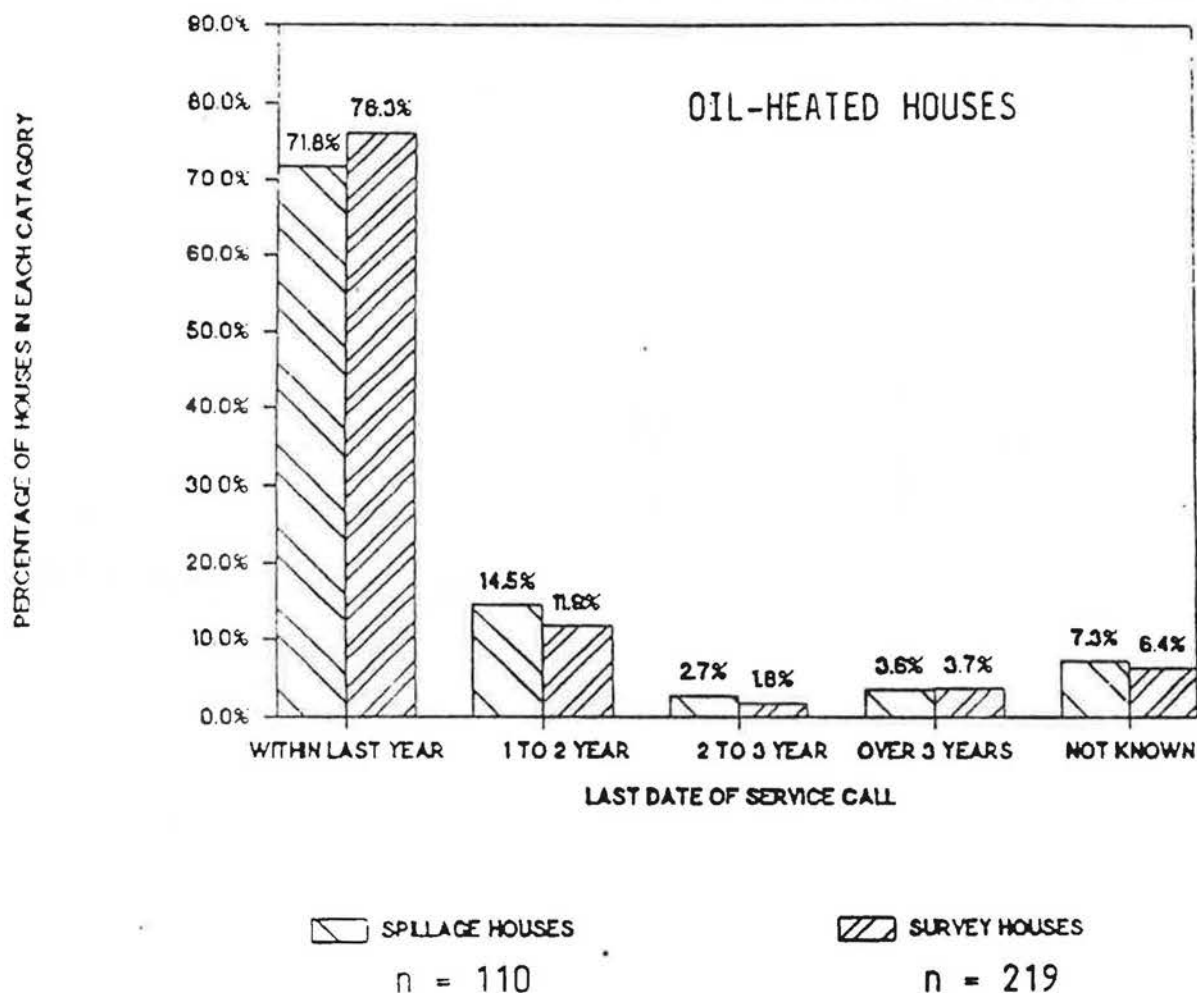
GRAPH 15: Distribution of Houses by Date of Last Service Call

Graph 15 presents the distribution of oil-heated houses by date of last service call. Houses that have had their furnace serviced in the last year appear to have a lower proportion of spillage incidents. The distribution of houses in these categories is almost identical to the gas-heated houses.
