RESIDENTIAL COMBUSTION VENTING FAILURE

PROJECT 5:

REMEDIAL MEASURES FOR WOOD-BURNING FIREPLACES:

AIRTIGHT DOORS WITH DIRECT AIR SUPPLY

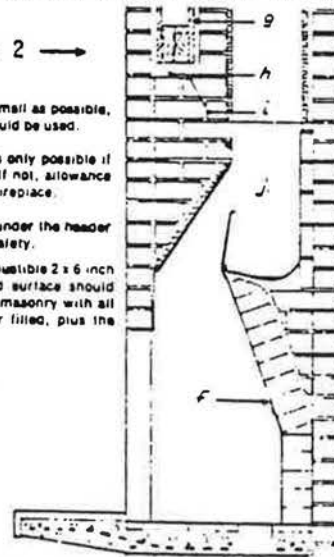
Compare Figure 1 with Figure 2 which is taken from "Fireplace Report", an industry guide for the design and construction of fireplaces and chimneys published by the Alberta Masonry Institute. Note the differences between Figures 1 and 2. The major shortcomings in Figure 1 are:

- (1) Plywood sheathing which forms part of the outside wall, is in direct contact with the chimney's masonry blocks. Building code requires a minimum of 1/2" clearance.
- (2) The thickness of masonry in the smoke chamber (the portion above the throat up to the beginning of the tile liner) is only 4". The building code requires 7-1/2" of solid masonry.

- (4) People who have existing installations of fireplace inserts, heat exchangers and tight fitting glass doors in their fireplaces should inspect their fireplaces and make the necessary modifications if they find that their fireplaces are similar to our Figure 1. If modifications to the masonry fireplace is not a viable alternative, they should remove the fireplace insert or at least refrain from using it.

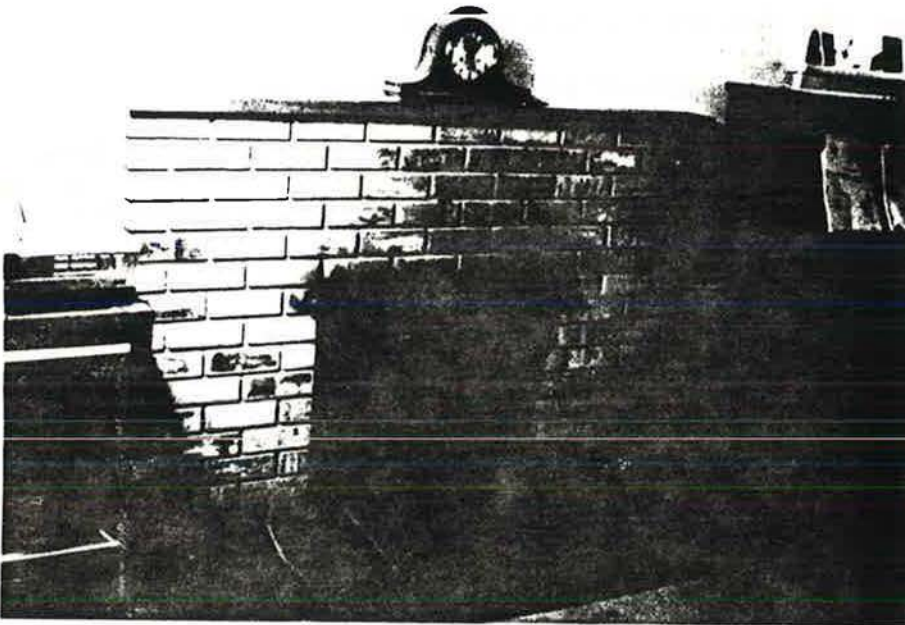
2. Fireplace as found.

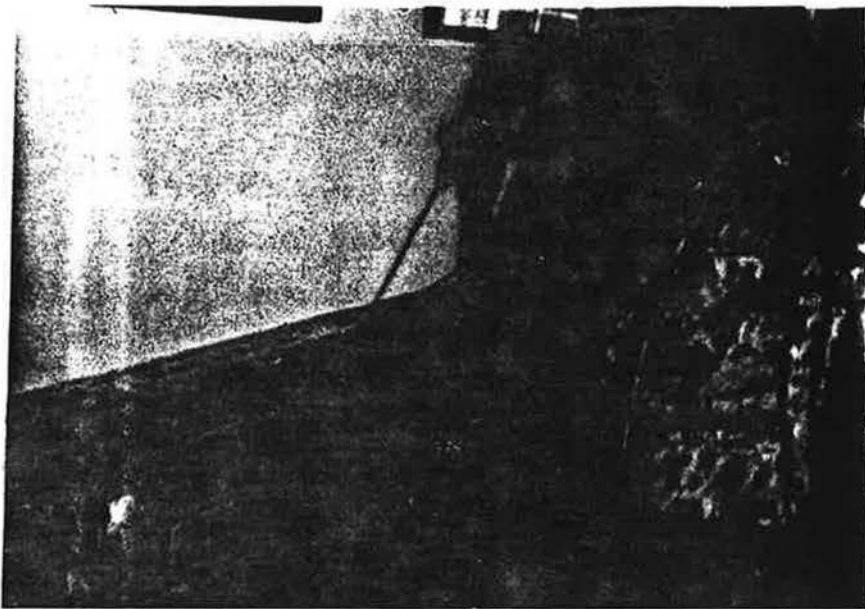
Drilling holes and noting the change of material that was being drilled through by feel and by examining the bore debris enabled the exact location of the bottom of the header to be found. Holes were drilled with an extended 9.5 mm masonry bit on a standard drill. The holes drilled diagonally, under the header, or directly through the mortar between bricks. The damage was slight and easily repaired, and the holes were completed quickly.

7. Drilling probe holes below mantle with extended masonry bit.

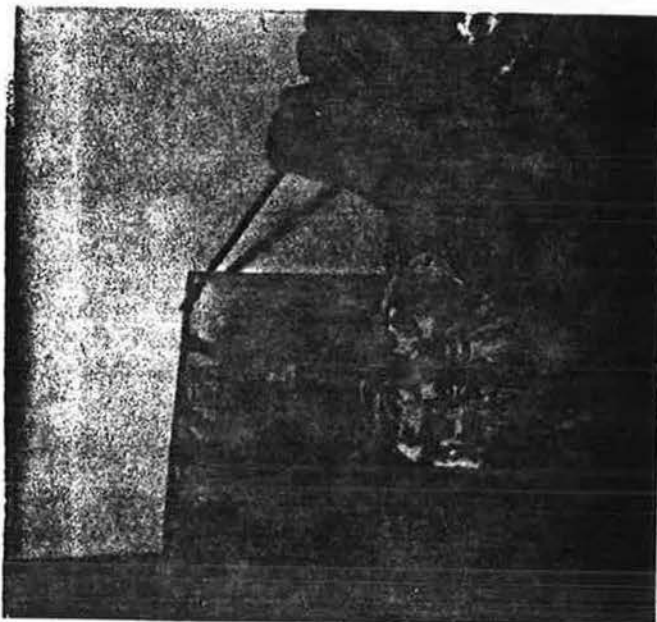
6. Estimating best locations for drill holes to locate (nearest combustible material next to unlined flue, e.g. header).
