**RESIDENTIAL COMBUSTION
VENTING FAILURES -
A SYSTEMS APPROACH**

**A SURVEY OF FIREPLACE
SPILLAGE INCIDENTS IN
TWENTY-FOUR HOUSES**

FINAL REPORT

**Prepared by
Sheltair Scientific Ltd.
Scanada-Sheltair Consortium**

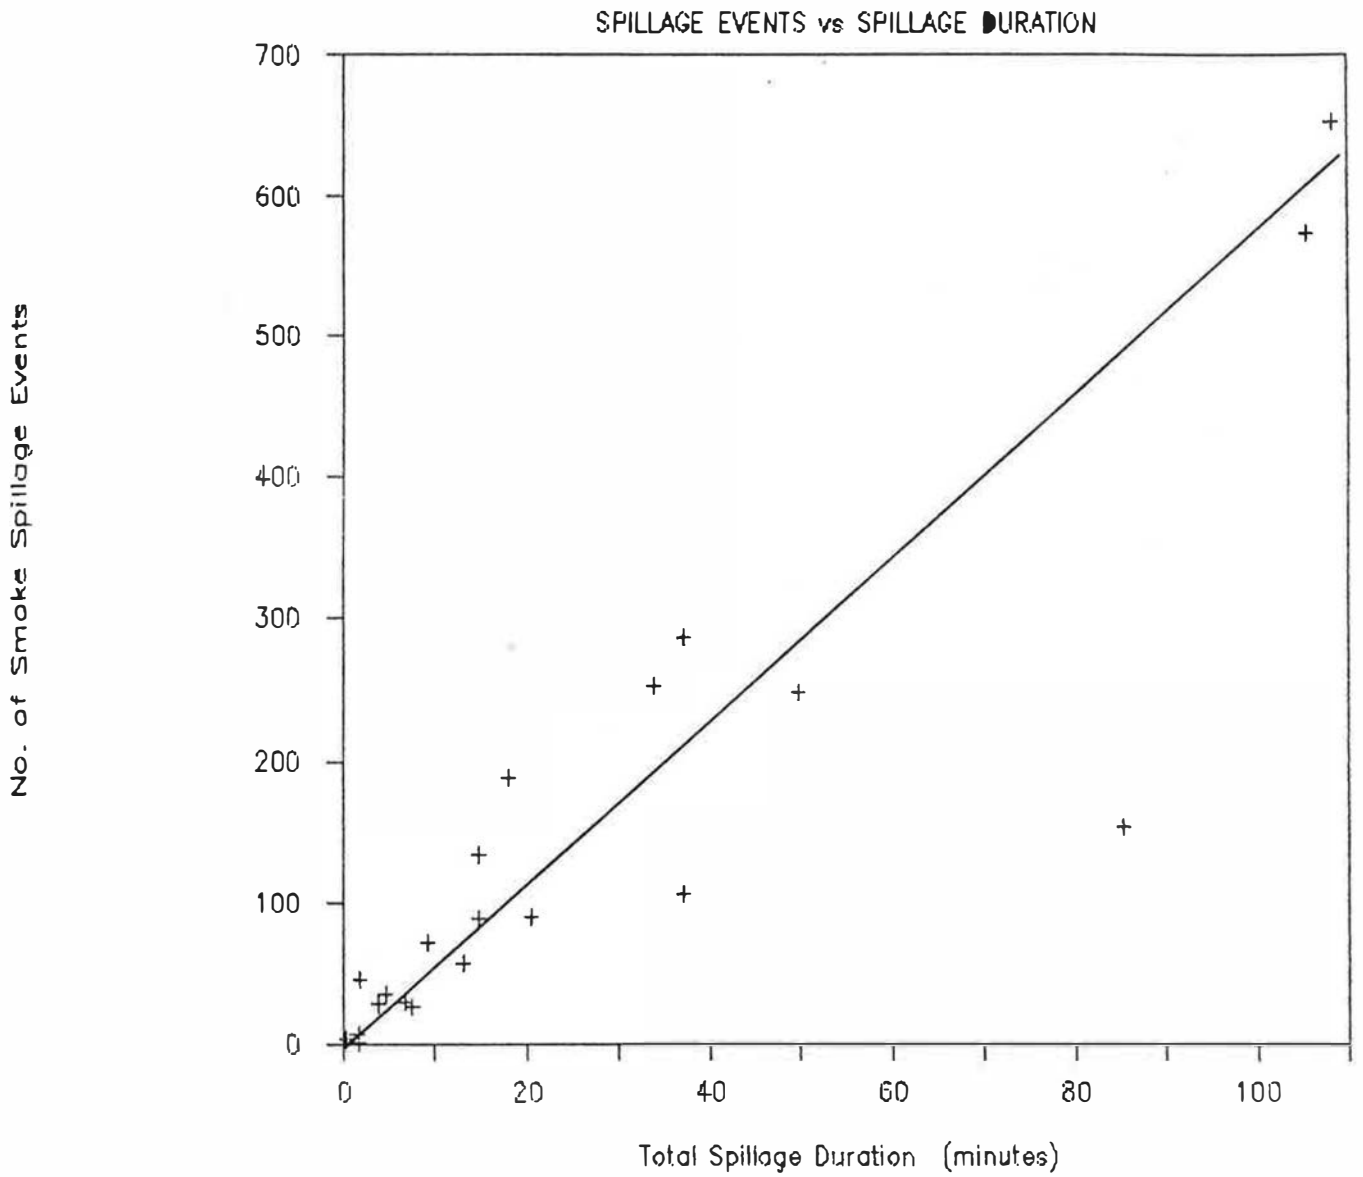
FIGURE 1
SMOKE SPILLAGE EVENT FREQUENCY IN RELATION
TO TOTAL SPILLAGE TIME FOR EACH FIREPLACE

The event frequency increases in proportion to the duration of smoke spillage for each fireplace. Consequently, the average length of a smoke spillage event is fairly consistent from house to house, averaging 0.2 minutes (or 12 seconds). The correlation between events and duration is illustrated in Figure 1, (correlation coefficient = 0.898).
