CONSTRUCTION DETAILS AFFECTING WALL CONDENSATION

Robert J. Kudder, Kenneth M. Lies and Kurt R. Hoigard*

SYNOPSIS

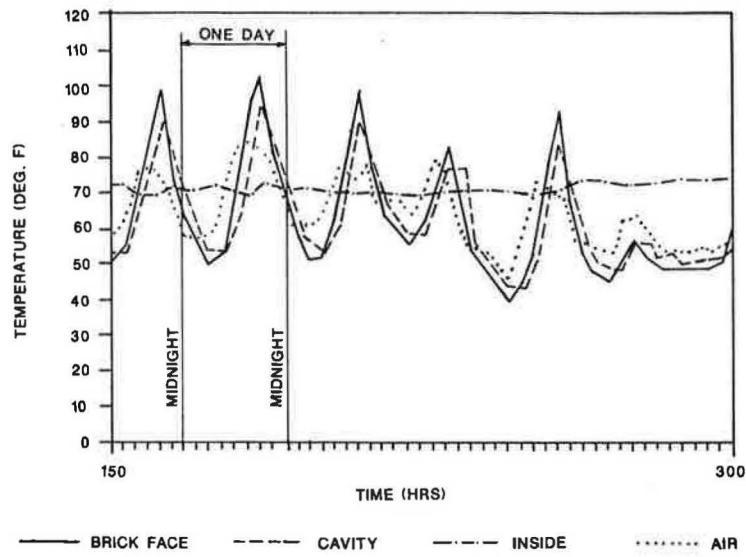
A building in the upper Midwest was instrumented to monitor the performance of the wall during the winter season. The typical wall cross section is shown in Figure 8. The details of the wall construction included the problems illustrated in Figures 1 and 3. The instrumentation program included thermocouples to measure the brick surface temperature, the cavity temperature, and the interior temperature. Relative humidity was monitored in the cavity and the building interior. Differential pressure transducers monitored the pressure difference between the interior and the cavity, and between the interior and the exterior. A portable weather station installed on the roof of the building monitored exterior air temperature, wind speed, and direction. The instrumentation program was conducted for approximately two months during the winter season. Data was acquired for both heating cycles and cooling cycles of the building operating system. Condensation performance was suspected as a problem because of the construction details observed, as discussed above. In addition, where exfiltration paths existed, such as at weep holes in the masonry or at sealant failures, condensation on the face of the brick was apparent, as seen in Figure 9. At times, during the early thaw of spring, the building surface was observed to be wet and dripping, and was described by the Owner as "weeping". When temperatures dropped well below freezing during this period, icicles formed on the face of the masonry. These phenomena occurred when there was no rainfall or snowfall immediately prior to these observations. Wall temperature measurement data for a 150-hour segment of the data record is shown in Figure 10. Measured relative humidity data, and differential pressure data for the same time period are shown in Figures 11 and 12. Calculated specific humidity for the same time period is shown in Figure 13. The temperature data in Figure 10 exhibits two interesting phenomena. During periods when the outside air temperature was lower than the interior temperature, and the building was being heated, the surface temperature of the brick was measured to be lower than the outside air temperature. A comparison between the predicted behavior of the wall on the basis of a conductive heat loss calculation, and measured temperatures and relative humidities, is shown in Figure 14. The cavity temperature and the brick surface temperature are approximately 15 percent lower than the outside air temperature. The relative humidity measured in the cavity at that time was 100 percent. Condensation had been occurring in the cavity for some length of time, and evaporation of the condensate lowered the surface temperature of the brick. Essentially, during the heating cycle at night, the building behaved as an evaporative cooling tower. This phenomenon has also been observed on other buildings with instrumentation programs incorporating heat flux transducers. Measurements were obtained which indicate that heat appeared to flow from the exterior to the interior during periods when the outside temperature was very low. Evaporative cooling, with perhaps some radiant cooling, accounts for the apparent reversal of heat flow.

Measured wall temperature data.

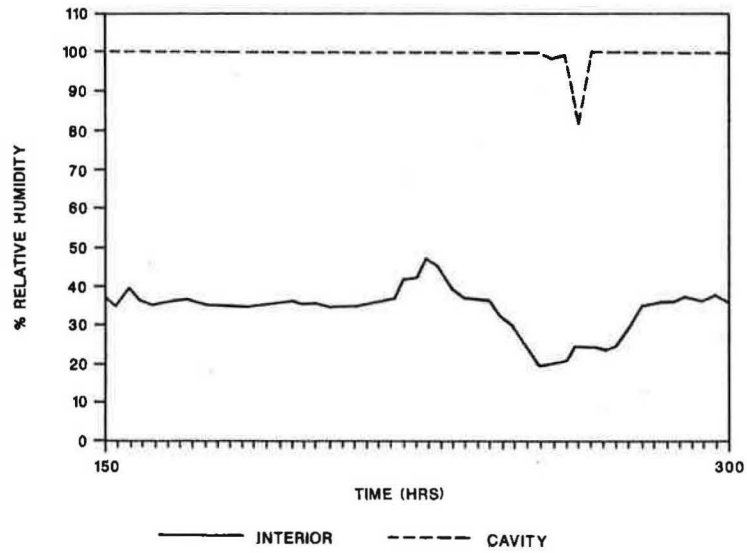
Figure 11

The temperature and relative humidity measurements indicate that interior conditioned air is circulating in the cavity, and that condensation is occurring. The lack of isolation between the interior and the cavity is also demonstrated by the differential pressure data shown in Figure 12. There is very little difference in pressure between the cavity and the interior, indicating an essentially unobstructed exchange of air. Additional differential pressure measurements were made during manual operation of the ventilating fans of the building HVAC system. Fans were turned off and the pressures were monitored for 20 minutes; fans were then turned on and the monitoring continued. The operation of the fans created no noticeable differential pressure between the interior and the cavity, confirming the existence of large air flow paths.

Measured wall relative humidity data.

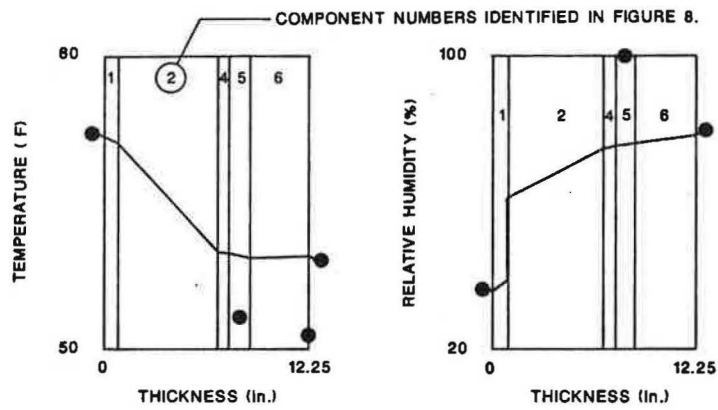
When the exterior air temperature was higher than the interior, and sun heating of the brick occurred, the cavity temperature was measured to be lower than the air temperature, while at the same time the brick surface temperature was predictably higher than the air temperature. A comparison during this period between the predicted behavior on the basis of conductive heat loss calculations, with measured temperature and humidity data, are also shown in Figure 14. Cavity temperatures lower than would have been predicted by conductive heat loss calculations during the cooling cycle of the building operating system are attributed to the circulation of cooled interior air in the cavity and the daily evaporation cycle of moisture trapped in the cavity. This daily evaporation cycle is best illustrated by the calculated specific humidity plots in Figure 13. Even though the relative humidity stayed at 100 percent during this time period, the specific humidity varied on a daily basis. This change of total amount of moisture in the air produced a cooling effect on the cavity.

Figure 13
Calculated specific humidity data.

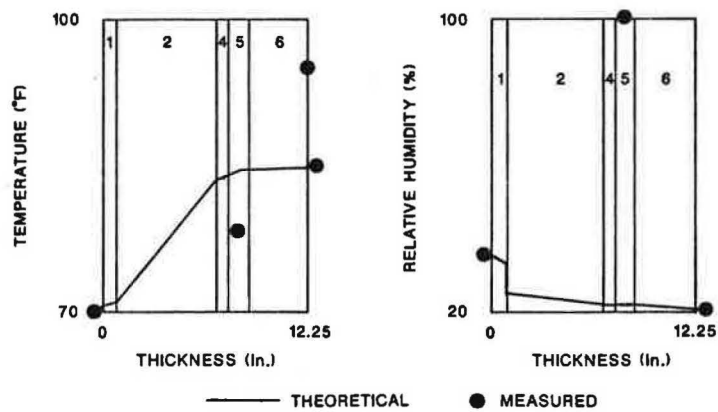
Figure 14

HEATING (Hour 174, 6 am)

COOLING (Hour 183, 3 pm)

Comparison of behavior predicted by conductive heat loss calculations with measured temperatures and humidity data.
