A CASE STUDY OF THE CAUSE OF ROOF MOISTURE DAMAGE

George A. Tsongas, Ph.D., P.E.
Mechanical Engineering Department
Portland State University
Portland, OR 97207

Bruce Bolme, P.E.
U.S. Army Corps of Engineers
Trail, OR 97541

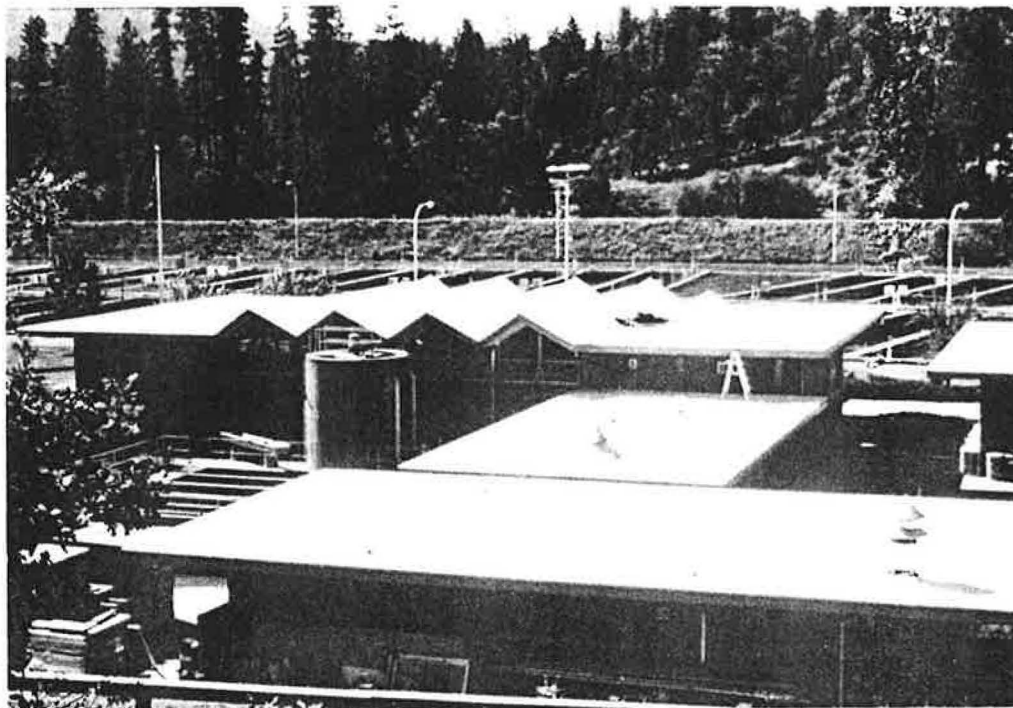
Fig. 1. Flat-roofed Cole Rivers Hatchery buildings.

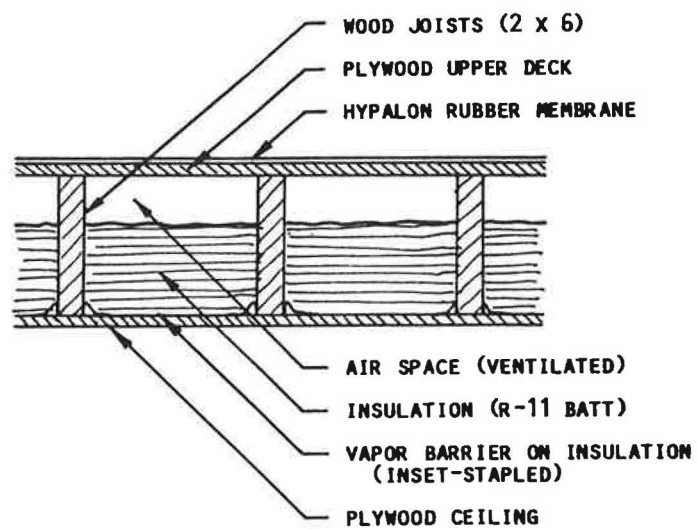
The roofs of the buildings are for the most part flat, except for slight sloping for drainage (see Figures 1 and 2). They consist of 3/8 in. (9.5 mm) 4x8 plywood sheets on the bottom (or inside) surface as well as the top (or outside) surface. The top surface is slightly sloped to drains (1/4"/ft min.). The two plywood deck surfaces are separated by 2x6 rafters connected to the bottom plywood with another 2x6 nailed onto the side of the lower rafters to provide the proper top plywood surface slope. The roof cavity contains R-11 mineral wool batt insulation with its aluminum vapor retarder facing insert stapled on the inside surface (thus the vapor retarder is not continuous). The roof cavity has minimal ventilation consisting of a one inch wide soffit vent opening on the bottom of the roof overhang at the roof edge. In actuality, there is little or no ventilation because 2x4 blocking was installed to nail the plywood sheet edges. That blocking and the batt insulation effectively restricts air flow so that the volume of air below each outer 4x8 plywood sheet is not ventilated. Finally, the outer plywood surface is covered with a hypalon rubber membrane.

Fig. 2. Flat roof cross-section sketch.
