INVESTIGATION OF CRAWL SPACE VENTILATION
AND
MOISTURE CONTROL STRATEGIES
FOR B.C. HOUSES

APPENDICES

Research Division
Canada Mortgage and Housing Corporation

Sheltair Scientific Ltd.
#2 - 3661 W. 4th Ave.
Vancouver, B.C. V6R 1P2

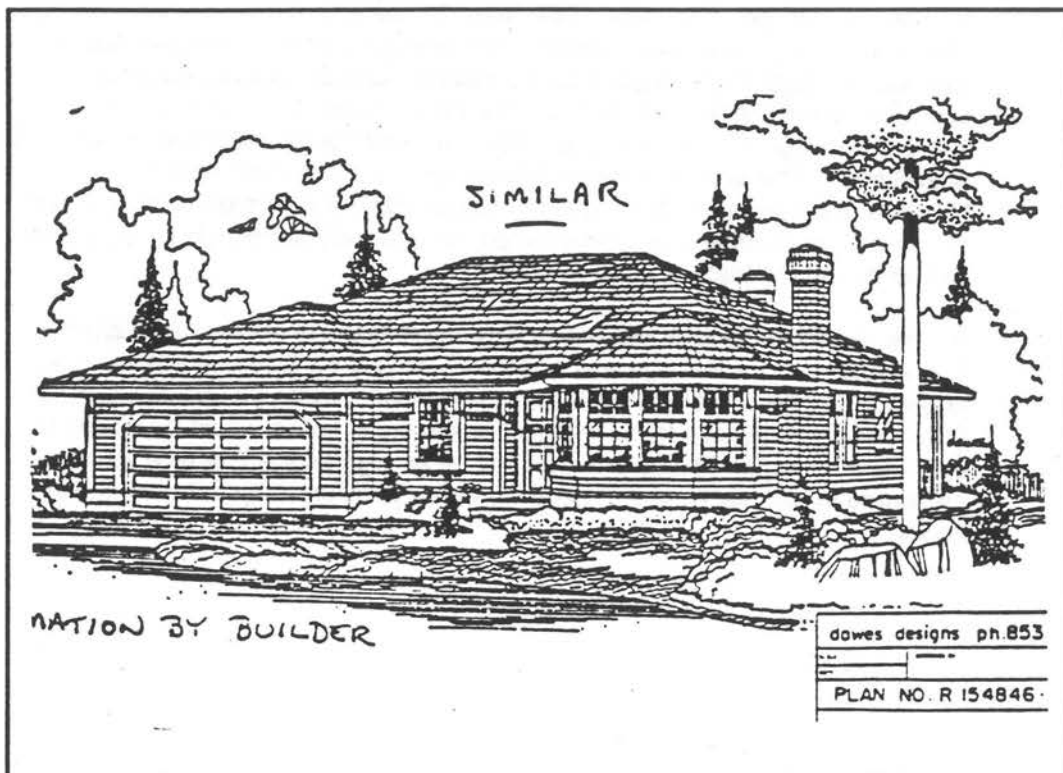
Figure 1: Front Elevation of House

The house was referred to Sheltair by NHWP who had received a complaint about surface water on the crawl space floor and high moisture and a musty smell in the living areas of the house.

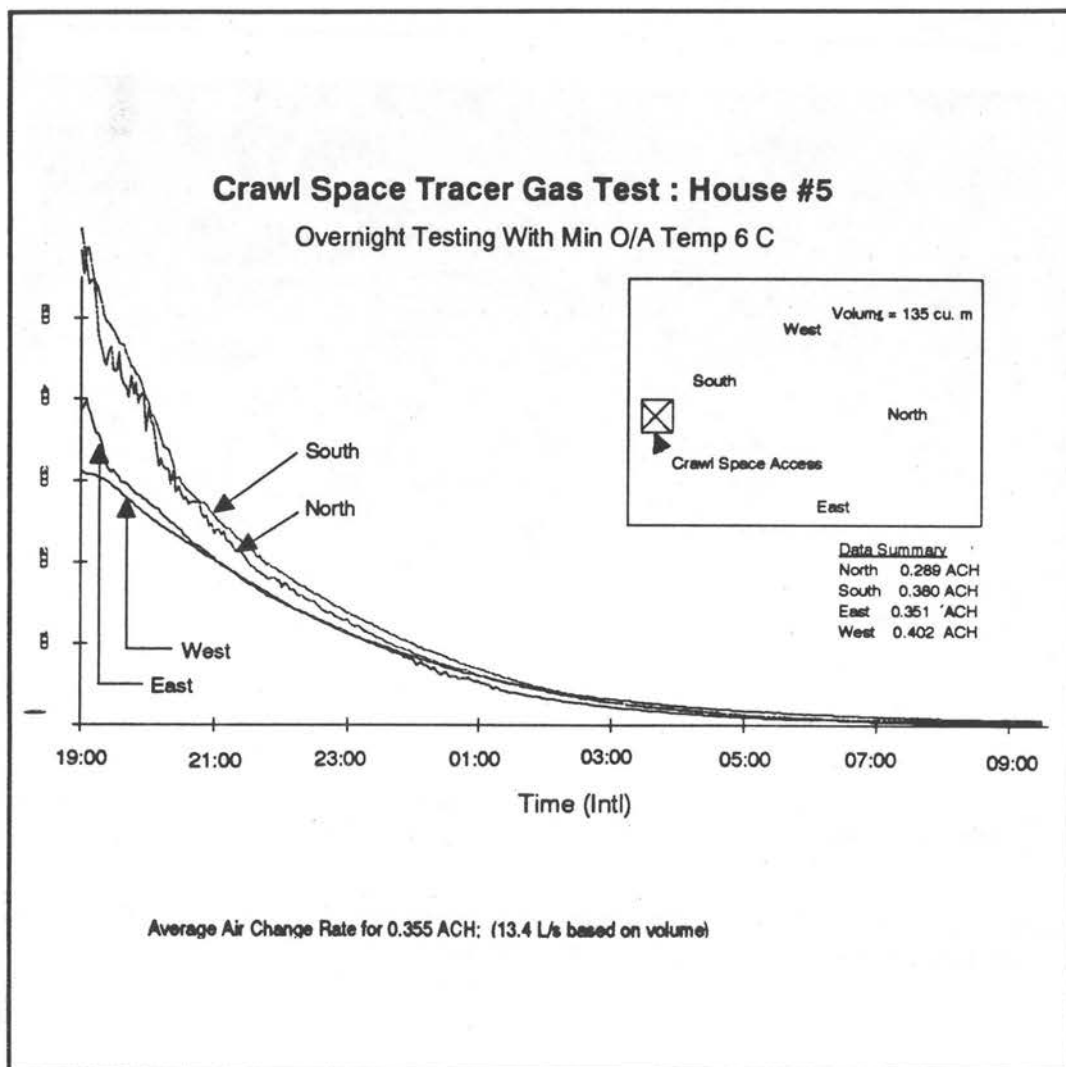
Figure 10: Graph Showing Steady Decay of Tracer Gas in House #5 Crawl Space

Tracer Gas Air Change Test: The house was initially unconditioned and the heating system was energized after initial moisture measurements were taken. When the house reached stable temperature conditions a tracer gas air change test was done. The air change test commenced in the evening and the tracer gas analyzer was left running until the next morning with an average ACH for the crawl space of 0.356. This calculates to 13.3 L/s of outdoor air entering the space through cracks and leaks driven by wind and stack pressure. The average temperature outdoors was 10 °C and in the space 18 °C. A summary of the data collected is provided below as well as a graph showing the decrease in air change rate as the distance from the crawl space hatch increases. It was observed that most of the interface leakage is in this area because of plumbing penetrations and the hatch itself.

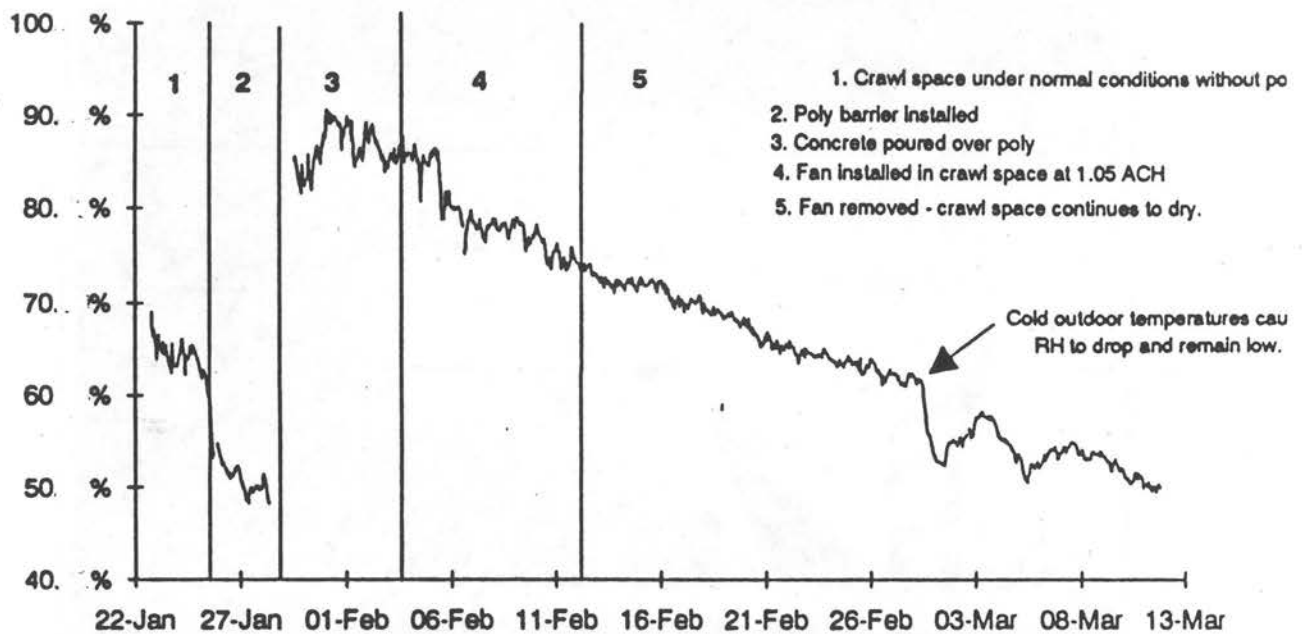
House #6 Post-retrofit Crawl Space Relative Humidity

After reviewing the data collected, it was seen that the moisture levels in the crawl space had stabilized at approximately 1.5 gm/kg higher than outdoors. This was a similar level that measured just prior to the placement of the new floor. This does not imply that the retrofit was not successful. The monitoring period was not long enough to give any satisfactoring conclusions about the long term effectiveness. At the time the data logger was removed, there was still considerable residual moisture in the structural members to hold the moisture at this steady level. During a cold period however, as can be seen in the graphs below, the crawl space dried out very quickly over 1 - 2 days and the levels did not rebound. Measurements of the slab MC show that the new concrete is already much drier than the original concrete MC. The following graphs & tables show the pattern of events and moisture levels over the entire monitoring period.

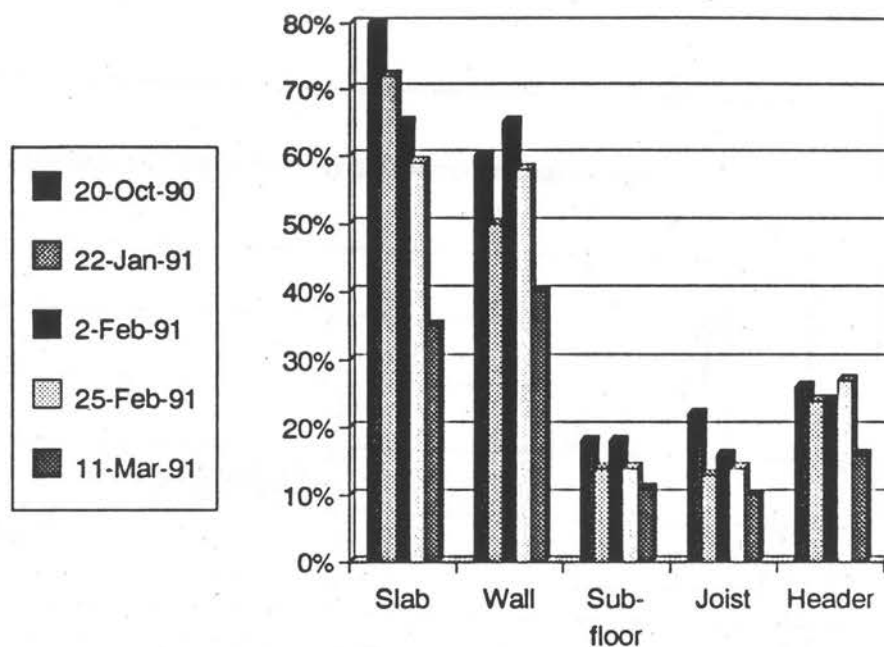
Moisture content measurements in House #6 crawl space over course of monitoring period.

Date	Location of measurement				
	Concrete M.C.		Wood M.C.		
	Slab	Wall	Sub-floor	Joist	Header
20-Oct-90	80%	60%	18%	22%	26%
22-Jan-91	72%	50%	14%	13%	24%
2-Feb-91	65%	65%	18%	16%	24%
25-Feb-91	59%	58%	14%	14%	27%
11-Mar-91	35%	40%	11%	10%	16%

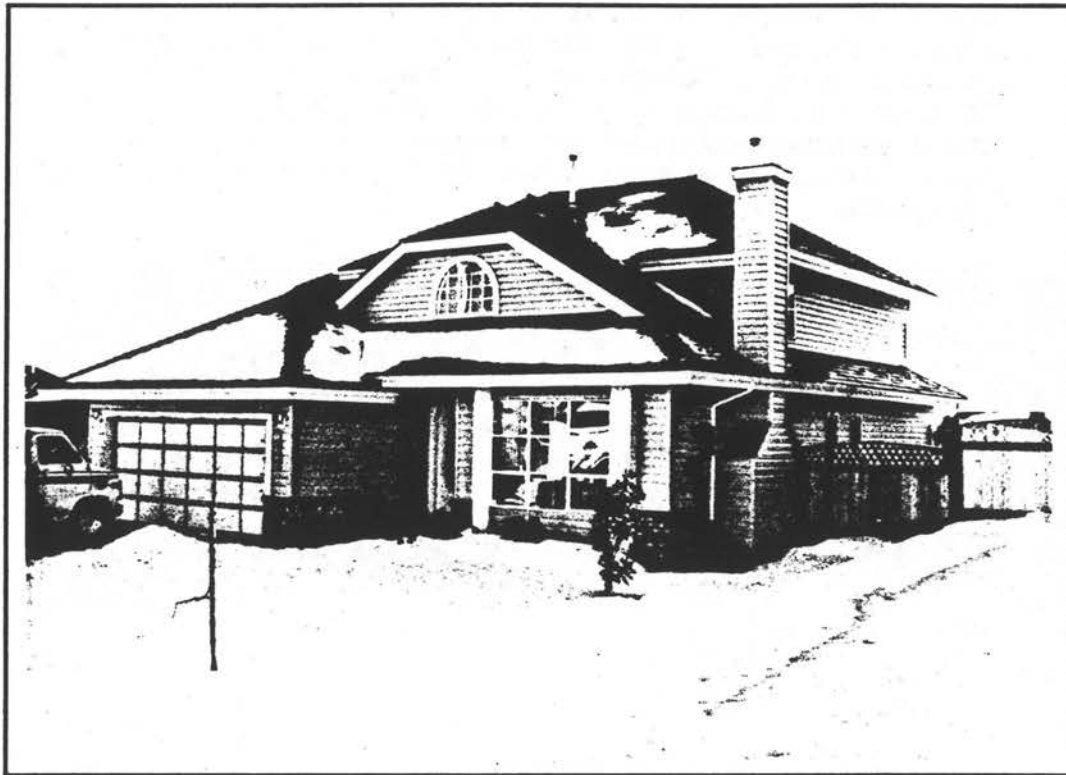
Figure 18: Front Elevation of House

Problem History: The owners had moved into their new home in May 1990. They used the crawl space for storage of camping gear and other materials. Dampness was noticed throughout the house by occupants. After several months of living in the home it was discovered that all of the materials stored in the crawl space had been ruined by excessive moisture. During raining periods the crawl space would be in float with up to six inches of water. The occupants assumed that poor drainage was the cause of their problems. The west side of the house was especially problematic, and became a swamp in wetter weather. The homeowner attempted to drain the entire lot, by digging a ditch along the west perimeter, and laying drain tiles at the bottom of the ditch. The ditch proved unsuccessful. The builder had no suggestions on how to solve the problem. The homeowners received help from the site supervisor for the developer of the subdivision, who first visited the site in November 1990. On December 24, 1990 three holes were broken through the concrete skin coat in the concrete, three pits were dug. A Little Giant water pump and piping system was installed as a temporary sump pump. (see photo) Continuous pumping reduced water levels from six inches to puddles. On January 3, 1991, vents were installed around the perimeter of the crawl space and left open, and additional warm air registers were opened into the crawl space. (see photos)

Findings and observations: The visit by researchers on January 4, 1991 revealed very high moisture levels in the crawl space and house. It would still be too early for the remedial measures to have any impact. Due to the cold weather at the time, windows throughout the house were covered in thick condensation and ice. Inspection of the crawl space revealed an extremely wet situation, with pooling and running water throughout, and heavy condensation build-up behind batts and behind the wall moisture barrier.

Moisture Content: Moisture content of wood varied considerably depending on location, with the wall sill joints ranging from 60 - 85%, and the sills themselves ranging from 15-24%.

It was difficult to understand the strategy that had been adapted by the contractor to resolve the moisture problem. The addition of crawl space vents would presumably assist in drying out the space. The addition of warm air supply to the crawl space may also be explained in terms of shortening the dry out period. However with open puddles around the crawl space, warmer temperatures could lead to additional humidity entering the living areas of the house. To evaluate this potential problem measurements were taken of pressure differential between the house and crawl space and outdoors. Figure 20 illustrates the pressure differentials in between these three zones, and reveals that under the normal operating condition, with the furnace blower running at low speed, the house is depressurized by over two Pascals relative to the crawl space. With the furnace blower operating at high the situation is even worse. The homeowners can expect more moisture problems indoors than before, given this situation. Advice was offered by researchers free of charge to assist in reversing the air and moisture flows. An offer was also made to develop a long term solution for their crawl space moisture problems. However the occupants decided to wait for further action from the site supervisor, or from the New Home Warranty Program if necessary. A short term solution was outlined for the residents, as follows:
