Auditing the All-Electric Multifamily Building

By Vicky Hayes

A rehabbed, all-electric multifamily building can give an auditor one whale of a headache—or the satisfaction of a job well done, if idiosyncrasies are transformed into insights.

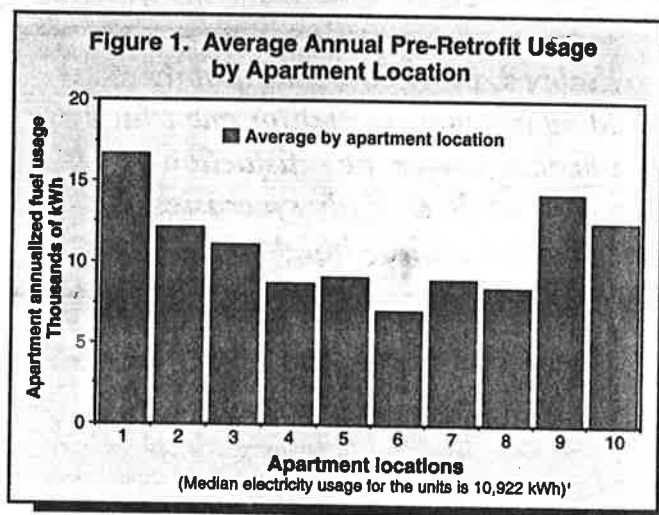
Auditors at the Steinhorst Square complex found the apartments were built as a series of boxes within the frame of the original factory building. Massive gaps created severe convection currents.
