**Monitoring of Automatic  
Diagnostic Sensors for  
Oil-fired Heating Equipment**

Final Report

**Canada Mortgage And Housing Corporation**  
National Office  
682 Montreal Road  
Ottawa, Ontario

September, 1991  
BLP File No. 2513

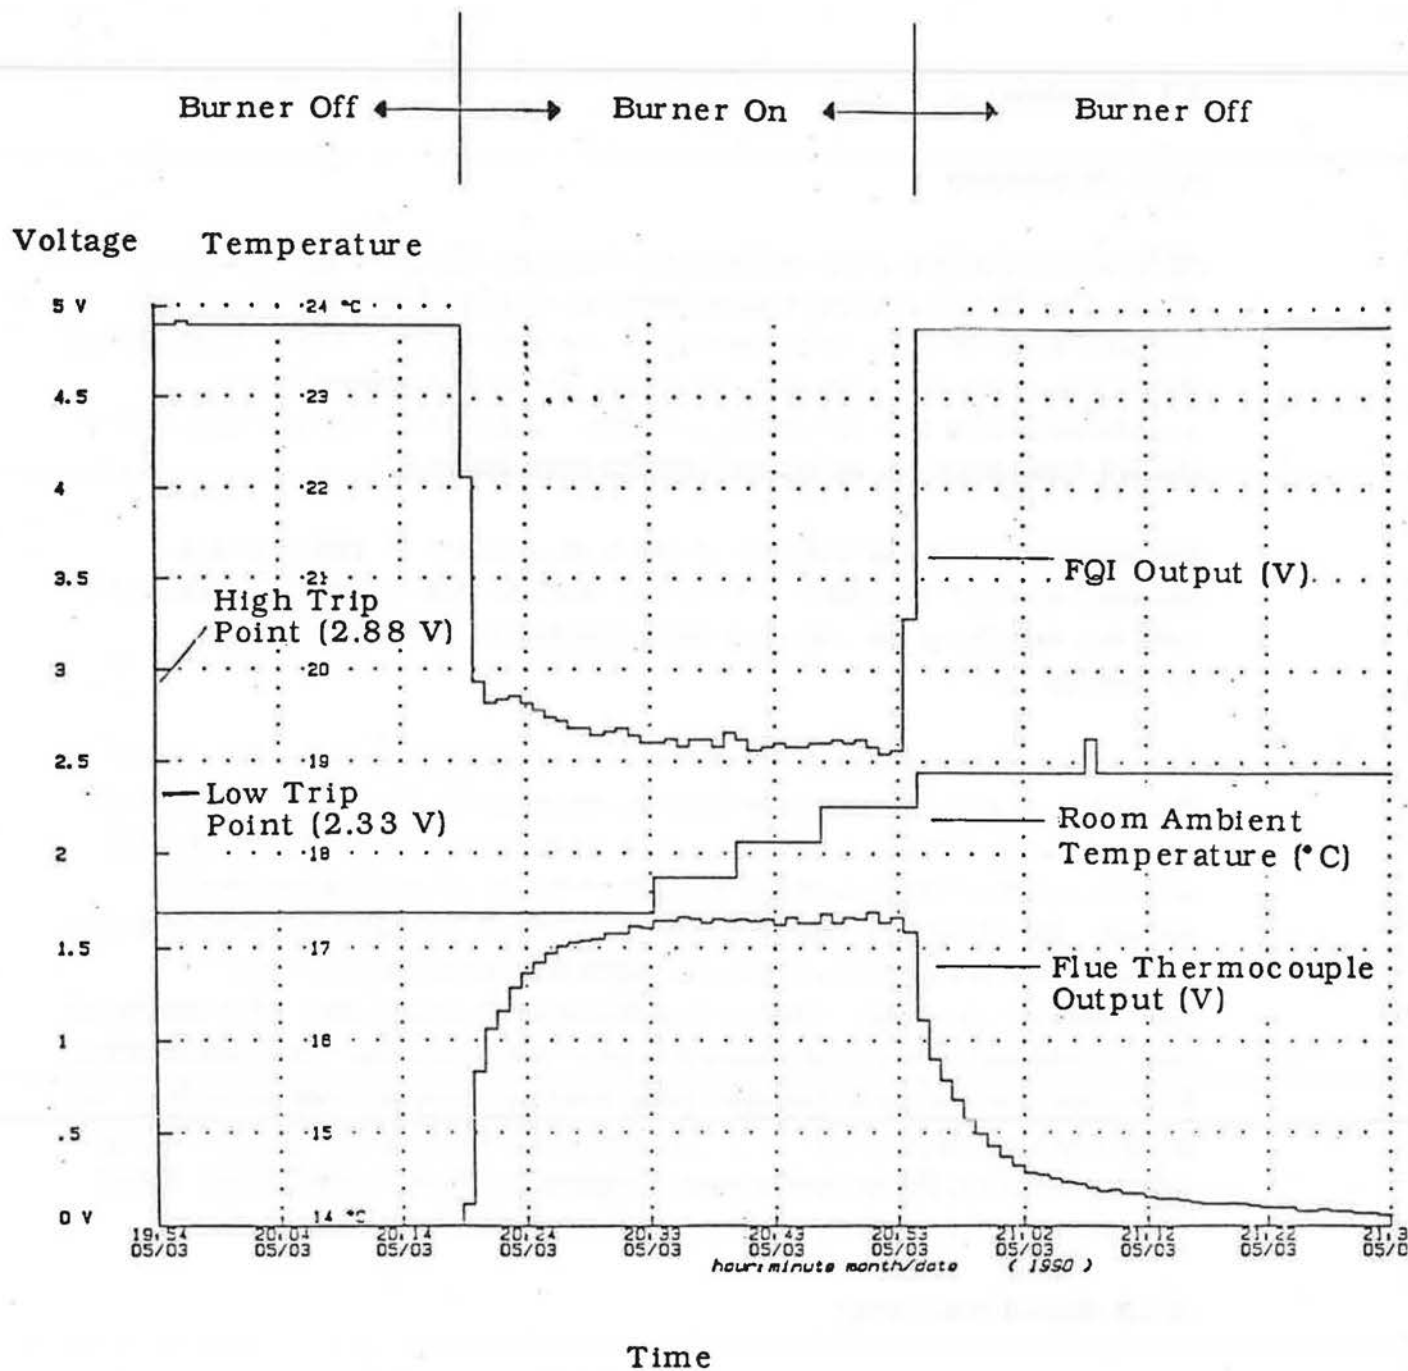
**Figure 3.1 – Sample Firing Cycle**

Note that the FQI output is 5 V when the burner is off. At 20:19 the burner ignites and the FQI signal approaches a steady state value. Between 20:19 and 20:21, the FQI output was above the HIGH trip of 2.88 V, causing an erroneous HIGH light condition. After 20:21 the FQI output falls below the HIGH trip and the OK light would have been illuminated. This initial erroneous HIGH alert is normal. It is a function of the refractory liner in the combustion chamber warming up and its effect on the light reaching the CAD cell. If the firing cycle gets interrupted, it is possible that an invalid HIGH alert would be generated. This is a very unlikely circumstance. It should be noted that future FQIs will have a timer that will keep the indicator light colour on the FQI from changing during startup. Therefore no erroneous HIGH alerts will result during startup or if a firing cycle is prematurely interrupted.

At 20:27, the voltage attains a steady state value of roughly 2.6 V indicating near perfect performance. The time required for the CAD cell to reach steady state (*response time*) is an important characteristic. The response time for this firing cycle is approximately six minutes. After 34 minutes the burner shuts off. The voltage just prior to 20:53 is the most reliable as the CAD cell has fully warmed-up. It is this value that was plotted and tracked in Section 3.2.1 and Appendix A.

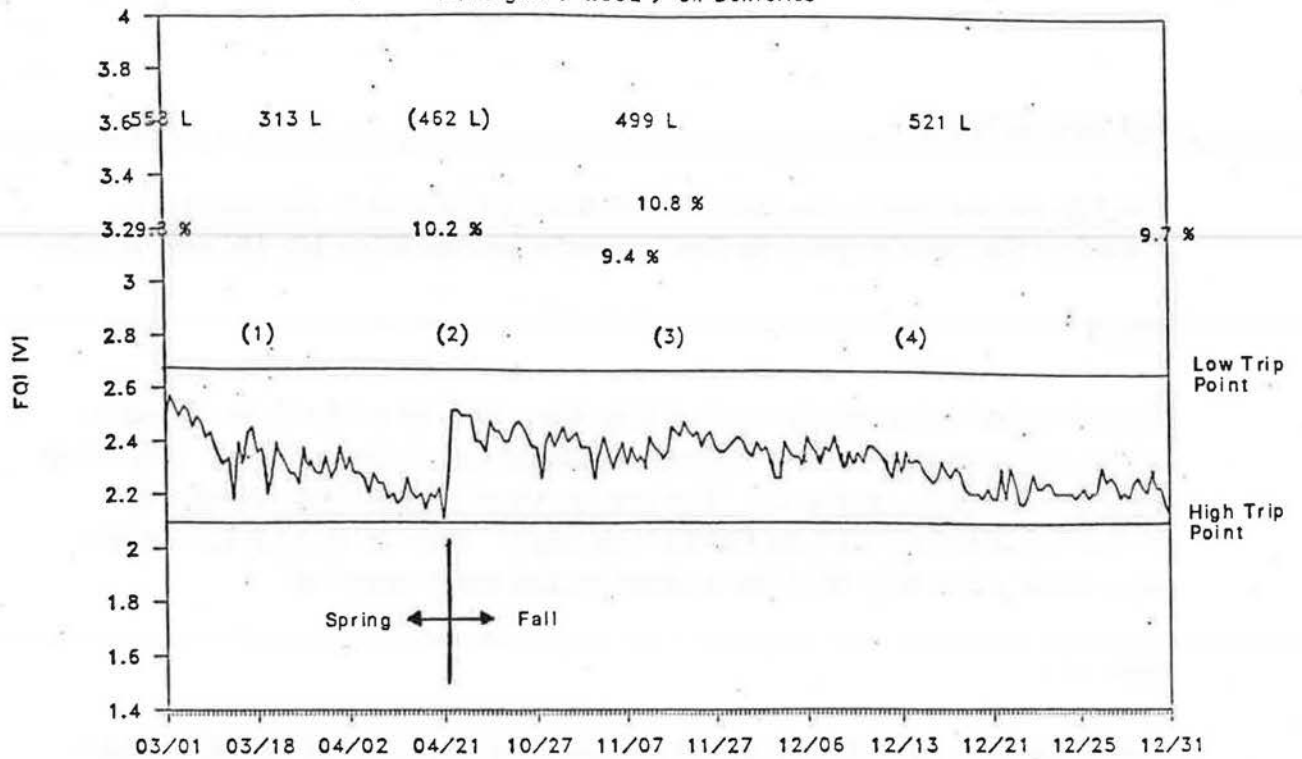
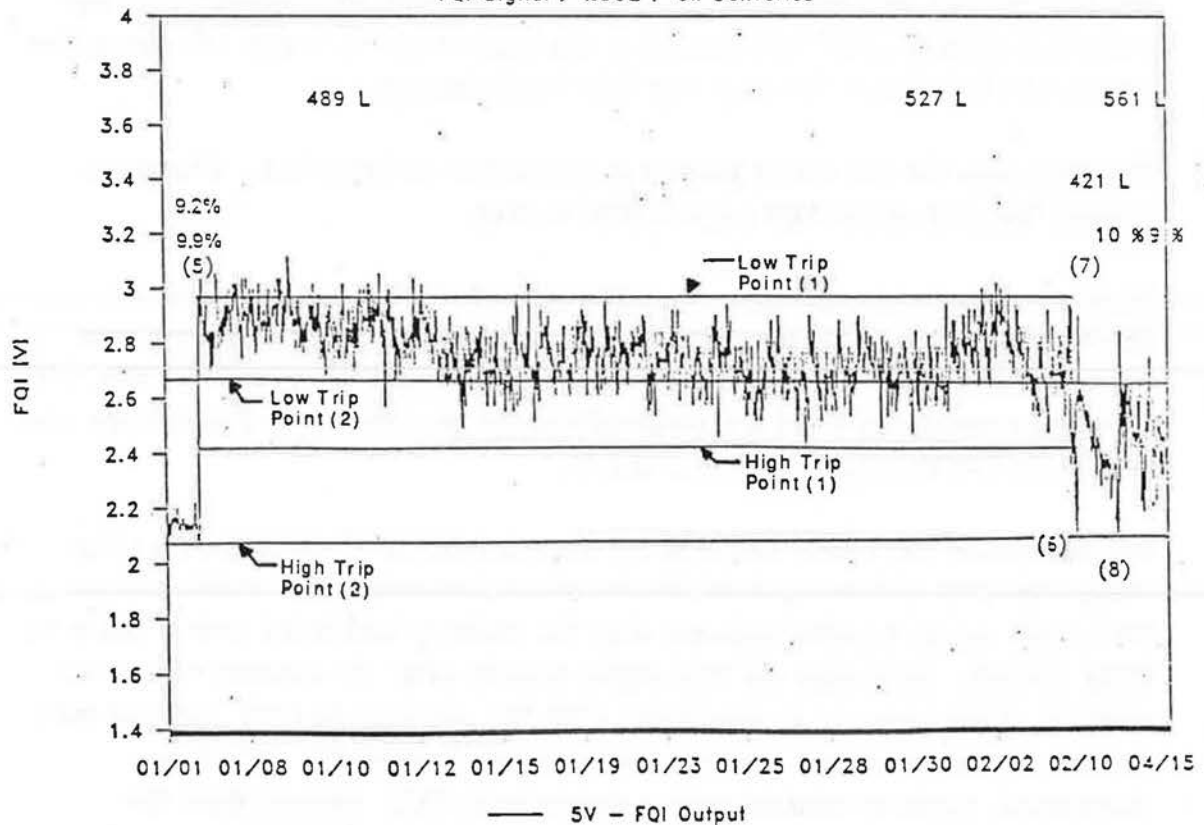
Figure A.1 - Site 1A FQI Results

previous spring as the CO<sub>2</sub> content was measured to be 10.2% on April 26, 1990 at 10:00h.

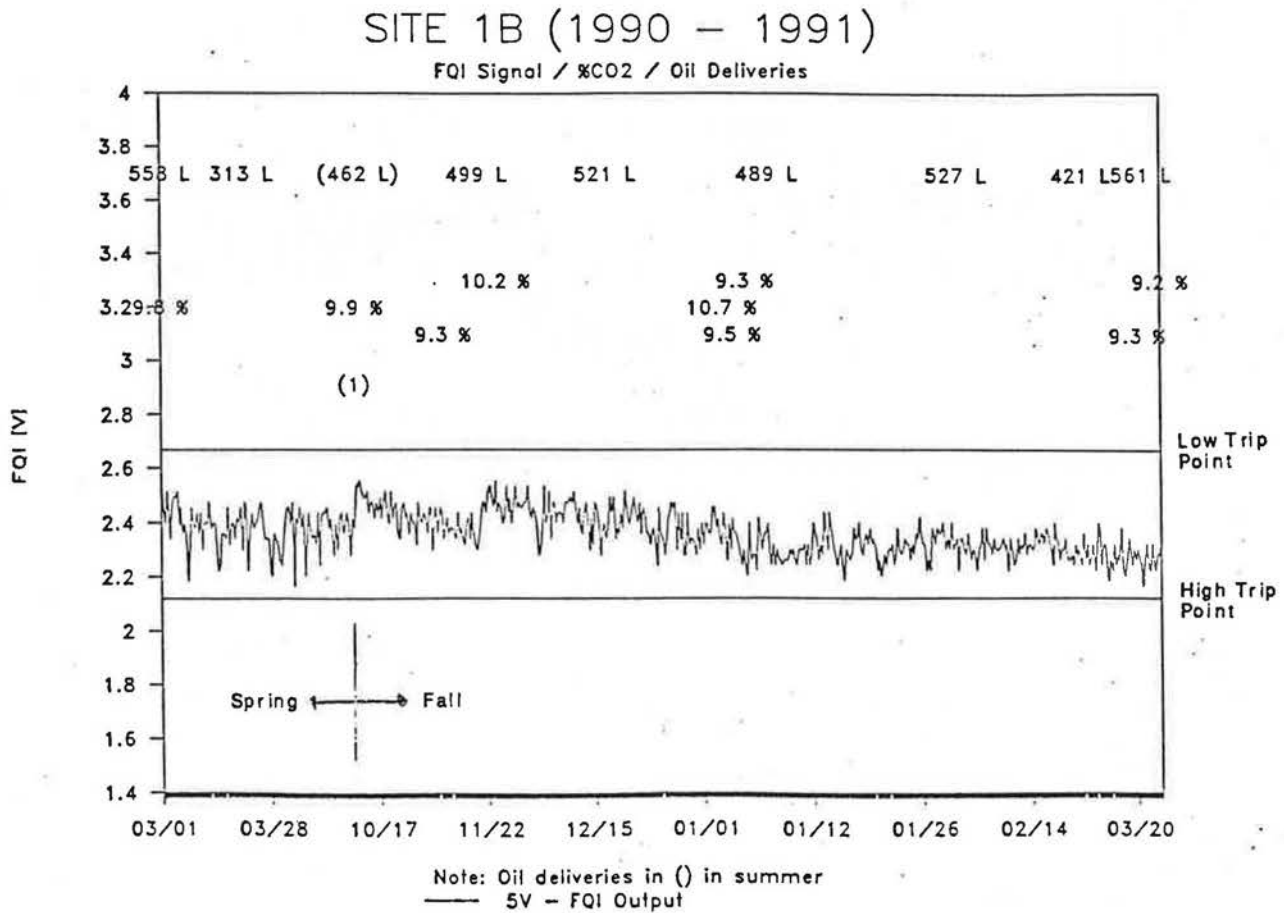
**Figure A.2 - Site 1B FQI Results**

CO<sub>2</sub> measurements taken at the time of the installation and coincident with item (1) (9.8% and 9.9%) were in agreement with the lack of drift over the '89-'90 season. Over the course of the '90-'91 heating season there is a small amount of downward drift. With the exception of one CO<sub>2</sub> reading of 10.4%,

taken on January 4, 1990 at 15:20h, this drift tracks the measured CO<sub>2</sub> content. There were no alerts at site 1B.

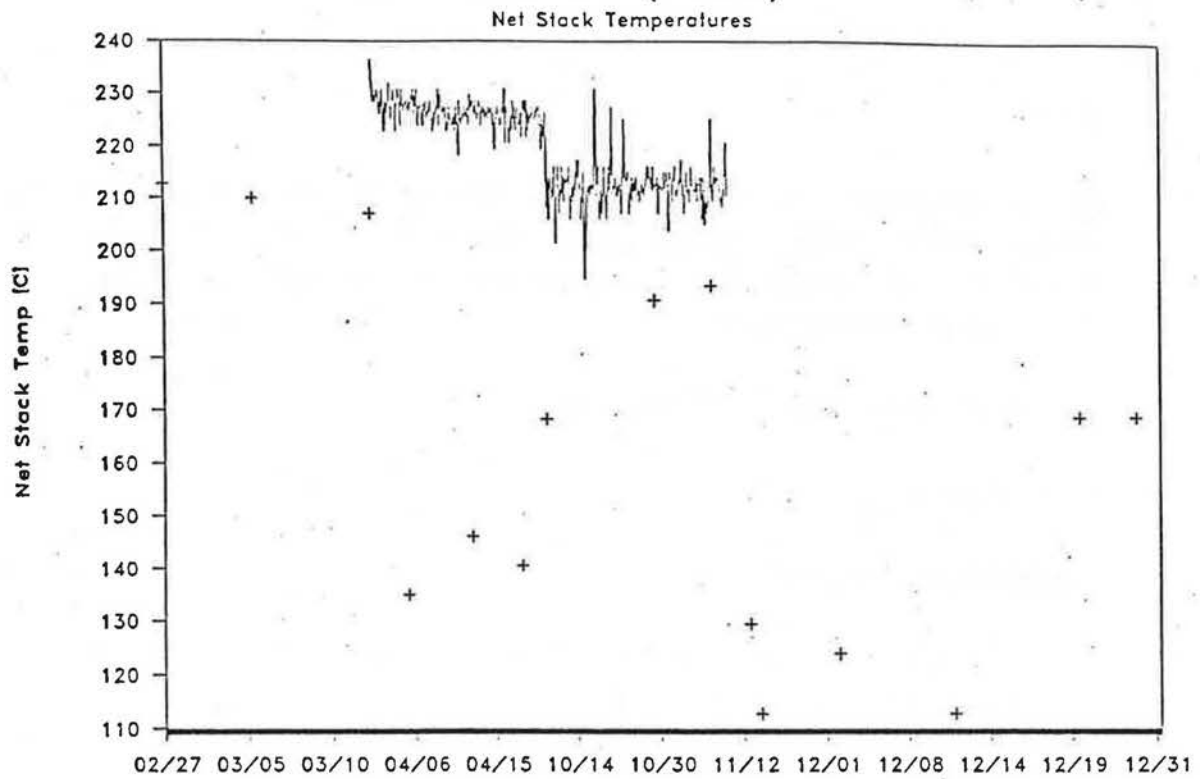
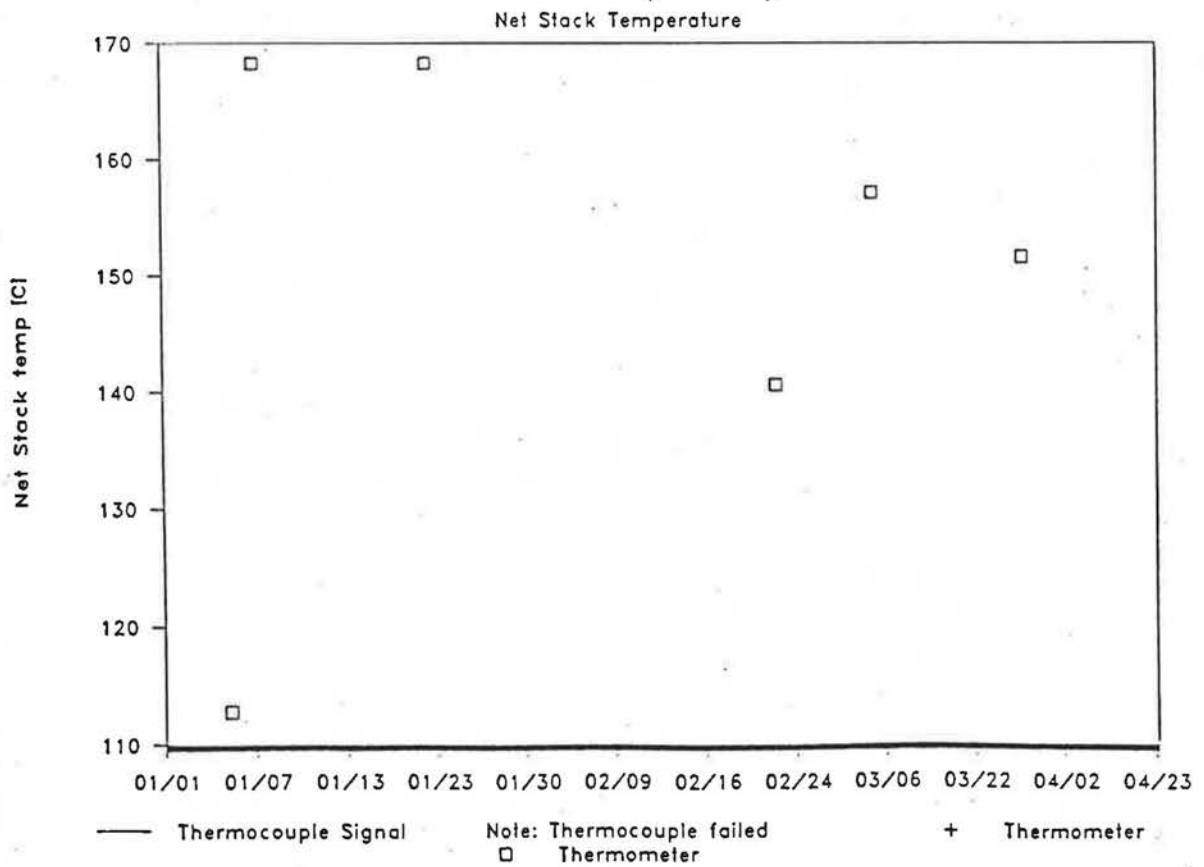
Figure B.3 – Site 4 Stack Temperature

- "Less soot buildup than would be expected over a 2 year period"
