PRESSURISATION TESTS OF SELECTED APARTMENTS AS A BASE FOR ANALYSIS OF NATURAL VENTILATION IN MULTI FAMILY BUILDING

J. Sowa

Warsaw University of Technology, Institute of Heating and Ventilation, Warsaw, Poland

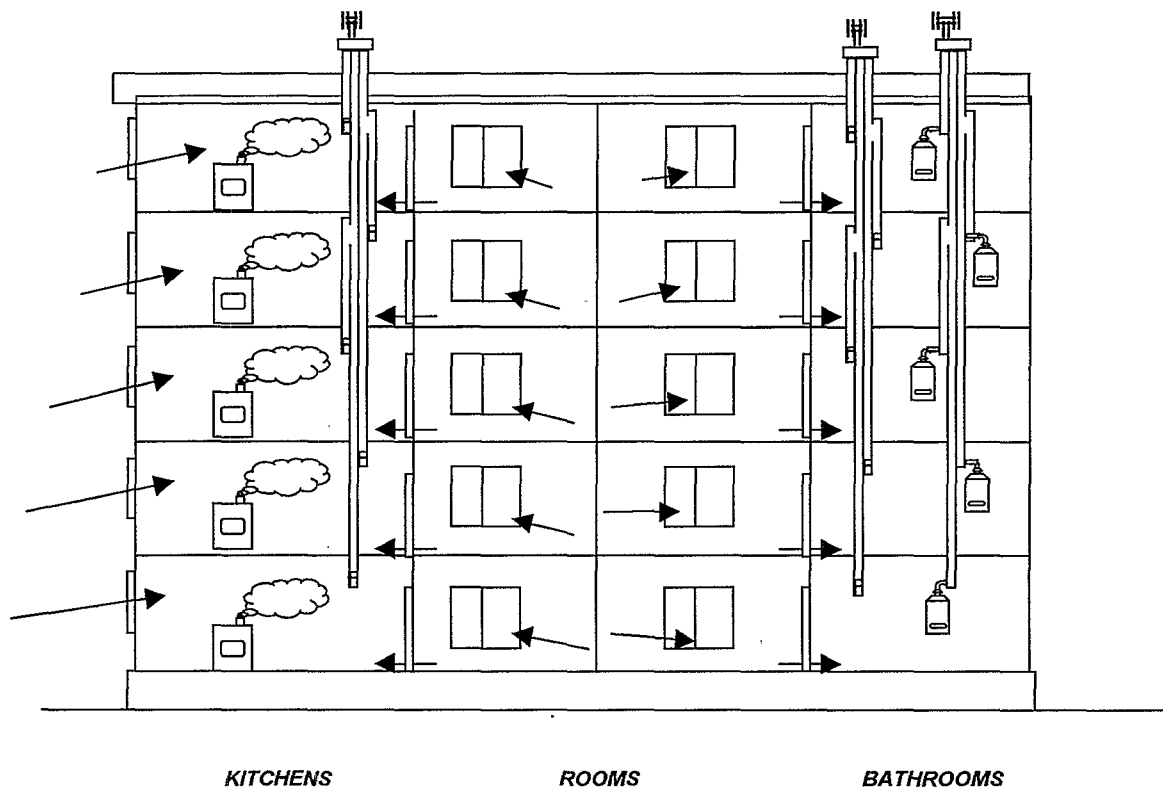
Figure 1. Scheme of stack ventilation in analysed building

The construction of the building is quite heavy. The walls are made of brick and concrete with heat transfer coefficient $U \approx 1.0 \text{ W/m}^2\text{K}$. The building has been equipped with natural ventilation (stack ventilation). It has been assumed that air would infiltrate through cracks in double glazed wooden frame windows (typical solution in that time in Poland) and that air would be removed from the apartments by grilles located in kitchens and bathrooms. The grilles have been connected to the stacks. Kitchens or bathrooms located at first floor have common stack with corresponding volumes at third floor (similarly grilles at second and fourth floor are connected to the same stack). Only apartments located at 5 floor have individual stacks equipped with special H shaped fittings to minimise the risk of back – draughts.

In late seventies the apartments had been equipped with gas water heaters. Open flame gas appliances with flue balances had been located in bathrooms (current regulations forbid locating gas appliance in such a small volume). Lately, some energy conservation actions have taken place. Among others, window cracks have been sealed with soft rubber “o”-ring gaskets. Few occupants reported their dissatisfaction with existing situation. Also chimney-sweep service reported improper operation of ventilation and ordered improvements. Some actions connected with repairing of ventilation stacks and flues have been undertaken, but not radical improvement has been observed.
