Case Study Field Evaluation of a Systems Approach to Retrofitting a Residential HVAC System

I.S. Walker, J.A. McWilliams and S.J. Konopacki

September 2003

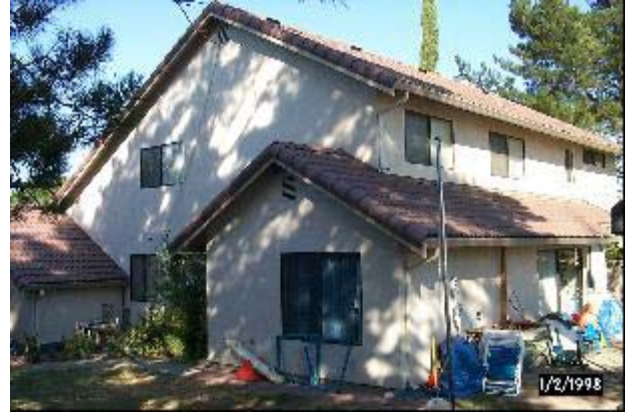
Figure 2(b). Exterior side view of Concord test residence showing gable attic vents and existing outside AC condenser unit placement [lower left].

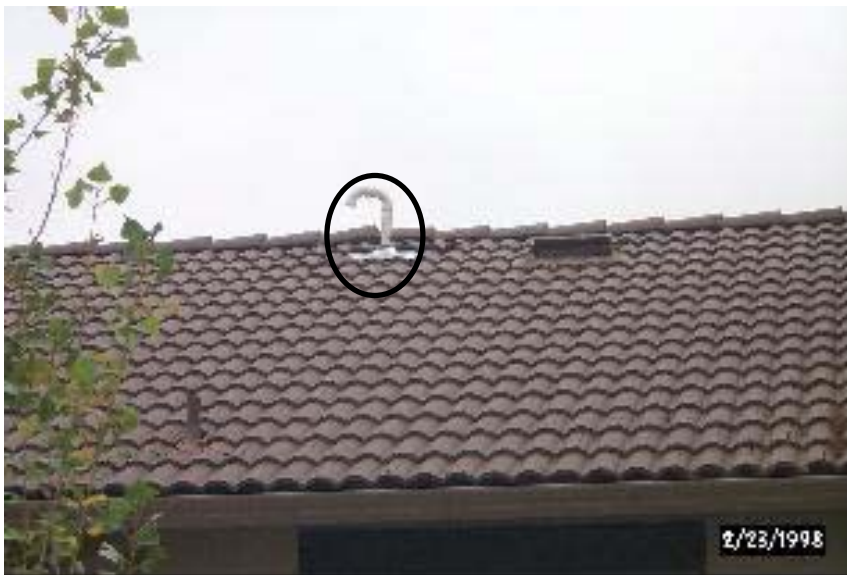
Figure 9. Installed roof mounted furnace flue pipe.

4. The existing gas furnace and air-handler were removed from the garage and replaced with a downsized high-efficiency unit in the attic to allow for the use of an economizer. An Amana Air Command 95IIQ GUYA horizontal flow variable speed two-stage gas furnace (GUYA070BX40) with a $\frac{3}{4}$ hp blower motor was selected with the following specifications: 66,900 Btu/h (20 kW) high-fire rate output, 46,400 (13.5 kW) Btu/h low-fire rate output and 95.5 AFUE at standard conditions. In direct vent mode, this furnace is designed to draw combustion air from the outside; however it was installed to draw combustion air from the attic. The furnace flue pipe was installed through the roof as shown in **Figure 9**. The air handler is equipped with a General Electric ECM (Electronically Commutated Motor) (2.3 Series). These motors are advertised to be 20% more efficient than a standard motor at full load and 30% more efficient at low speed. The DC design allows the fan speed to be easily adjusted over a large continuous range of speeds. The new system used a control strategy that slowly increased the air handler speed at the beginning of each cycle. Another advantage of these motors is that the torque does not change much with an increase in load so the fan is able to overcome ductwork resistance, and deliver a given airflow regardless of duct restriction.

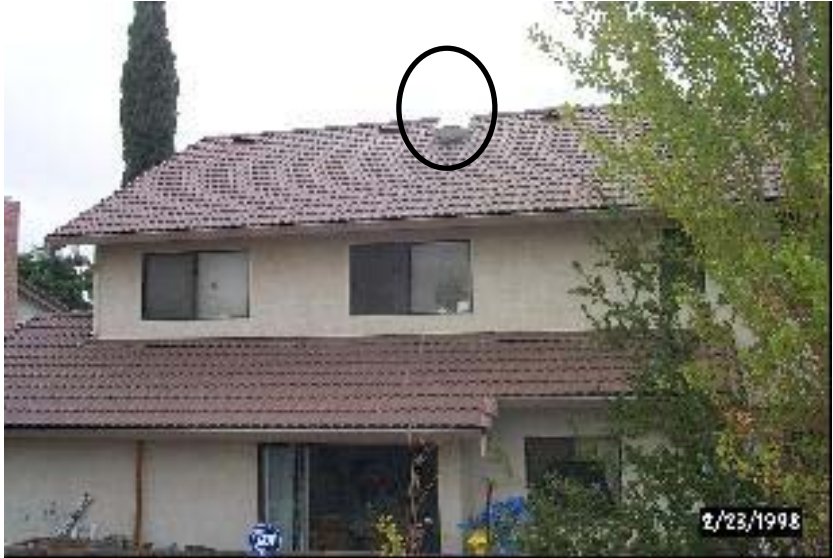
Figure 10. Installed roof mounted economizer vent.

6. Installed "Smart Vent" (fresh air ventilation controller model SV10) temperature-controlled economizer in attic (through the roof – the economizer roof-vent is shown in **Figure 10**). The economizer monitors indoor and outdoor temperatures. When the set temperature difference is met the fan is turned on and a vent damper is activated allowing

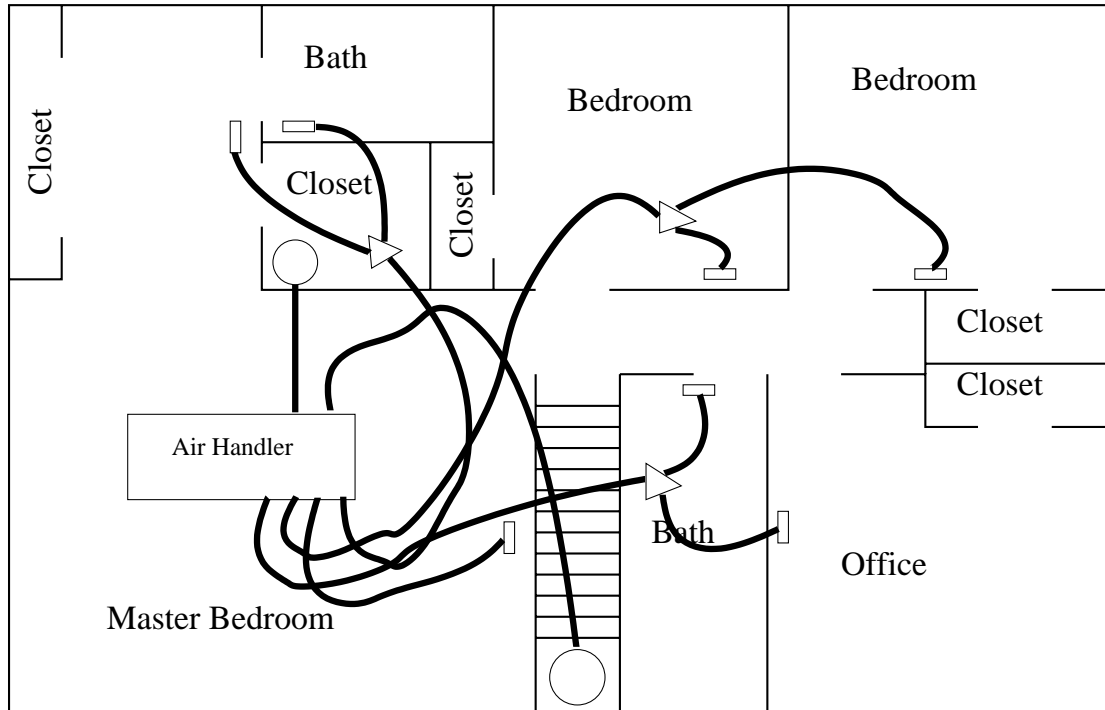
Figure 11. Retrofit duct schematic of case study residence. Changes were only made to the upper level ducts. The return was modified as well, and is not shown.

The retrofit duct schematic for the supply side of the systems is shown in **Figure 11**.

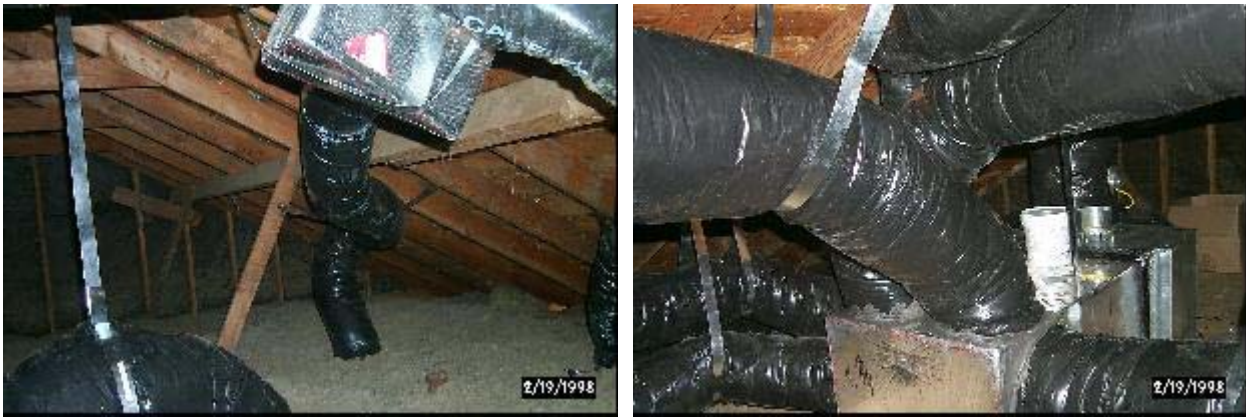
Figure 12. Initial installation of ductwork hanging from ceiling of attic [right shows smooth bend out of plenum].

9. Replaced metal ducts in the attic with new R-4 flexible ducts because the contractor thought they were undersized. Initially the contractor hung the flex-ducts from the attic ceiling with smooth bends as shown in **Figure 12**. However, we planned to add insulation over the ducts and wanted them installed directly on the attic floor plane. The contractor then placed the new ducts on the floor per our request in **Figure 13**, but unfortunately did not take the time to lay the ducts with smooth bends as shown in **Figure 14**.

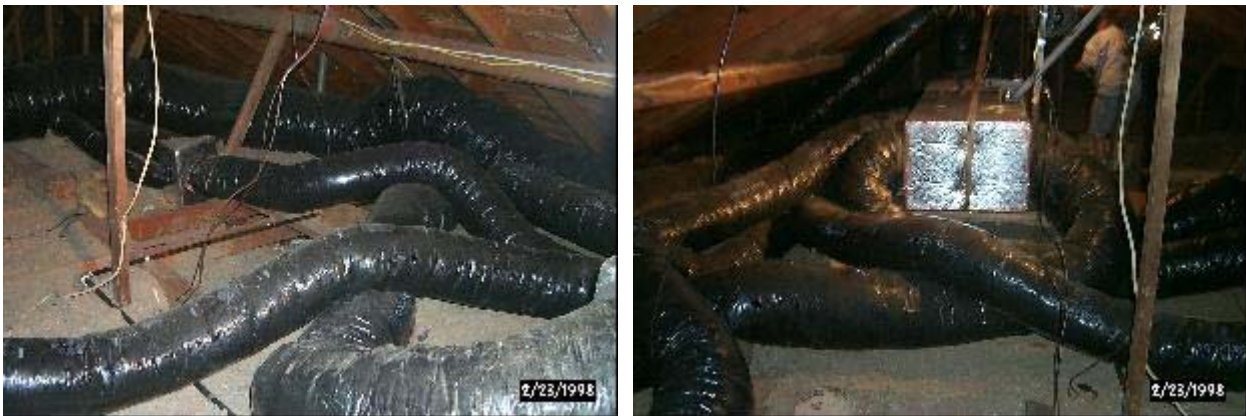
Figure 13. Second and final installed retrofit of ductwork after being moved to attic floor and before adding insulation.

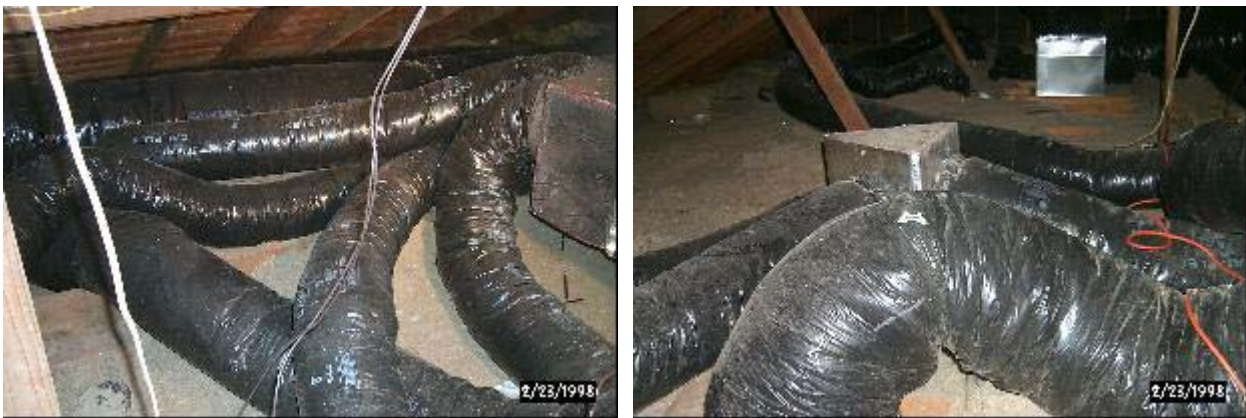
Figure 14. Second and final installed retrofit of ductwork after being moved to attic floor and before adding insulation showing tight bends.

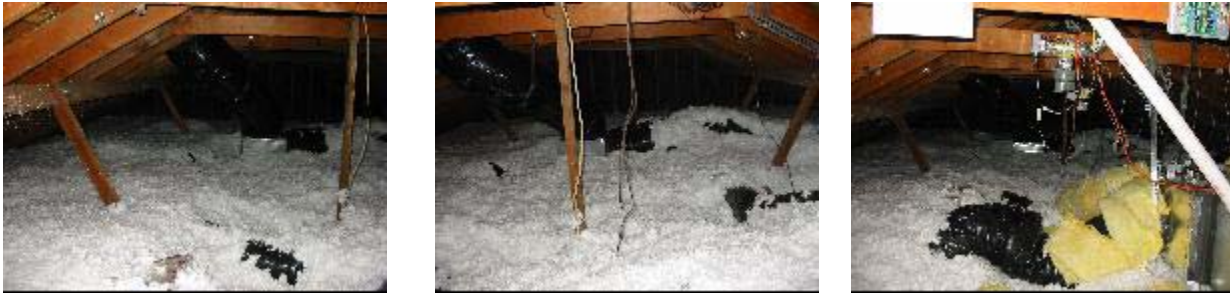
Figure 15. Attic floor with flexible ducts and additional blown-in insulation over ducts. The yellow material is fiberglass wrap insulation.

10. Added R-8 fiberglass wrap to R-4 insulated attic flex ducts for a total insulating value of about R-12 as shown in the right hand photo in **Figure 15**.

11. Added at least 4" (R-12) of blown-in fiberglass insulation to R-4 attic flex ducts for a total insulating value of R-16 as in **Figure 15**.

15. Added 5” (R-17 R3.4/inch) of blown-in fiberglass insulation to R-37 attic floor plane for a total insulating value of R-54 as shown in **Figure 15**.
