Thermography

Testing of the Thermal Insulation and Airtightness of Buildings

Swedish Council for Building Research

D5:1980

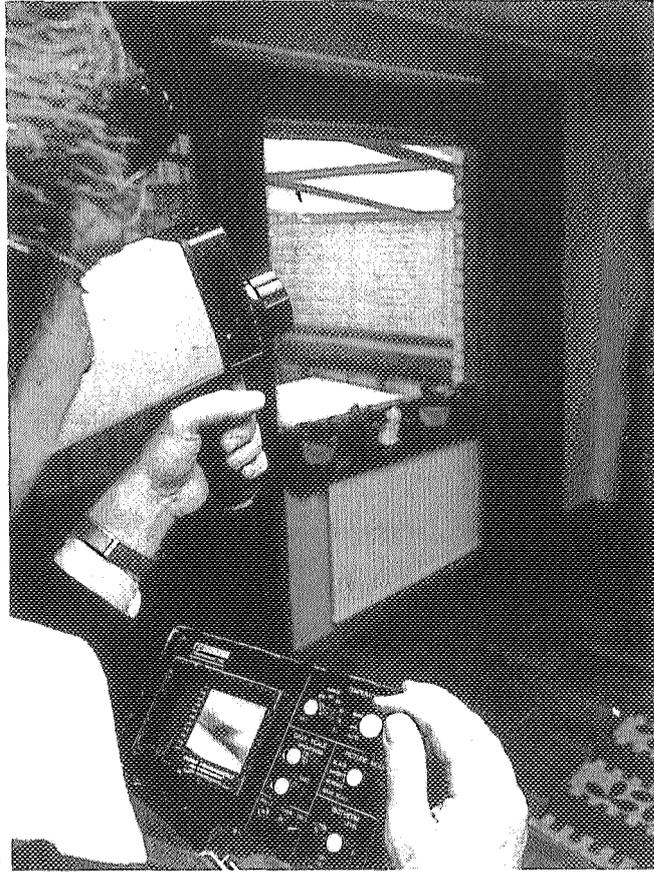
Fig. 3. Thermography by using an IR camera, AGA THV 750, and two different types of thermogram for the same surface.

- a) Thermography with an IR camera of sections of the wall and ceiling. The thermal image appears on the oscilloscope screen.
- b) Thermogram of the wall-ceiling junction according to a). No isotherms imposed (monochrome image). The measuring range applied is indicated by a number (in this case 2) at top left in the thermogram.
- c) Thermogram of the same section as in b) but with two isotherms imposed (isotherm image).

The properties of an infrared camera are determined by its sensitivity range, its thermal and optical resolution capacity, the size of the image field, and the rate of scanning. Modern infrared cameras, with a range of sensitivity of $2.0\text{--}5.6\ \mu\text{m}$, are equipped with a scanning system which permits measurement of the individual energy fluxes emitted by a large number of elements over a surface, and the camera is capable in this way of forming a "radiation image" of the surface. This radiation image (thermal image) is presented on the screen of an oscilloscope (FIG. 3a). This thermal image can be photographed with an ordinary camera, in which way a thermogram is obtained (FIG. 3b and 3c).

In the black-and-white thermal image (see the detail in FIG. 3b), portions which are darker in the grey scale represent surfaces of a lower temperature than portions of a lighter grey colour.

In the thermal image (FIG. 3b), the density is a function of the radiated energy and thus the temperature of the different portions of the surface under investigation. The temperature range of the IR camera is about -20°C to $+2000^\circ\text{C}$. In the vicinity of $+30^\circ\text{C}$, the infrared camera measures temperature with a resolution of 0.2°C . At lower temperatures, the sensitivity is somewhat lower. This is also evident from the calibration curve for the camera, FIG. 6b.

Thermograms taken with these two types of camera are broadly composed in the same way. There are some differences regarding scales and the indication of the appropriate measuring range. In thermograms taken with THV 680, the grey scale (graduated into ten sections) is at the bottom of the thermogram, FIG. 13b. This grey scale is not shown in thermograms taken with THV 750, FIG. 3. In these, the graduated scale is placed vertically along the

left of the thermogram. The measuring range is indicated in THV 680 by the position of the black mark on the vertical scale at the left or right. In THV 750, the measuring range is indicated by a number at the top of the thermogram, see FIG. 3b.

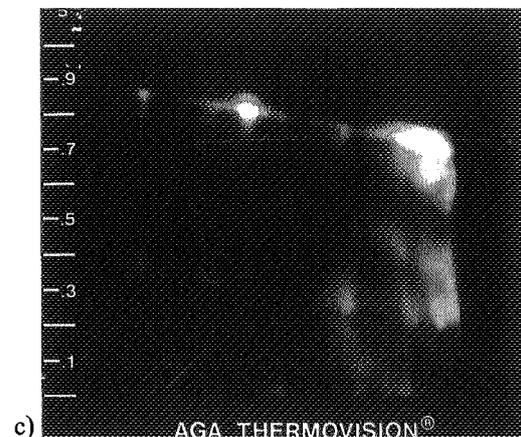
Fig. 25. Thermograms of the same section of wall taken from the inside and the outside.

Conditions during measurement:

Cloudiness	cloudy
Outdoor air temp	- 1°C
Indoor air temp	+ 19°C
Wind conditions	3–4 m/s (about 45° away from facade)
$P_i - P_u$	+ 15 Pa

- Construction of external wall with steel sheeting on the outside.
- Thermogram of top of wall section (taken from the inside). Certain warmer areas appear near the vertical profiles and also the horizontal wall members. The warmer areas are due to outward leakage of room air. The thermogram of the same wall section, taken from the outside, is shown in c).
- Thermogram of same section of wall as in b). The warm room air which leaks through the construction warms the surface of the sheeting facade at certain points. Owing to the prevailing wind conditions, these warm areas are slightly displaced to the left in the thermogram.

When the pressure inside the building is higher than that outside, points of leakage appear in the thermogram, both on the inside and the outside, as warmer areas. Under such conditions leakage is shown up in a more diffuse manner, especially on the warm side where variations in temperature are generally smaller than when air is leaking inwards. The reason for this is that the difference in temperature between the room air and the surface of the wall is generally small. In the latter case, measurement outdoors may be advantageous (see FIG. 25).

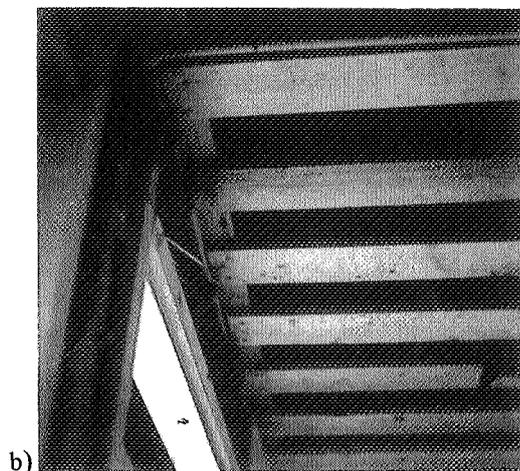
Fig. 42. Insulation and airtightness defect at the eaves due to incorrect placing of insulation material and to bad placing of windprotection.

- a) Construction at the eaves.
 b) Defects found in insulation (PE-film is not mounted here).
 c) Thermogram of section at wall- ceiling junction. Colder areas in the ceiling appears as well marked dark strips, which indicates leakage of air into the construction through the ducts formed by the secondary spaced boarding.

$$\Delta t = 2.0^\circ\text{C}$$

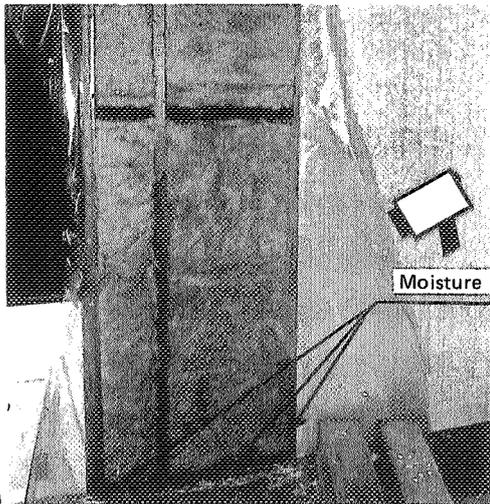
Fig. 72. Defect in insulation due to condensation of moisture in construction. The outer layer of insulation consists of expanded polystyrene.

Conditions during measurement:
 cloudiness cloudy (rain)
 outdoor air temp + 8°C
 indoor air temp + 19°C
 wind conditions approx 2 m/s (perpendicularly to facade)
 $P_i - P_u = -4 \text{ Pa}$

- a) Construction of external wall.
- b) Opened up wall section corresponding to section of surface in thermograms c) and d). Correct placing of insulation material. The sole plate and parts of the vertical studs are wet (free water).

- c) Thermogram of external wall at floor-wall junction. The wall surface has a somewhat irregular temperature distribution. Owing to moisture in the construction, the area near the skirting board exhibits differential cooling. The section corresponds to junction between external wall and intermediate floor.

d) $t_{ref} = +18^\circ\text{C}$
 $\Delta I = -1.8$ isotherm units
 $\Delta t = 2.5^\circ\text{C}$
 $v = 0 \text{ m/s}$

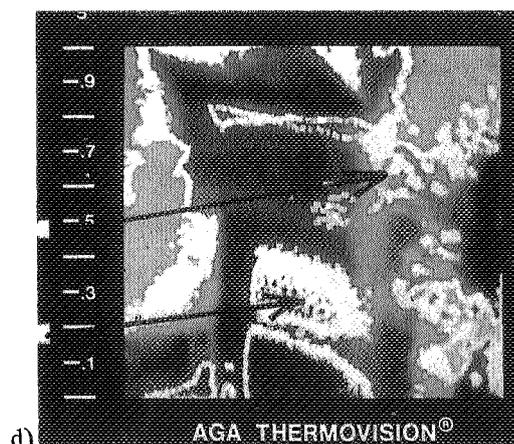
Fig. 77. Insulation and airtightness defect due to incorrect placing of insulation material and insufficient wind protection.

Brace wall, from the outside:
 100 mm mineral wool
 posts 45 x 95 mm, 600 mm distance
 between centres
 plastic film
 tongued and grooved board (secondary
 spaced boarding)
 13 mm gypsum wallboard

Conditions during measurement:
 cloudiness cloudy
 outdoor air temp +2°C
 indoor air temp +20°C
 wind conditions 2–5 m/s (to facade)
 $P_i - P_u$ - 5 Pa

- a) Construction of wall at bay window.
- b) Defective insulation and airtightness. Air leaks into construction at studs and in corners, and then spreads along ducts between the panelling planks.
- c) Thermogram of section near bay window. The vertical portion of the external wall is cooled down unevenly due to spreading of outside air along ducts formed by the secondary spaced boarding construction.
- d) $t_{ref} = +19^\circ\text{C}$
 $\Delta I = -1.5$ isotherm units
 $\Delta t = 2.0^\circ\text{C}$
 $v = 0$ m/s

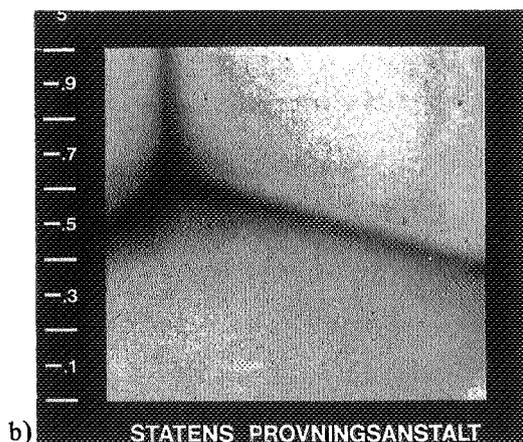
Fig. 101. Satisfactory performance of joint at sole plate.

- a) Joint seal at sole plate consisting of Rockwool S-list.
- b) Thermogram of section at floor-wall junction. When this system is used, airtightness is satisfactory.
- c) $t_{ref} = +23°C$
 $\Delta I = -2.1$ isotherm units
 $\Delta t = 3.0°C$
 $v = 0$ m/s

- d) See FIG. 101. During the investigations, joint sealing with EPDM rubber strips gave satisfactory results. The results appeared to be comparable with those in b). During checks 12 months after the first measurement, no appreciable change in performance was found.

In sealing joints, the choice of material is of great importance for the performance of the seal. Certain types of material are unsuitable with regard to both performance and workmanship. When sealing strips of mineral wool are used, it is essential that the strips are folded prior to placing in the joint, and that there is sufficient sealing material in the joint (2–4 strips as a rule), see FIG. 97. It would appear that sealing performance is best when foamed polyurethane, sole plate seal of EPDM rubber, or the Gullfiber "Fogfiber" system is used. See FIG. 99–101.

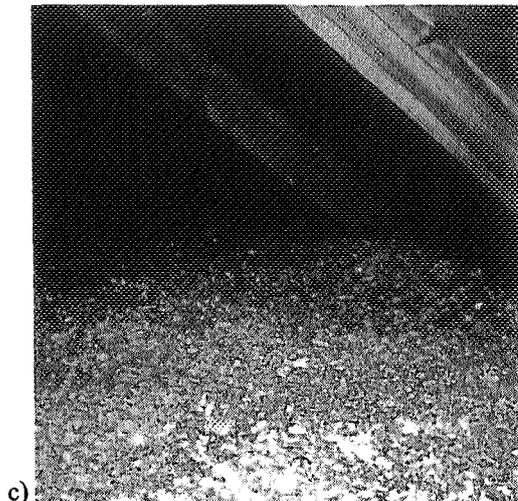
Fig. 108. Additional insulation to prevent leakage of air into construction at the eaves and at junctions between floor and constructional timber.

Floor, from above:
 50 + 150 mm mineral wool
 19 mm secondary spaced boarding
 polyethylene film
 13 mm gypsum wallboard

- a) Construction of flat roof at inset balcony.
- b) Defects noted in insulation and airtightness on the flat roof.
- c) Insulation of flat roof after placing the additional insulation.

Filling with sawdust about 20 cm thick on original insulation of about 20 cm, see Fig. 109.

Thermographic investigation of the building element after the improvement showed that thermal insulation and airtightness performance of construction had greatly improved. There were no more convective air movements in the wall construction, see Fig. 109.

a) Thermogram of colder area at wall-ceiling junction and on wall to the left of french doors (before improvement). For cause of defect see Fig. 108 b).

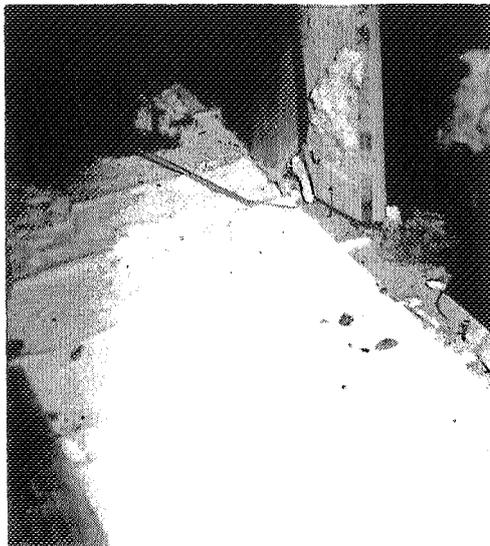
Fig. 124. Part of floor construction opened-up one year after injection of plastics foam. Two different qualities had been used.

a) Satisfactory placing of foam.

b) Defective placing of foam (shrinkage and cracking).

Urea-formaldehyde foam is most suitable for use as additional insulation in walls and floors where the original insulation consists of some other material. The results of measurements show that insulation and airtightness performance is satisfactory provided that material and workmanship are kept under close supervision. Serious damage has occurred in cases where the material did not have the correct composition or was not applied in the correct way (the spray equipment was not kept clean). In

such cases, both moisture damage in building elements and extensive shrinkage of the insulation material have been found, FIG. 124.
