**18TH ANNUAL AIVC CONFERENCE
ATHENS, GREECE, 23-26 SEPTEMBER, 1997**

**AIRTIGHTNESS OF APARTMENTS
BEFORE AND AFTER RENOVATION**

Keijo Kovanen and Jorma Säteri

VTT Building Technology, P.O. Box 1804, FIN-02044 VTT, Finland

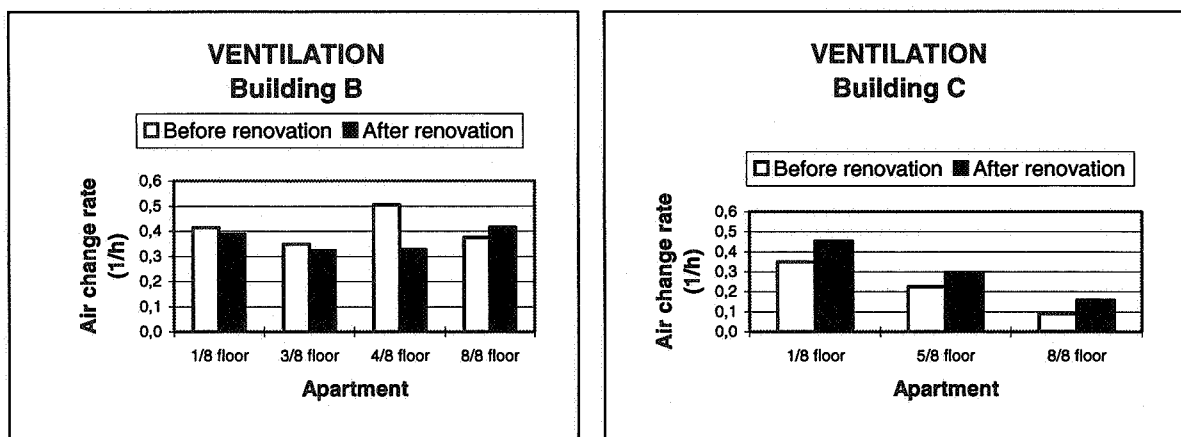
The air change rate could be measured before and after the renovation only in buildings B and C. The results are presented in Figure 3: the ventilation unit operated at half capacity, which is the normal situation.

Figure 3. Air change rates in buildings B and C.

The air change rate in building B remained nearly the same after the renovation. In one apartment, the air change rate decreased remarkably. The ventilation improved in building C as a result of the renovation, but the air change rate in every apartment remained below the Finnish recommendation value of 0,5 1/h during normal ventilation conditions. The same situation existed in building B.

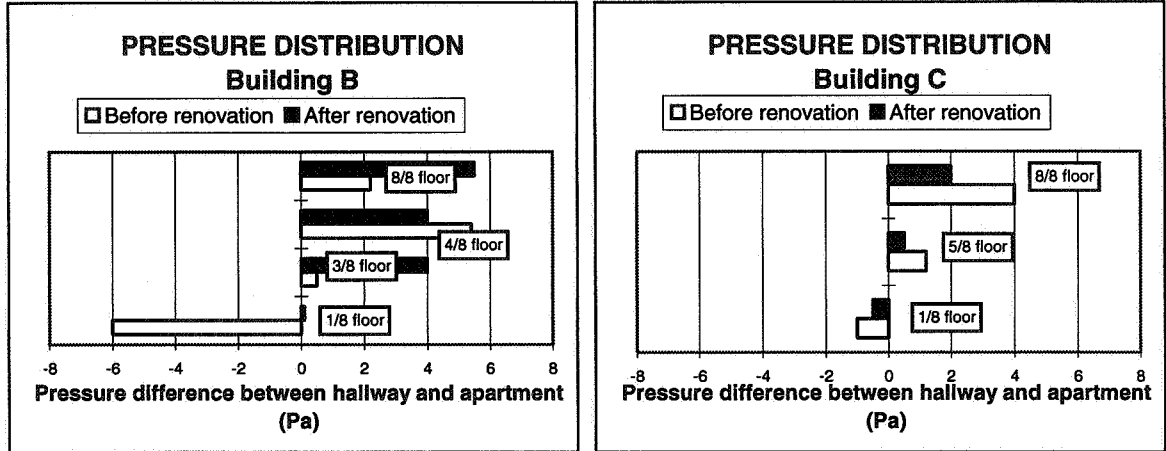
The underpressure between the apartments and the hallway increased due to the renovation, but one apartment on the first floor of building C remained overpressurized (Figure 5).

Figure 5. Pressure differences between hallway and apartment in buildings B and C.

Pressure distribution could be measured before and after the renovation only in buildings B and C. The results are presented in Figures 4 and 5.

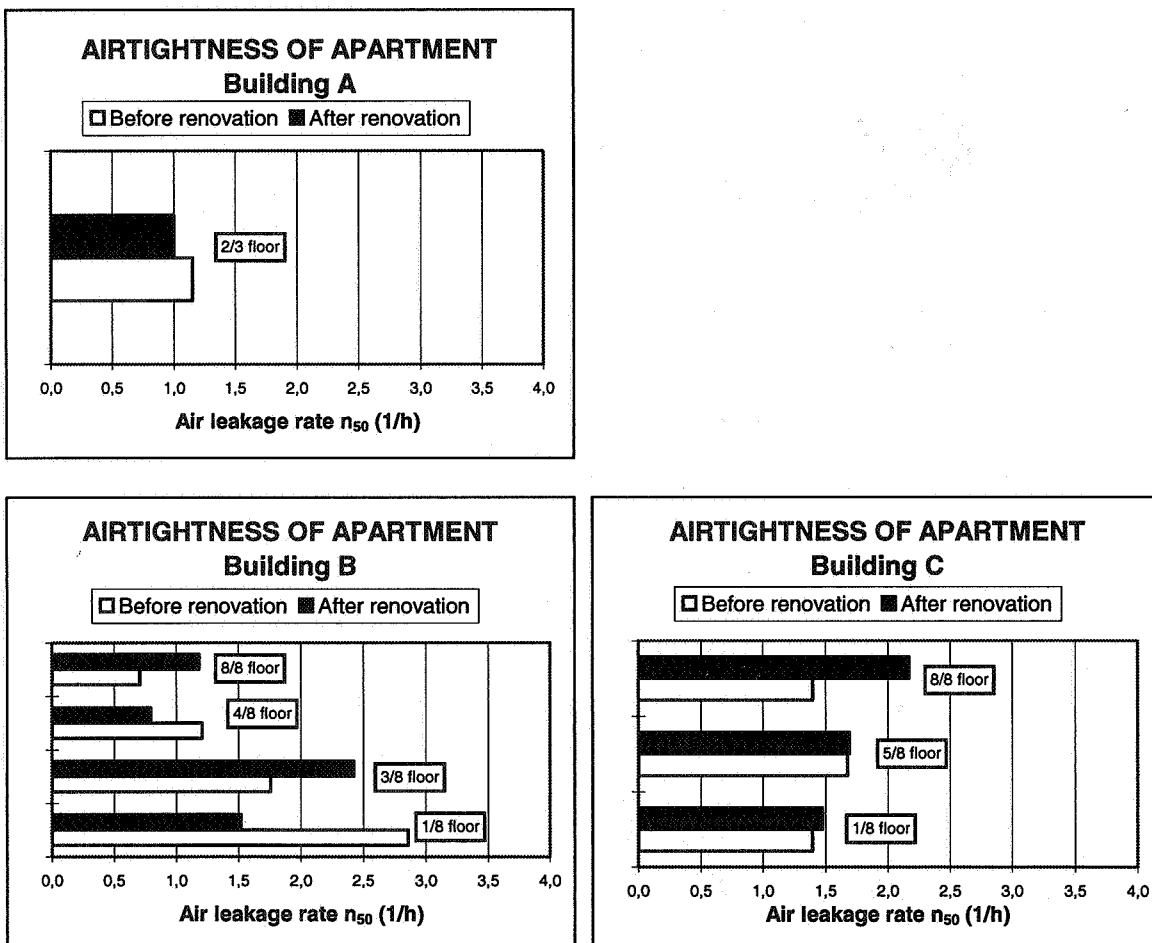
The airtightness of the whole apartment is presented in Figure 6. Airtightness is given by the air leakage rate at a 50 Pa pressure difference (n_{50}). The smaller the air leakage rate, the more airtight the apartment.

The airtightness of the apartment in building A improved as a result of the renovation (Figure 6). The air leakage rate value of 1.1 1/h after the renovation indicates a reasonably tight apartment.

In buildings B and C the airtightness of some apartments improved due to the renovation, but in a few other apartments it got worse (Figure 6). Poor workmanship was usually evident in these cases. A great difference in the airtightness of the apartments is apparent.

Figure 6. The air leakage rate n_{50} in three buildings.

A great difference in the airtightness of the apartments was noticed. Airtightness ranged from 0.7 1/h to 3.1 1/h before the renovation and from 0.8 1/h to 2.9 1/h after the renovation. In most cases, the airtightness of the apartments increased due to the renovation. There were, however, apartments which became leakier. Poor workmanship was evident in these cases. The main leakage route seemed to be the balcony door. The airtightness of the windows and the apartment door improved in every single case.
