DURABILITY OF AIR TIGHTNESS SOLUTIONS FOR BUILDINGS

Peter Ylmén, Magnus Hansén and Jörgen Romild

*SP Technical Research Institute of Sweden
Box 857
SE-501 15 Borås, Sweden*

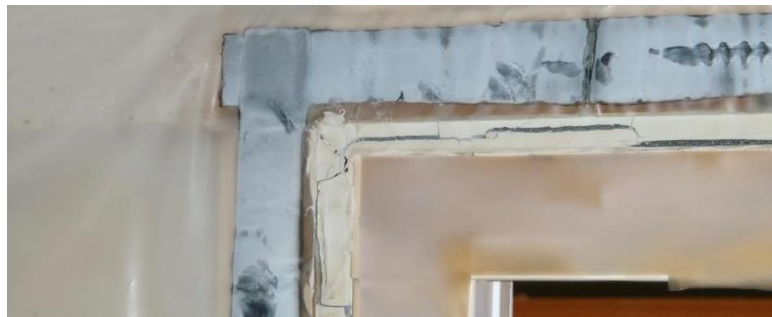
Figure 6. Joint sealant around a window.

The joint sealants used in this test which became dense and hardened homogeneously remained so, whilst other less dense sealants had set in an uneven manner, with hard sections and soft sections..

This can be caused by the less dense joint sealants do not harden or cure sufficiently quickly and thus are not able to cope when the building sections move, with cracks occurring as a result, see figure 6.
