Development of Infiltration Modeling Parameters for a SIPs Building

Abstract

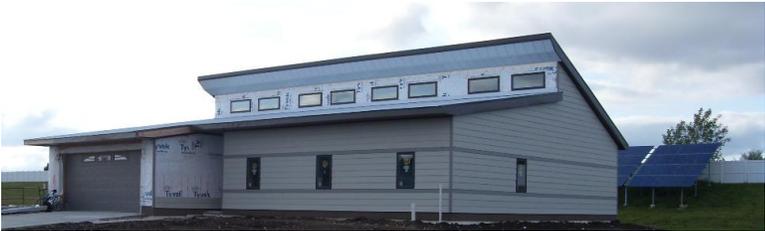
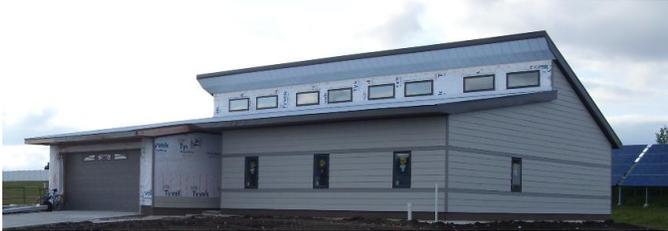
Figure 1 Photo of the Equinox House in Urbana Illinois in May 2010.

Equinox House is a super-insulated, super-sealed residence recently constructed in Urbana, Illinois. Urbana Illinois is a region with hot, humid summers and cold winters. Figure 1 is a recent picture of Equinox House undergoing placement of exterior siding. After all wall and roof panels were installed, a series of blower door infiltration tests were conducted as silicone caulk was applied to all wall and roof panel seams. The effect of the sealing process and the cost related to the sealant and labor are presented in this paper. The goal was to reach an ACH (air change per hour) less than 0.6 in accordance with Passive House design standards before adding drywall to the interior of the house. The house construction process, sealing and infiltration measurement results, and the cost impact of the sealing effort are described.

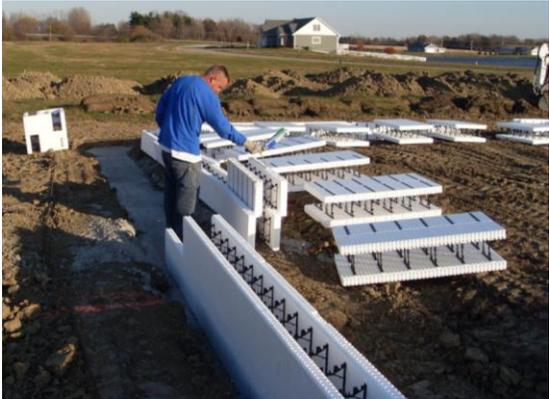
Figure 2 ICF (Insulated Concrete Form) foundation wall used for Equinox perimeter.

Figure 2 is a photo of the ICF being placed around the building perimeter. Reinforced concrete, 15.2 cm thick, is poured between the Styrofoam sides of the ICF block, as shown in Figure 3.

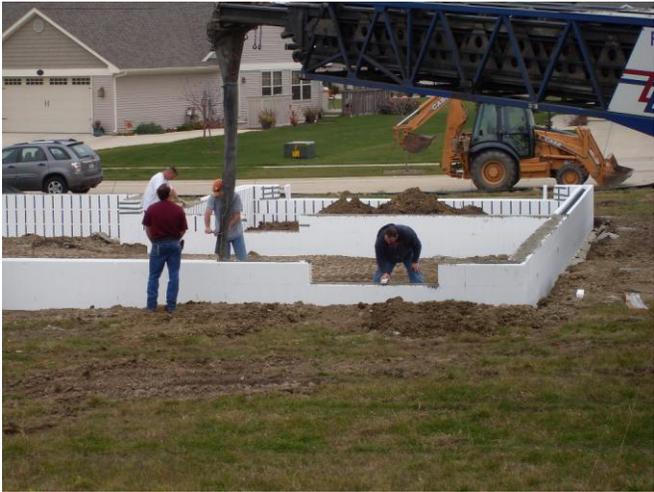
Figure 3 Concrete poured in ICF foundation wall.

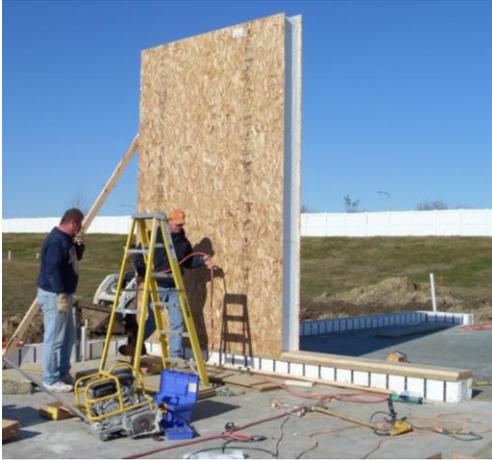
Figure 4 Placement of the first SIPs wall panel on the foundation wall sill plate.

Two layers of treated lumber 31 cm wide by 1.9 cm thick was bolted to the top of the concrete foundation wall, forming the base for the wall panels. Untreated lumber 29.2 cm wide and 3.8 cm thick was screwed and nailed onto the sillplate lumber. SIPs (Structural Insulated Panels) were placed on top of the sillplate lumber. A channel milled into the bottom edge of the SIPs wall panels fit over the 29.2 cm by 3.8 cm lumber, allowing nails to attach the wall panel to the sill. Figure 4 shows the installation of the first SIPs wall panel on the sill.

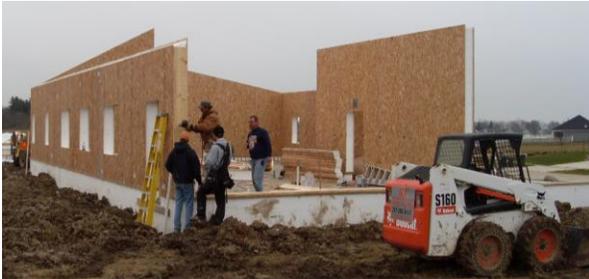
Figure 5 Continued placement of SIPs wall panels around the house perimeter.

Figure 5 shows continued placement of SIPs wall panels and Figure 6 shows the last roof SIPs panel being placed on the house. The SIPs can be up to 2.4 meters wide by 7.3 m long with a thickness of 31.4 cm including the two layers of OSB (1.11 cm per OSB layer) and 29.2 cm of Styrofoam. Between each wall panel and each roof panel is a Styrofoam spline with an OSB layer glued on its outside layer. The spline is 7.6 cm thick and plugs into the 3.8 cm deep channels milled into the edge of each SIPs panel. Ringshanked nails are driven on each side of the panel seams into the spline to fix the walls and roof together. The walls and roof of the house required 5 days with approximately 6 to 7 laborers to erect. This consisted of two days to erect the house walls, one day to construct internal structural framing for the roof, and two days to install the roof panels.

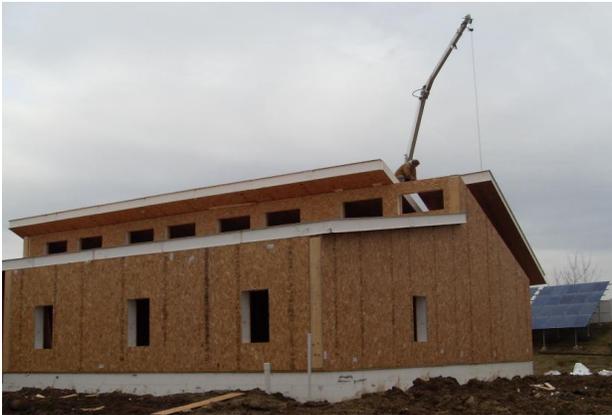
Figure 6 Installation of SIPs roof panels on Equinox.

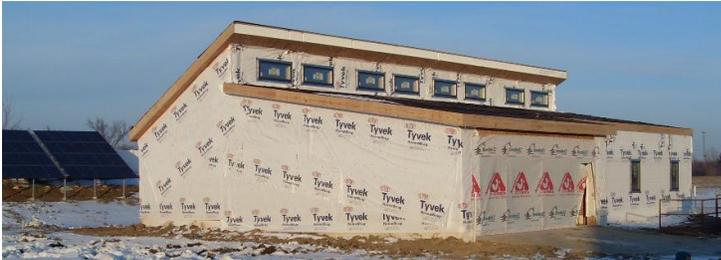
Figure 7 Completed SIPs panel installation with house wrap and windows installed.
