**EVALUATING TEST EQUIPMENT FOR
AIR TIGHTNESS OF CONSTRUCTION
DETAILS**

By Kevin Knights, Retro-Specs Ltd

CMHC Project Officer: Pierre-Michel Busque

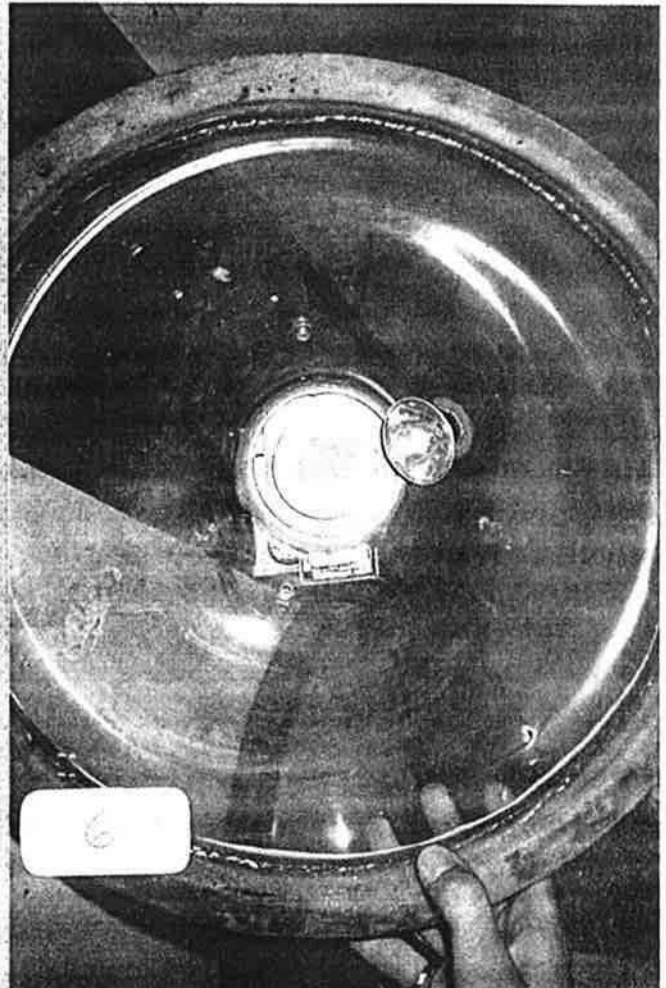
Equipment Development

- A) Container with soap solution; Prototype 1, offset vacuum pump and clear flask; Test performed on brick tie, air barrier membrane mounted on plywood
- B) Test sample showing signs of bubbling at leak point
- C) Prototype 1, offset vacuum pump and clear flask; Test sample on masonry block
- D) Prototype 2, hand-held vacuum with clear dome
 - 1) Prototype 3, hand-held
 - 2) Prototype 4, addition of variable speed switching and pressure differential switch and indicator.
 - 3) Prototype 5, variable speed trigger.
 - 4) Prototype 6, relocate for ergonomics/ thumb trigger.
 - 5) Prototype 4, urethane open cell gasket seal.
 - 6) Prototype 4, light and air baffle, gasket seal coated with silicon.
 - 7) Prototype 5, new hollow ridged closed cell neoprene rubber seal, separate from finished trim.
 - 8) Prototype 5, new closed cell neoprene rubber seal and trim, manufactured in one piece.
