Radon remedial do not

measures last

By Bertil Clavensjö

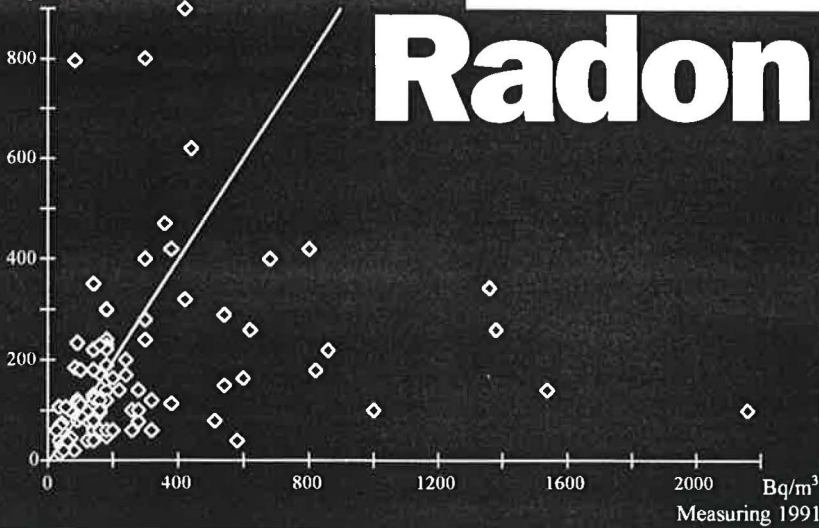
Measuring after mitigation

Bq/m³

The figure shows radon contents measured immediately after remedial measures and during check measurements in 1991. Points to the right of the diagonal indicate that the radon content in the building was higher in 1991 than previously.

The results of measurements in 1991 showed that the radon content had markedly increased in about 40 % of the single dwelling houses in relation to the content measured after the sanitary measures. In 18 of these the content was so high that it constituted a sanitary inconvenience.
