# Information Paper

## Ventilating cold deck flat roofs

J C Beech BSc and S Uberoi BSc

*The current recommended minimal ventilation level for the cold deck flat roof design is evaluated using an experimental roof. The work suggests that there may be a need for ventilation to be increased above the minimal level in instances where natural draught ventilation is low or where roofs are of complex plan. Results of this work are under consideration by the British Standards Institution as part of an overall review of flat roof design recommendations. In the interim this Information Paper offers provisional guidance for designers and those involved in the maintenance and upkeep of cold deck roofs.*

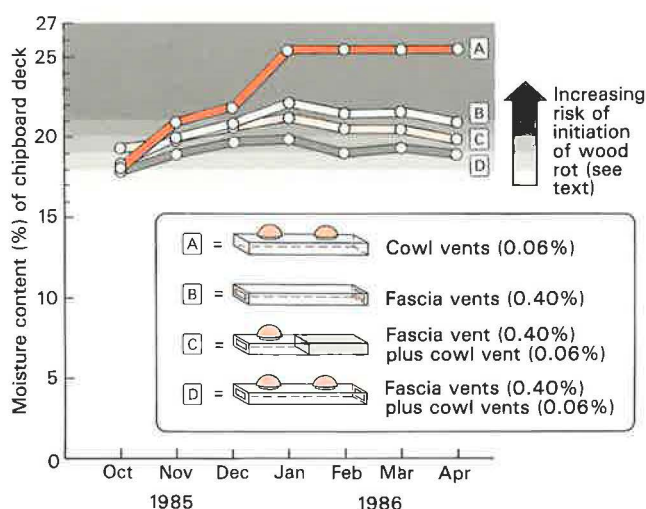
**Figure 2** Test roof: evaluation of current minimum ventilation level (0.4% of plan area at fascia). Maximum moisture content values (each month) are shown for the chipboard deck

Moisture contents of the chipboard deck of the experimental roof are shown in Figure 2. With fascia ventilation at 0.4% of the plan area (B) it can be seen that moisture contents close to or in excess of 20% occurred throughout the winter period from November onwards. On present understanding this pattern of moisture content, where prolonged dampness is encountered, could lead to the establishment of wood rot. In this case rot was not detected but at the end of the 1984/85 winter, some surface mould was observed on the chipboard deck. Although not structurally significant, the presence of mould was further evidence that damp conditions had been sustained in the roof and that more serious problems could follow. Under these test conditions high moisture contents were only found in the decking. Moisture content of the timber joists never rose to a level where there was any significant risk of rot, indicating how the risk of high moisture content may be distributed within the roof: the cooler surfaces of the deck probably being a more likely site for condensation under winter conditions if ventilation is inadequate.

When fascia ventilation (0.4%) was coupled with cowl ventilation (0.06%), deck moisture contents were lower but were still sustained significantly above 17% for the monitored period suggesting that the ventilation level was still inadequate (Figure 2, C and D). With only cowl vents open (A), moisture contents reached the maximum recordable value. This demonstrates the hazard associated with low levels of ventilation and supports BS 6229 which does not permit cowl vents as the sole route for ventilation.

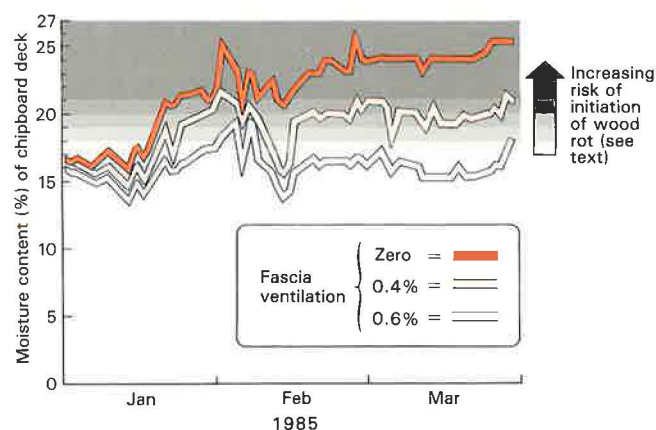
**Figure 3** Test roof: moisture contents of chipboard deck with different levels of ventilation. Continuous data are presented for a single location in an equivalent position in each roof cavity. Note: Fascia ventilation is provided only at one end of the roof cavity and one cowl vent (0.06% of plan area) is open in each case (configuration C in Figure 2)

In the following tests, fascia ventilation was provided only at one end of the roof cavity and one cowl vent was kept open. The room below the roof was maintained at 65% rh/18°C. Under these conditions, when the fascia ventilation was set at 0.6% of the plan area, the moisture content of the deck was sustained below 17% throughout the monitored winter period, except for a short period at the beginning of February, Figure 3. Under this pattern of moisture content change, the chipboard deck would not be considered at risk from wood rot. The effectiveness of the 0.6% level of ventilation was further endorsed during the following winter when the moisture content of the deck did not rise above 18% even though room conditions below the roof were maintained at a more hazardous (75%) relative humidity.

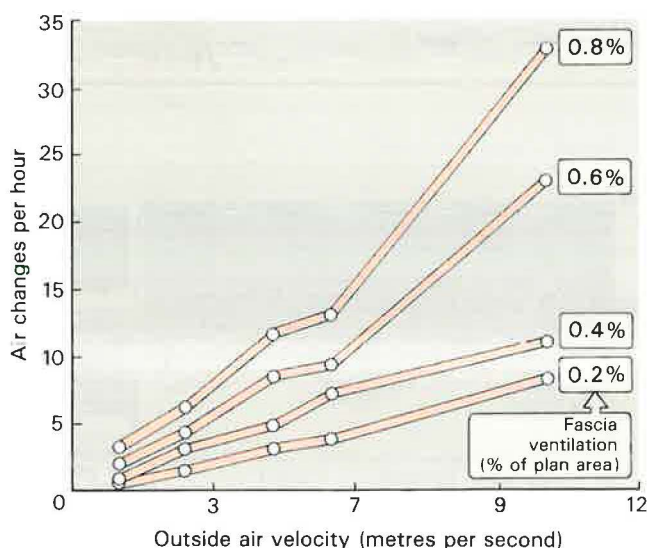
Figure 5 Test roof: air exchange rates for different ventilation levels and wind speeds (mean values for replicated tests)

The effectiveness of different ventilation provisions was also assessed by using a tracer gas to measure air change rates in the roof cavities. Data from the experimental roof show the strong influence that windspeed has on the air change rates for different levels of ventilation (Figure 5). In more complex roof plans the air change rates cannot be assumed to be constant within the roof. For example, preliminary work on the school roofs included in this study revealed less effectively ventilated zones at points distant from vents. So, where fascia vents can only be provided at one end of the roof, it is clear that the positioning of deck vents requires careful consideration.
