# Sound Isolation and Fire Resistance of Assemblies with Fire Stops

by T.R.T. Nightingale and M.A. Sultan

**This Update examines various fire-stopping techniques that meet the intent of the National Building Code of Canada (NBC) with respect to fire resistance and that do not adversely affect the sound isolation of the wall assembly. The information is derived from the results of an industry-sponsored consortium project led by the National Research Council's Institute for Research in Construction (IRC).<sup>1</sup>**

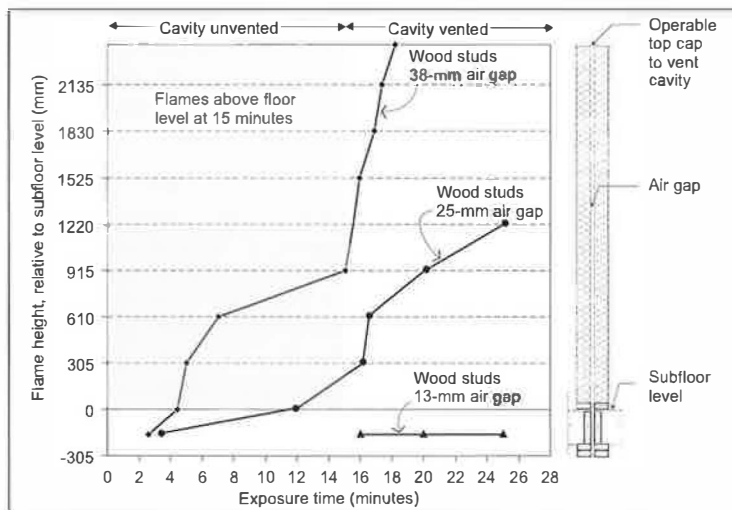
**Figure 2.** Location of the flames in the air gap as a function of time (assuming that the temperature in the wall cavity must be 550°C or higher to support flames). Data begins when the flames reached the first set of thermocouples, which were 168 mm below the subfloor level. Data for the steel-stud wall is not shown as the flames did not reach the first set of thermocouples at any point in the test.

The temperature of the gases in the wall cavity, and indirectly, the location of the flames, was determined by thermocouples placed throughout the wall cavity. Figure 2 shows the position of the flames as a function of time for three of the four assemblies (assuming that a flame exists when the temperature of the hot gases is 550°C or greater).

Flames were contained in the space between the joist headers and did not reach the subfloor level within 15 minutes. Opening the cap at 15 minutes did not have an appreciable effect on the height of the flames; they remained below the subfloor level.
