Retrofit Wall System for Insulation and Lead Encasement in Older Multifamily Housing

ABSTRACT

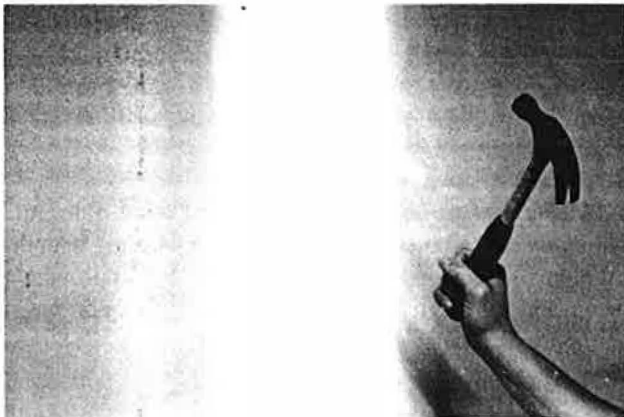
Figure 2 The prototype composite wall was subjected to impact testing to determine how well it would withstand the impact and what would be required to repair the wall. Here a hammer blow has left a dimple in the wallboard joint. Unlike common drywall, there was no "breakthrough" on the back. Repair involved simply filling the dimple with joint compound.

In order to assess the durability of the system, the prototype wall was subjected to impact testing. The wall was subjected to the ASTM standard drywall impact test and performed significantly better than typical wall construction of paper-faced drywall supported on 2x4 wood studs and insulated with fiberglass. "Failure" on the composite wall was a small hairline fracture that was easily repaired with drywall compound. "Failure" of typical wall construction would require removal of the broken drywall, replacement with a new piece, and extensive patching with tape and drywall compound. The prototype wall also was subjected to hammer blows, as shown in Figure 2.

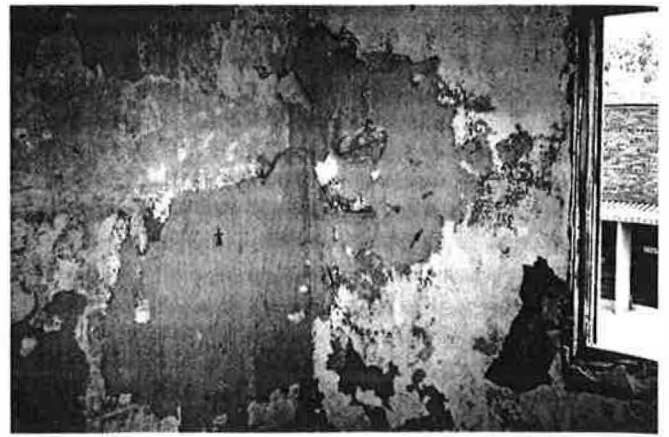
Figure 3 A Public Housing Authority unit was rehabilitated with the installation of an innovative composite wall system. This system undid years of hard use followed by extended vacancy and major moisture damage. High moisture levels from a leaky steam heating system had combined with uninsulated masonry walls to destroy the exterior wall lath and plaster finish.

Field Testing. Subsequently, the system was field tested in an unoccupied unit of the Brooks Homes of the Chicago Housing Authority (CHA); see Figures 3 through 5.

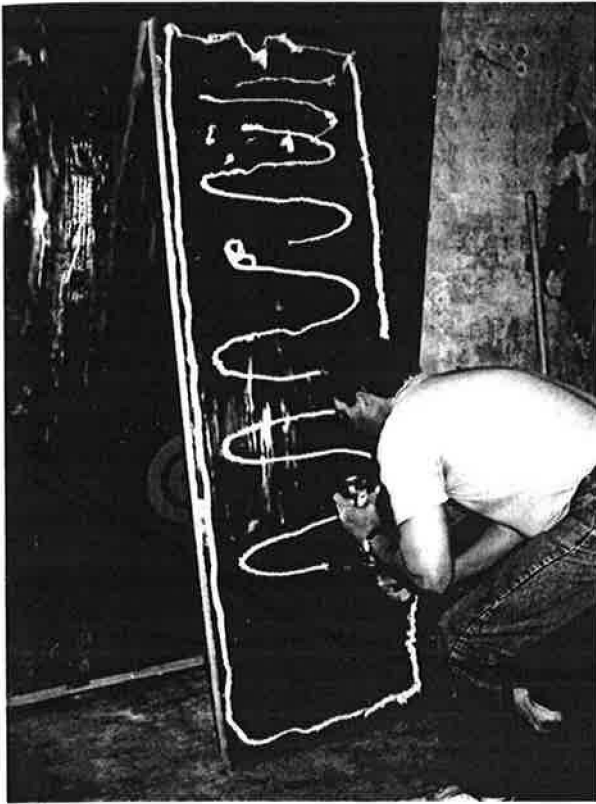
Figure 4 Polyurethane foam adhesive was used to fasten 1½ in. thick rigid foam insulation to the interior surface of the walls. The exterior wall insulation used was a polyisocyanurate insulation with foil facers and an R-12 rating (1½ in. thick). Foam adhesive and drywall screws fasten the ½ in. thick cellulose-reinforced gypsum wallboard to previously installed 2 × 2 wood nailers (top and bottom) and to the rigid foam insulation.
