Green Products Brighten Multifamily Rehab

An abandoned inner-city building gets a second life as a ten-unit affordable cohousing project. What's more, the makeover used green products and materials and energy-efficient building practices and appliances.

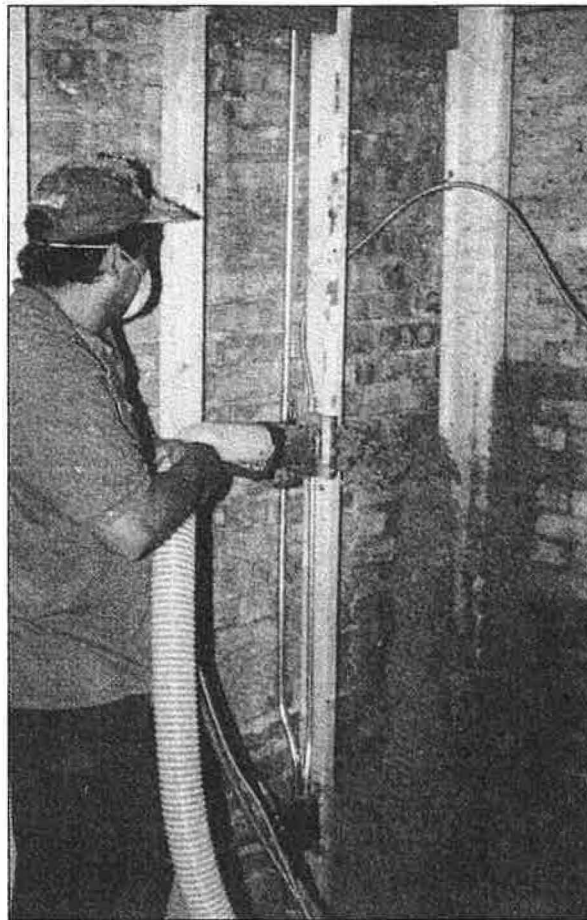
Spray rock wool was used to insulate the exterior walls.

Rock wool is made from rocks such as basalt and diabase. The rocks are heated and spun into fibers to form the insulation. The material is noncombustible and noncorrosive, and will not absorb moisture. The insulation is mixed with a dry adhesive for open-cavity installation. It is mixed with water when installed utilizing a pneumatic spray. Immediately after installation, a stud scrubber is used to shave off the excess insulation, which is then transported back to the hopper for installation. The insulation dried within seven to ten days at the WDA building. The insulation was installed in November and there was no heat in the building.

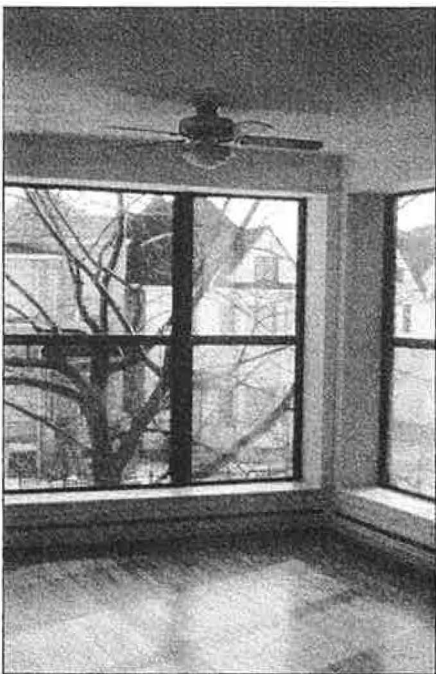
The windows are double-glazed with a low-e coating, and the floor was finished with a water-based polyurethane.

All the windows in the building required replacement. The windows were replaced with double-glazed, low-e single-hung windows by Quaker (Weather Tite series 4050). The frames are aluminum with a thermal break. The R-value of each window unit is 2.88.

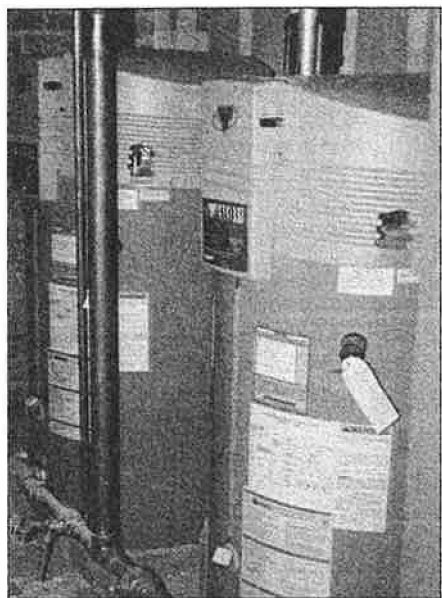
Two 60-gallon A.O. Smith Clyclone water heaters provide domestic hot water for the building.

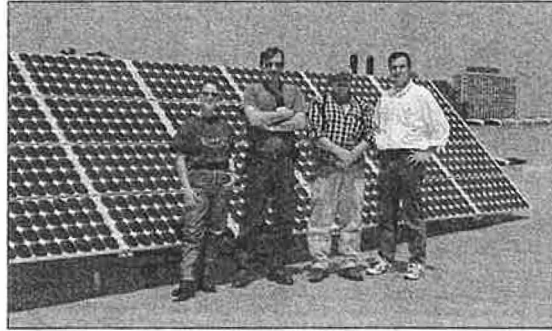
Maureen Davlin, Allan Fenske, Dave Sullivan, and Paul Knight stand in front of the 2.4 kW rooftop PV system.
