BUILDING RESEARCH NOTE

AIR LEAKAGE TESTS ON POLYETHYLENE MEMBRANE INSTALLED IN A WOOD FRAME WALL

C.Y. Shaw

Division of Building Research, National Research Council of Canada

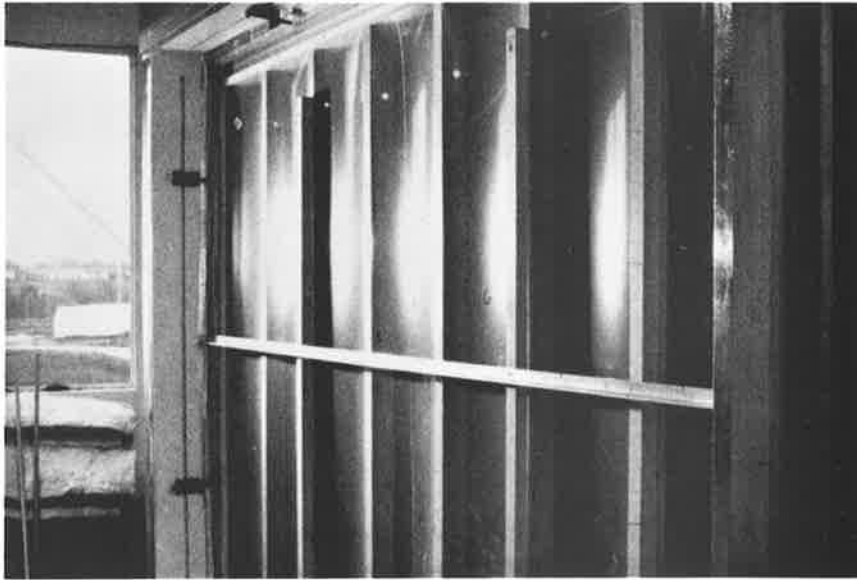
FIGURE 3
DEPRESSURIZATION TEST

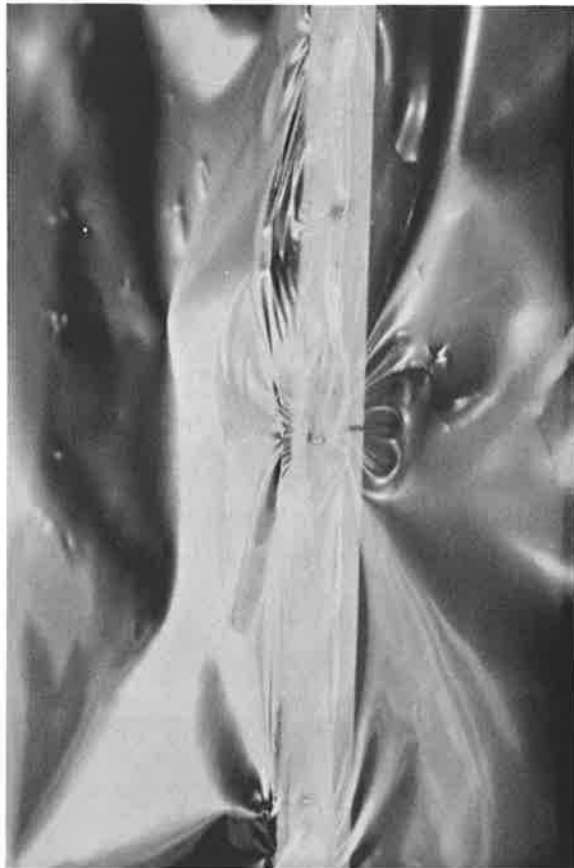
FIGURE 8

CONDITION OF POLYETHYLENE AFTER GYPSUM BOARDS
REMOVED ($\Delta P_{\text{POLY}} = 865 \text{ Pa}$)

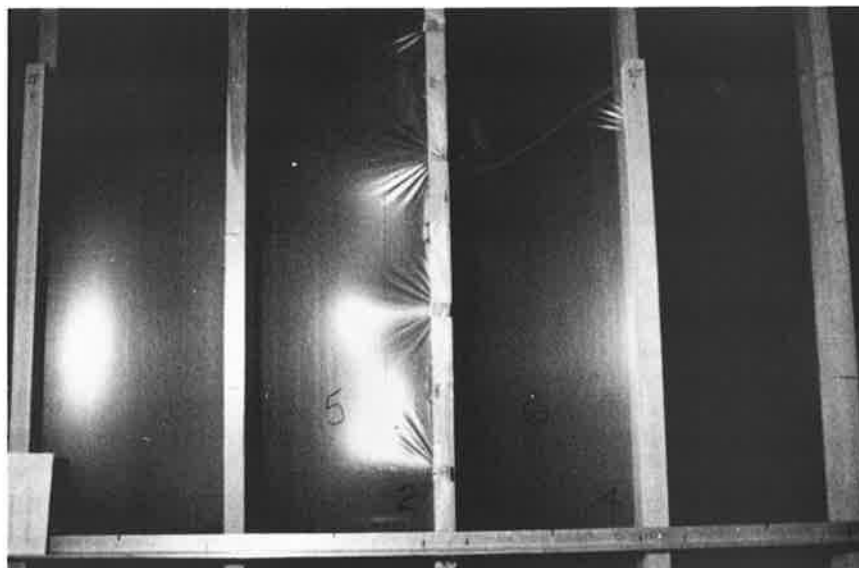
FIGURE 9b

REINFORCED POLYETHYLENE UNDER DEPRESSURIZATION

Test 2a indicated that the weakest point of the polyethylene was at the staples. To overcome this problem, a piece of duct tape was placed on the polyethylene before it was stapled to the wood frame. The measured air leakage rates (Fig. 9a) increased continuously with the pressure differential for a pressure difference as high as 700 Pa. This kind of treatment for improving the strength of polyethylene locally works well to prevent it from tearing around the holes (Fig. 9b).

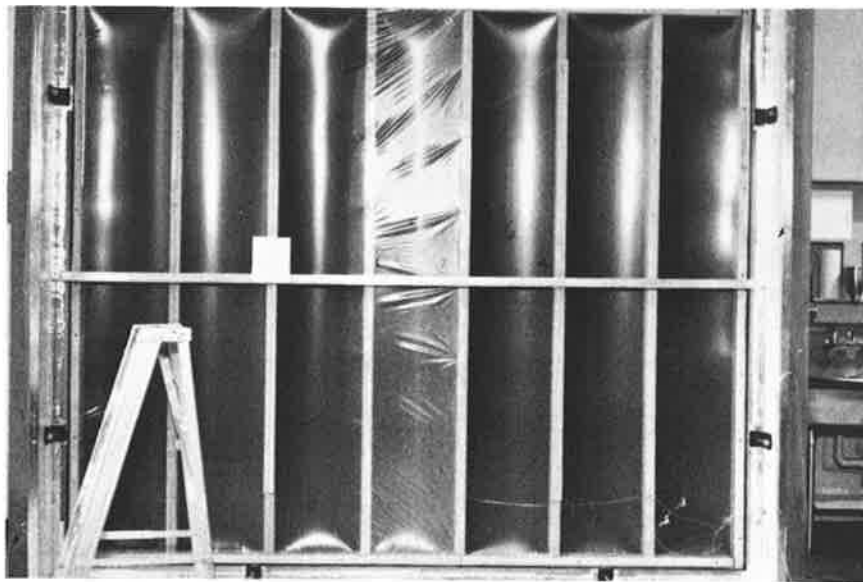
FIGURE 10 b

CONDITION OF 400 mm WIDE JOINT UNDER DEPRESSURIZATION

This configuration was similar to that of Test 2a except that the two sheets of polyethylene were overlapped by 400 mm. The wider overlap permitted the joint to be stapled to two studs, instead of one as in the case of Test 2a. Figure 10a shows the measured air leakage rates. The air leakage characteristics were similar to those in Test 2a, but the air leakage rate through the 400 mm joint was smaller than that through the 40 mm one. Permanent tearing appeared at the holes, but the polyethylene sheets were held together and in place firmly by the two columns of staples (Fig. 10b).

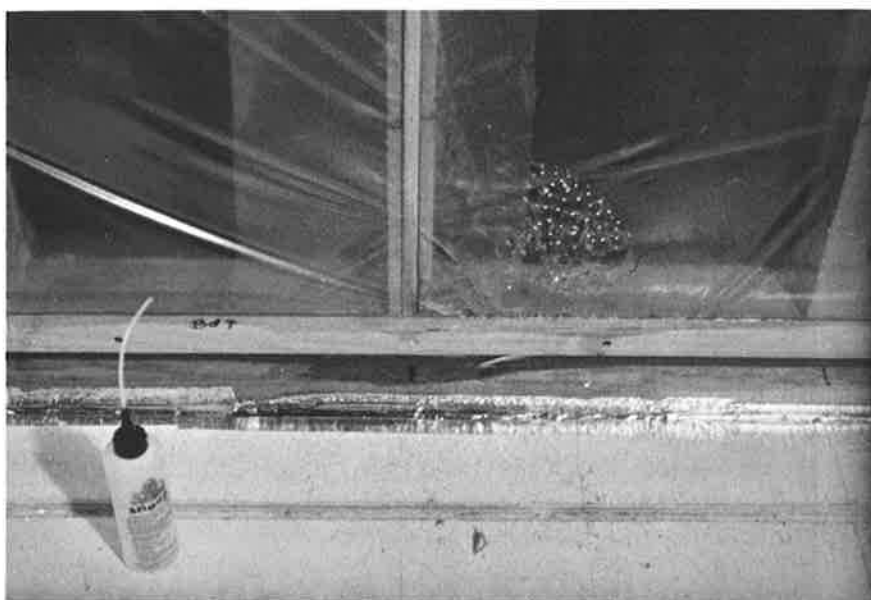
FIGURE 12 b

SOAP BUBBLE TEST SHOWING THE AIR LEAKAGE SOURCE,
SPLINE METHOD

The spline method was developed to eliminate the air leakage through the joint between two sheets of polyethylene. Figure 12a shows that the measured air leakage rates were much greater than that for a full sheet of polyethylene with no joints (Test 1a). There was no air leakage through the joint, but some air leakage was found at locations where two joints met (e.g., corners, see Fig. 12b).

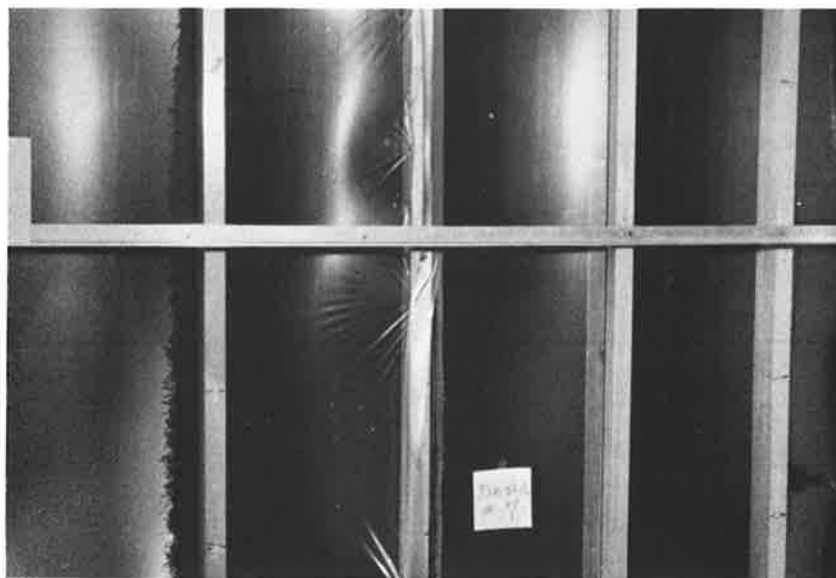
FIGURE 14 b

CONDITION OF TAPED JOINT UNDER PRESSURIZATION

pressurization, however, the tape failed to hold the polyethylene sheets together (Fig. 14b).

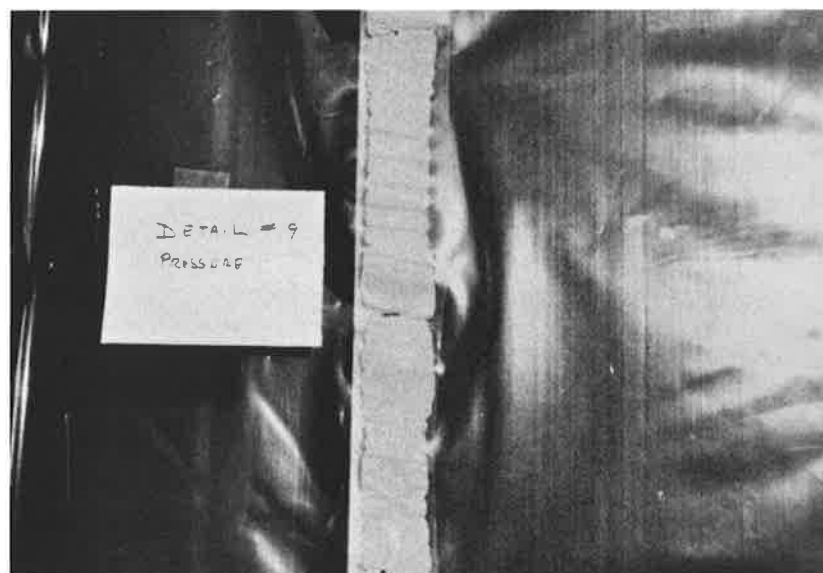
FIGURE 16 b

CONDITION OF CAULKED JOINT AFTER
 GYPSUM BOARDS REMOVED
