Surveying the moisture contents of cavity-filled timber-framed dwellings

J R Southern, LRIC and G High

This paper describes a method of surveying the moisture contents of timber in those timber-framed dwellings which have had the cavity between their cladding and the sheathing thermally insulated after occupation. It gives guidance on moisture levels likely to be acceptable for the timber frame and suggests remedial action should high moisture levels be found.

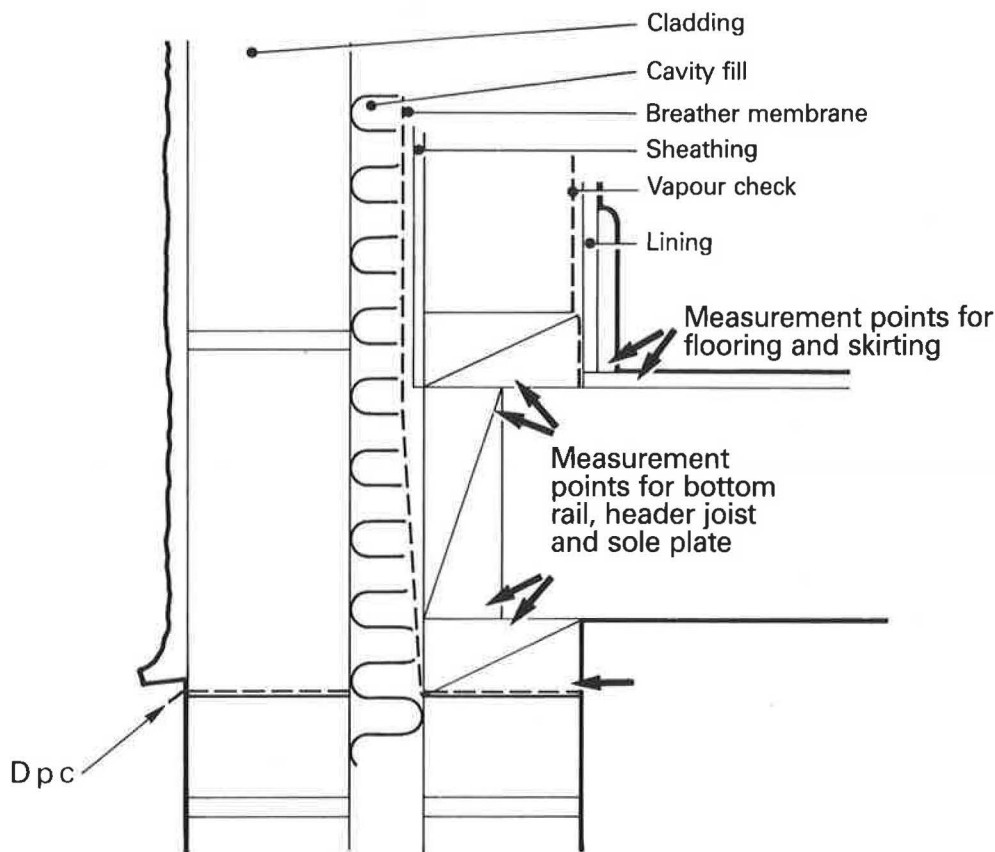
Figure 1 Locations of measurement points from inside the dwelling on each floor level and under the ground floor

The first measurements should be in the skirting and flooring around the perimeter of the house (Figure 1).

Moisture-meter readings should be taken at the locations described below and shown in Figure 1:

In timber skirtings 10 mm up from the floor at 1 m intervals along the perimeter wall, and in timber, chipboard or plywood floors 10 mm from the skirting at the same intervals.

Under the ground floor in all timber members at 2 m intervals around the perimeter, 10 mm from the intersection of members.

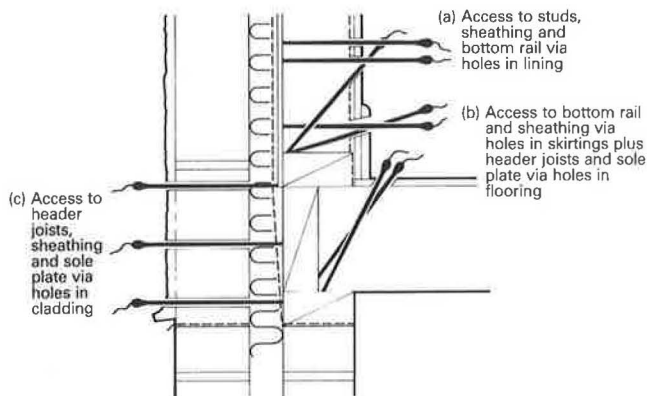
Figure 2 Positions of access holes drilled in lining or cladding, or in flooring and skirting, to obtain measurements from structural timbers and sheathing at ground or first-floor level

under-buildings, first-floor structural timber, and for external access are given in Figure 2.

Access to ground-floor and first-floor structural timbers can be gained as shown in Figure 2: (a) through the lining, (b) through the skirting and floor boards or (c) through the outer cladding.

Initially, to minimise damage, only one of the three types of drilling illustrated in Figure 2 should be used. It is suggested that sets of readings are taken at a minimum of eight locations with at least one set in the timbers of each wall. When working from the inside, moisture-content readings can be supplemented by examination through larger holes using a fibre-optic viewer to check for mould growth or damp staining.
