ABATEMENT OF ASPERGILLUS NIGER CONTAMINATION IN A LIBRARY

E.N. Light, CIH J.A. Coco, CIH A.C. Bennett K.L. Long

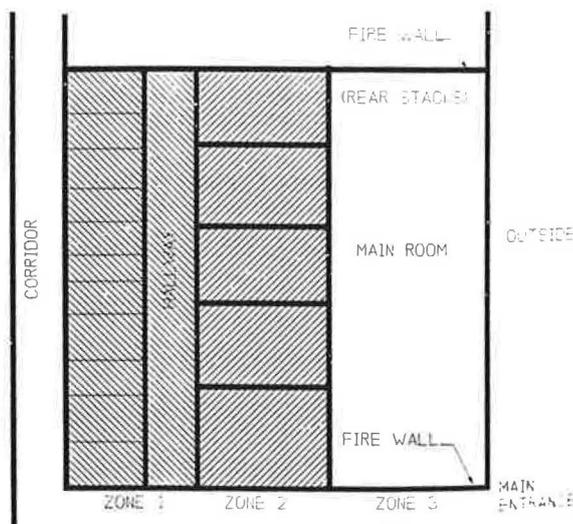
Figure 1 Library abatement project

The library under investigation is located in the Washington, DC, metropolitan area and is part of a 20-year-old educational facility of 160,000 ft² (14,857 m²). Of primary concern were the library and adjacent offices, which shared a common air handler. For purposes of this project, the space was subdivided into three zones (see Figure 1) as follows:

- Zone 1: Library main room (approximately 5000 ft² (464 m²) and site of the most direct water damage).
- Zone 2: Six library rooms adjacent to the main room (approximately 2000 ft², 186 m²).
- Zone 3: Sixteen offices adjacent to Zone 2 (approximately 5000 ft², 464 m²).

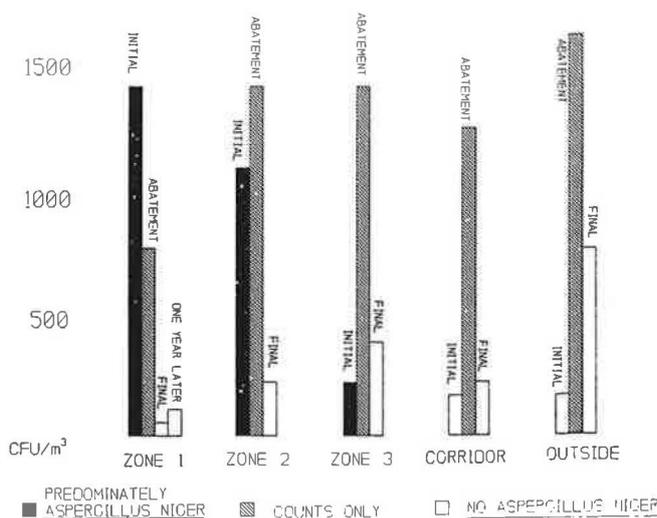
Figure 2 Comparison of peak fungal counts

1. The library investigated had a significant microbial contamination problem, as reflected in high airborne concentrations of *Aspergillus niger*.
2. Initial in-house clean-up efforts were not successful because of a failure to identify and remove or disinfect all reservoirs of mold growth.
3. A detailed abatement effort permanently reduced airborne fungal counts to background levels and eliminated *Aspergillus niger* from subsequent air samples (see Figure 2).
