**CMHC Research Project
Testing of Air Barriers
Construction Details**

REPORT

Report No. 30132.OR/2

August 26, 1991

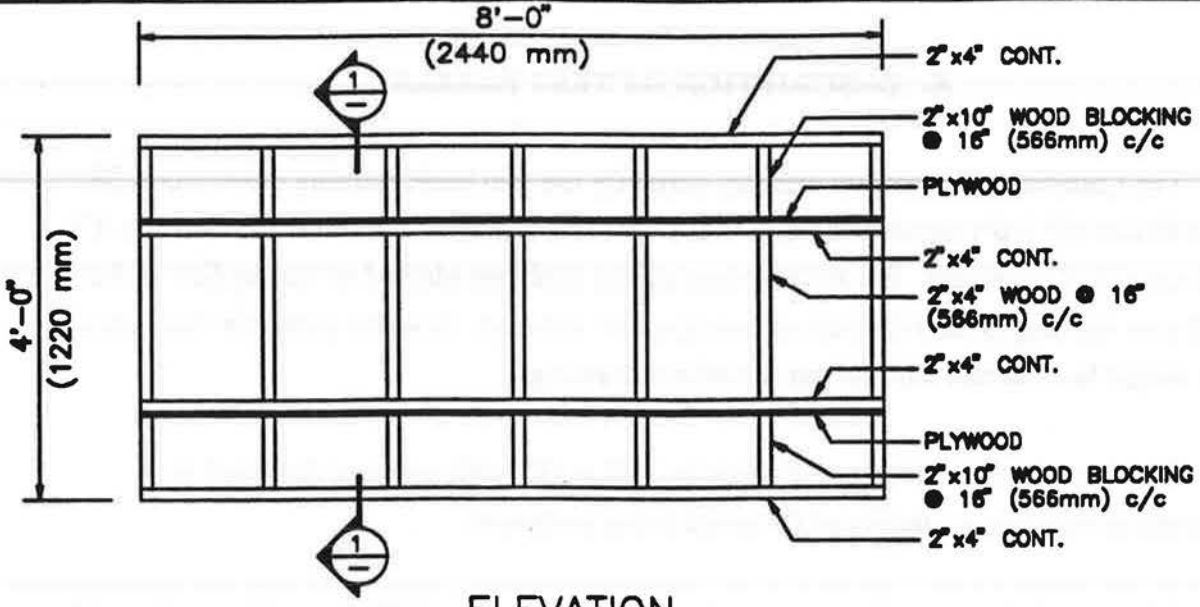
SECTION 1

This detail incorporated the joints between the foundation sill plate, the header joist, the plywood flooring and the bottom plate of the wall framing above. In order to maximize the lineal feet of joint, the upper section of the panel was the mirror image of the lower section. The four test sections addressing this detail are shown in Figure 5.1.

ELEVATION

PANEL No. 1 POLY APPROACH PANEL No. 2 EASE APPROACH PANEL No. 3 ADA APPROACH PANEL No. 4 TRADITIONAL APPROACH

This detail used a spun bonded olefin film sheet (Tyvek[®]) to wrap the exterior face of the header joist. This connected to the polyethylene air/vapour barrier on the inside. A bead of acoustic sealant was placed between the Tyvek sheet and the polyethylene at each of the bottom plate locations. 12 mm gypsum board was attached to the studs with standard

This panel used the same framing as panel no. 1. The exterior air barrier was made by first loosely attaching a layer of 12 mm fibreboard on the exterior surface of the studs and header using roofing nails. This surface was covered with TYVEK, stapled as required to hold it in place. A second sheet of fibreboard was then installed, nailing with longer roofing nails on 300 mm centers.

As seen in Figure 5.1 the exterior air barrier (sandwiched olefin membrane) extends past the header joist and under the foundation sill plate. It is therefore not interrupted by the header joist detail. In practice, it would be connected to the foundation wall below. In the test panel it was sealed to the bottom of the sill plate with tape.

This panel used open cell, ethafoam gaskets 100 mm wide by 5 mm thick to seal framing joints. These were placed between the foundation sill plate and header joist; the header joist and plywood flooring; and the plywood flooring

and bottom wall plate. The interior air barrier and vapour retarder were provided by a sheet of 12 mm, foil backed gypsum board attached with drywall screws on 300 mm centers. All screw heads were covered with a layer of drywall compound. An ethafoam gasket was also placed between the wall framing and the perimeter of the gypsum board to prevent air leakage at the edges.

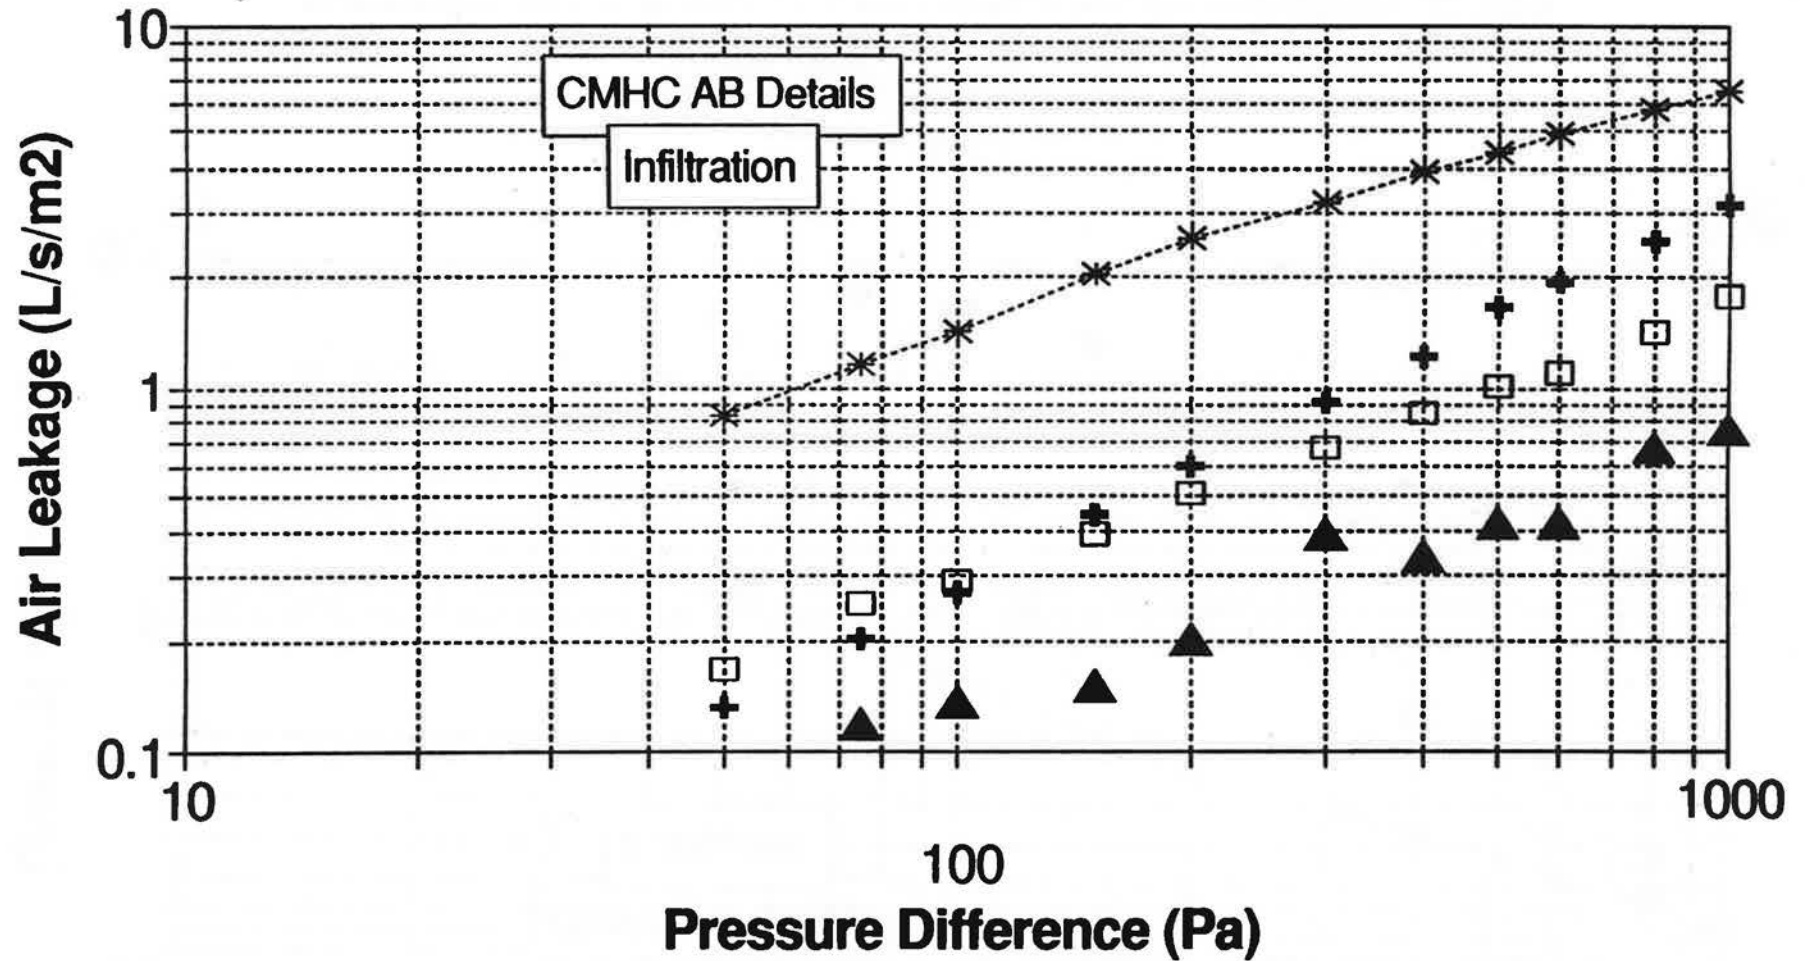
Graph 6.1

HEADER JOIST DETAIL COMPLETED PANEL

□ POLY, panel 1
 + EASE, panel 2
 ▲ ADA, panel 3
 -* Traditional, panel 4

Flow rates at 75 Pascals for Panel 1 and Panel 2 were about 24% and 18% respectively of the "Traditional" test section. The lowest leakage rates were achieved with Panel No. 3 (ADA). Its air flow at 75 Pa was about 10% of Panel No. 4 (Traditional). The air flow values and characteristics at 75 Pa, and lower pressure differences, are more meaningful than those at 1000 Pa in relation to moisture transfer and drying potential.
