**CMA Chalifour, Marcotte
et Associés Inc.**

**Enquête sur le terrain portant
sur l'étanchéité à l'air, le
mouvement de l'air et la qualité
de l'air intérieur des tours
d'habitation au Québec**

RAPPORT FINAL

Septembre 1991

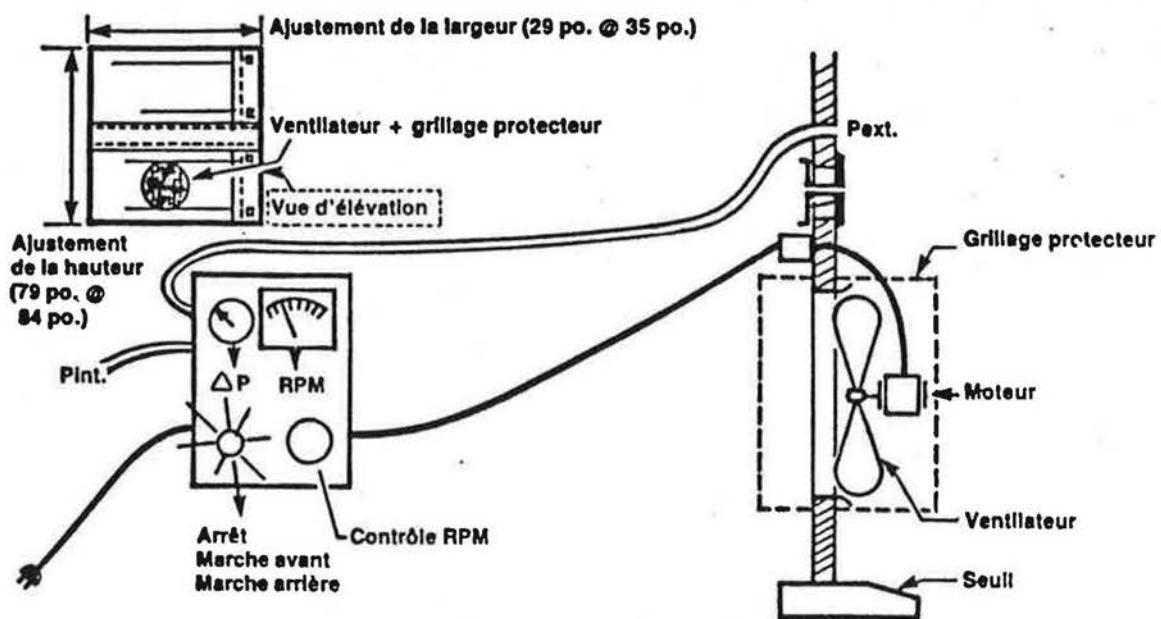
**FIGURE 2 : RESULTATS EXPERIMENTAUX**

La procédure d'essai consiste à maintenir un différentiel de pression entre l'intérieur et l'extérieur du bâtiment (ΔP) pour mesurer le taux d'infiltration d'air (V_{AIR}) avec l'aide des courbes caractéristiques du ventilateur (RPM & ΔP). Lorsque les résultats expérimentaux sont présentés sur du papier graphique "log-log" (figure 2 de l'annexe 4), on obtient une droite.

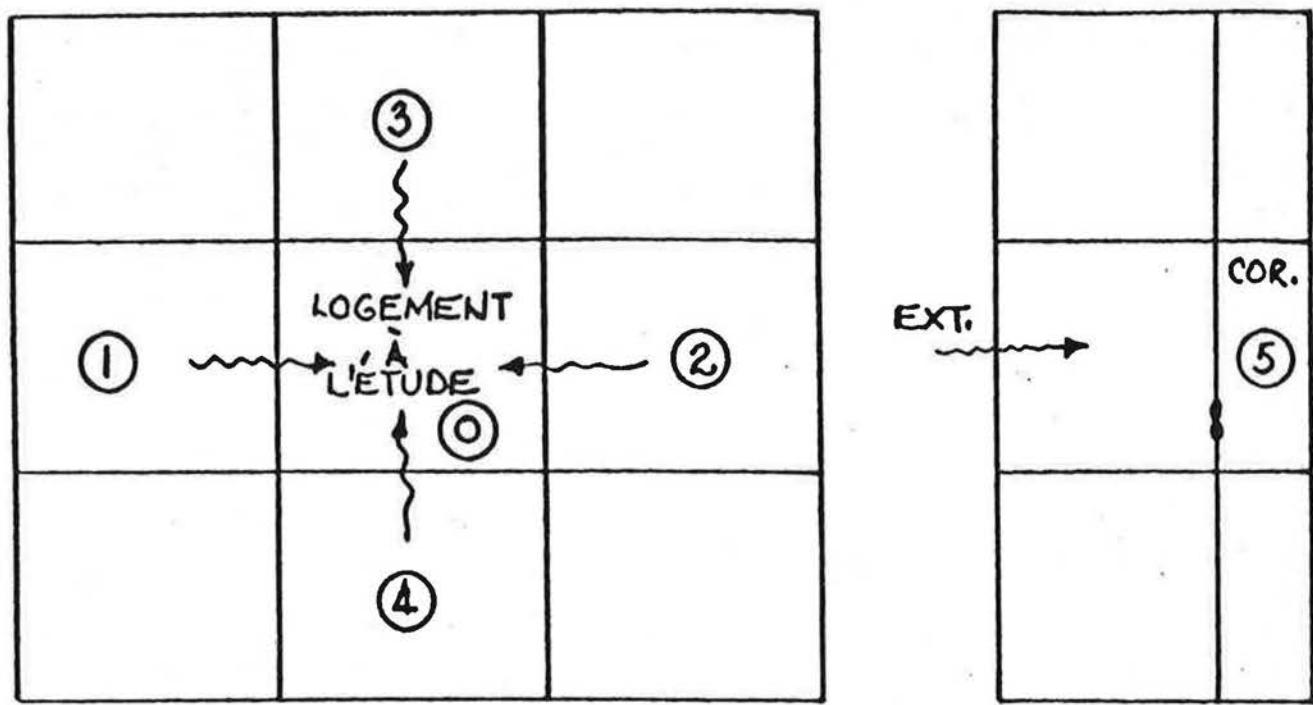
ANNEXE 5

EMPLACEMENT DU LOGEMENT TEMOIN

Appartement adjacent - 5e, corridor

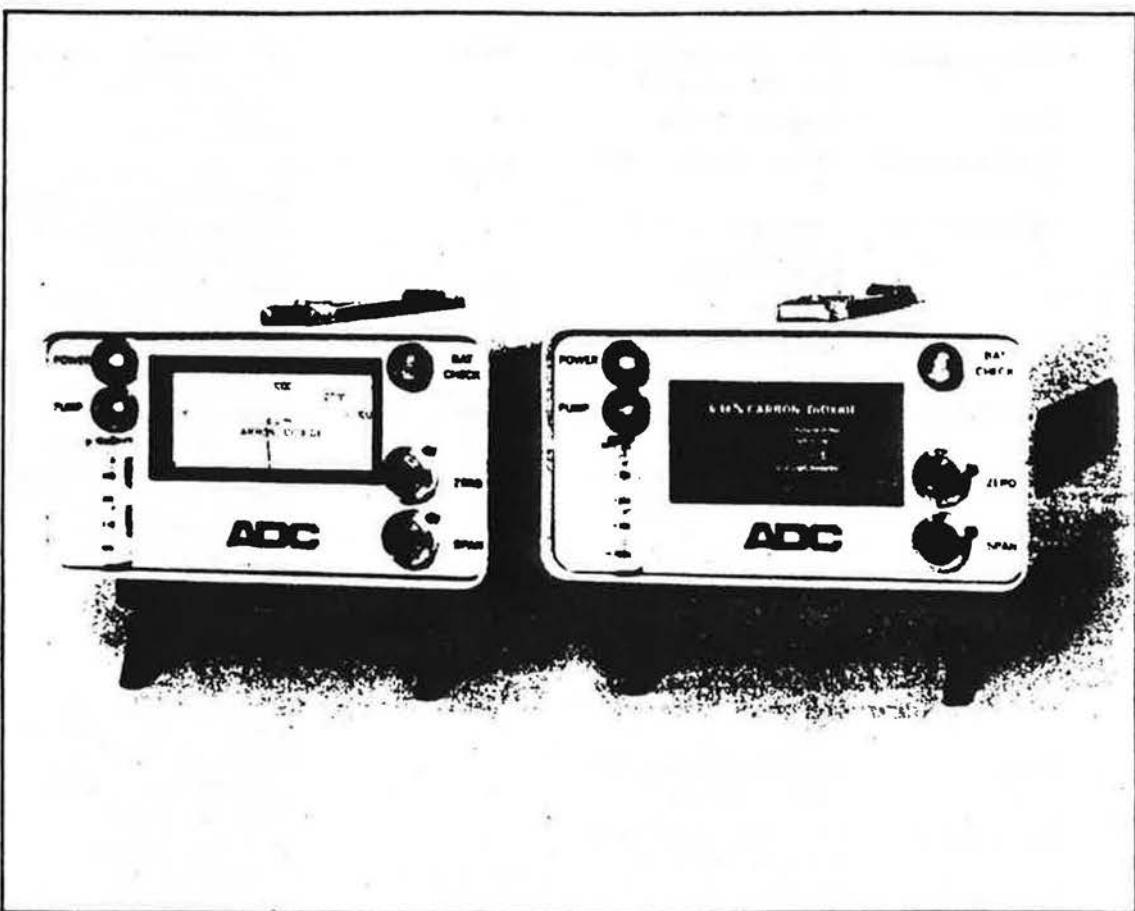
A range of lightweight, portable
battery-powered infrared gas analysers

- ★ Warm-up less than 3 minutes
- ★ No moving parts in optical system
- ★ Sample pump incorporated
- ★ No consumable chemicals
- ★ 8 hours operation between charges
- ★ Automatic battery protection

The 'PM 2' range of infrared gas analysers has been developed for applications requiring a tough, easily transportable battery-powered gas analyser for routine sampling. With the use of probes and filters it provides a low cost analyser for the measurement of furnace atmospheres, stacks, internal combustion engine exhaust gases, controlled atmosphere chambers etc.

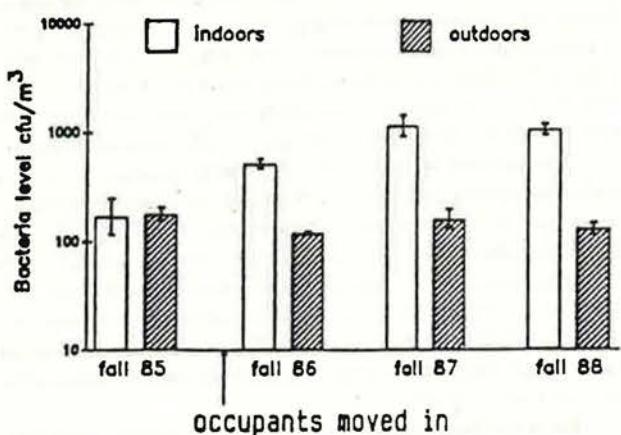
Figure 1 Bacteria levels in new townhouse apartments before occupancy and after one, two, and three years of occupancy

170 cfu/m³ and increased statistically significantly ($p < 0.0005$) during the first year of occupancy to GM 520 cfu/m³, as seen in Figure 1. After two years of occupancy, the levels had risen further to GM 1,150 cfu/m³, which again was significantly ($p < 0.0005$) higher than a year before. This increase occurred in all three townhouses with six apartments each, regardless of ventilation system. After three years, the bacteria levels had stabilized to GM of 1,070 cfu/m³. During all these sampling periods, the outdoor bacteria levels were of the same order of magnitude, GM 110 to 150 cfu/m³ (Figure 1).

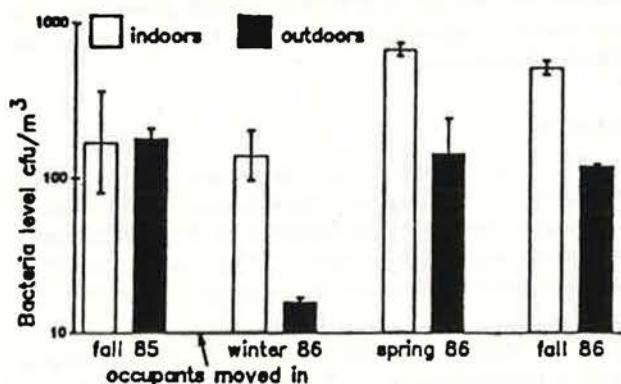
Figure 2 Bacteria levels in new townhouse apartments before and during the first year of occupancy

The bacteria levels during the first year of occupancy are presented in Figure 2. The geometric means of the bacteria levels were 140 cfu/m³ in the winter, 680 cfu/m³ in the spring, and 520 cfu/m³ in the fall.

During the first year of occupancy, the bacteria levels were monitored in different seasons (Figure 2). The total number of bacteria was almost the same in the unoccupied apartments and after four months of occupation. However, there was a significant difference in the bacterial flora. In the unoccupied apartments, the bacteria were mostly those of the outdoor air, while in the winter samples, the indoor air bacteria were of human origin and, in parallel, outdoor levels were very low due to the snow cover. In the results of this winter sampling, the indoor levels are clearly higher than those outdoors, which shows the importance of the intramural sources to the indoor air bacteria levels. This can also be seen in the spring and fall samples of the first year of occupation. Even if the outdoor levels were higher after the snow cover had melted, the indoor levels were clearly higher than those outdoors.

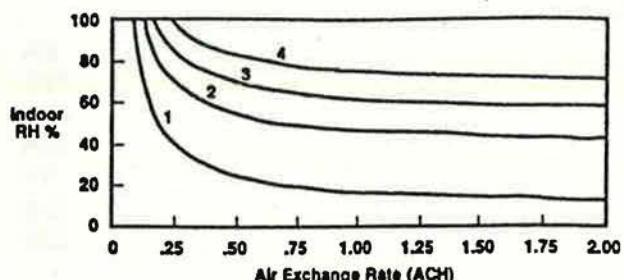
1	2	3	4
Outside Air Temp.	(Deg. F)	20	47	52	58
Outside Air R.H.	(%)	50	76	90	90
Indoor Air Temp.	(Deg. F)	68	68	68	68
Indoor M.P.R.	(Lb H ₂ O/Day)	20	20	20	20
Bldg. Floor Area	(Sq. Ft.)	1200	1200	1200	1200
Ceiling Height	(Ft.)	8	8	8	8

Figure 1 Effect of climate on ventilation effectiveness

The influence of climate and weather on the effectiveness of ventilation for indoor moisture control is shown graphically in Figure 1. A microcomputer program (Tsangas 1987) was used to predict the variation of indoor relative humidity vs. a building's air exchange rate for differing climates. A 1,200 ft² (112 m²) house with an internal moisture production rate (M.P.R.) of 20 pounds per day (9 kg per day) and a fixed indoor temperature was assumed. The outdoor temperature and relative humidity values were varied from a cold, dry climate (case 1) to a mild, humid climate (case 4). Case 2 represents typical average winter conditions in Portland, Oregon, whereas Case 3 represents typical average winter conditions in the coastal region. The results show that it is relatively easy to maintain fairly low indoor relative humidities in cold, dry climates, and in tightly constructed homes ventilation can be effective at reducing indoor relative humidities if they are too high. On the other hand, homes in

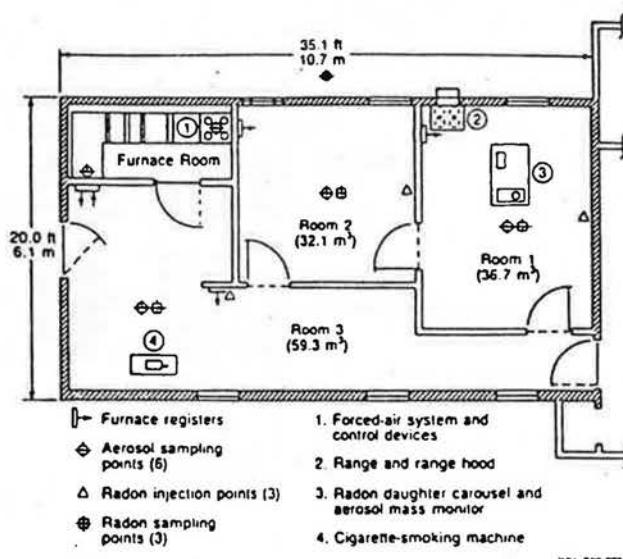
Figure 1 Floor plan of the three-room test space at the Indoor Air Quality Research House (IAQRH) depicting the typical configuration for instrumentation and sampling points.

The experiments were conducted at the Indoor Air Quality Research House (IAQRH), a two-story, wood-frame structure with a three-room test space that has been extensively weatherized to limit the infiltration rate to less than 0.1 air changes per hour (ach). A floor plan of this test space is shown in Figure 1. The interior volume of this space, including the furnace room, is 4,940 ft³ (140 m³). The net indoor air volume is 4,450 ft³ (129 m³). Doors connecting rooms 1, 2, and 3 were left open during the experiments, and for one series of tests, the door to the furnace room was closed. For a second set of experiments, the door remained open; this point will be noted later in the discussion of results. The system installed in the test space is a natural-gas-fired, natural draft residential forced-air furnace with an input heat rate of 42,500 Btu/h (12.45 kW) and a rated blower capacity of 1,125 ft³/min (1,910 m³/h) at 0.5 in. of water (125 Pa). The installation is typical of those found in residential applications. The furnace was modified to seal the combustion chamber, so that during furnace operation, combustion air is supplied from outside the building by a separate duct, and the combustion products are vented to the outside via another duct. Furnace fan control was also modified for direct control by the data acquisition and control computer. Extensive use of duct tape ensured that air leakage between the various furnace ducts and the furnace room was minimized.

A plan view of the test space in the IAQRH is in Figure 1, showing the location of the furnace and air cleaner system and the locations of the supply and return vents for the forced-air system. The four 14 in. by 4 in. (35 cm by 10 cm) supply registers were positioned approximately 7 ft (2.1 m) above the floor. These supply registers were connected to the outlet of the furnace plenum with 6 in. (15 cm) diameter galvanized sheet metal ducting. All joints were sealed, as were interior wall penetrations, to minimize extraneous air leakage pathways. Two supply ducts served room 3, with one outlet register located directly above the return air inlet, indicated in Figure 1 by the two arrows pointing in opposite directions. The opening of the return air register measured 18 in. by 12 in. (45 cm by 30 cm), and its centerline was located approximately 8 in. (20 cm) above the floor.

The indoor particle concentrations and size distributions were measured with instruments located on the second floor of the IAQRH. Copper sampling lines, 0.5 in. (1.3 cm) in diameter and 12 ft to 25 ft (4 m to 7 m) long, connected a central instrumentation manifold to the six sampling points shown in Figure 1. The ends of these sampling lines were located 6 ft (1.8 m) above the floor at each sampling point. Total particle number concentration was measured with a condensation nucleus counter (CNC), while particle sizes and concentrations were measured by an optical particle counter (OPC) for particles between 0.1 and 3 μm in diameter. For particles in the size range between 0.01 and 0.3 μm in diameter, an electrostatic classifier (EC) was used in conjunction with the CNC. Figure 3 depicts the connections between the sampling manifold and the various particulate monitoring instruments.

Cigarette smoke was selected as a test aerosol since it is a common, easily generated indoor pollutant. Usually five or six cigarettes were smoked individually in two smoking machines (at two 35 cc puffs per minute) placed on a table located in room 3, as shown in Figure 1. Both mainstream and sidestream smoke were emitted into the room. Typical cigarette burn time was six minutes, and usually two cigarettes were smoked simultaneously. This necessitated reentry into the test space to reload the smoking machines. Because only one machine was equipped with an automatic cigarette extinguisher, only one cigarette was used in the last reload, and the test space was not reentered again. Initial particle concentrations following combustion of the cigarettes were $(1 - 3) \times 10^5$ particles/cm³.

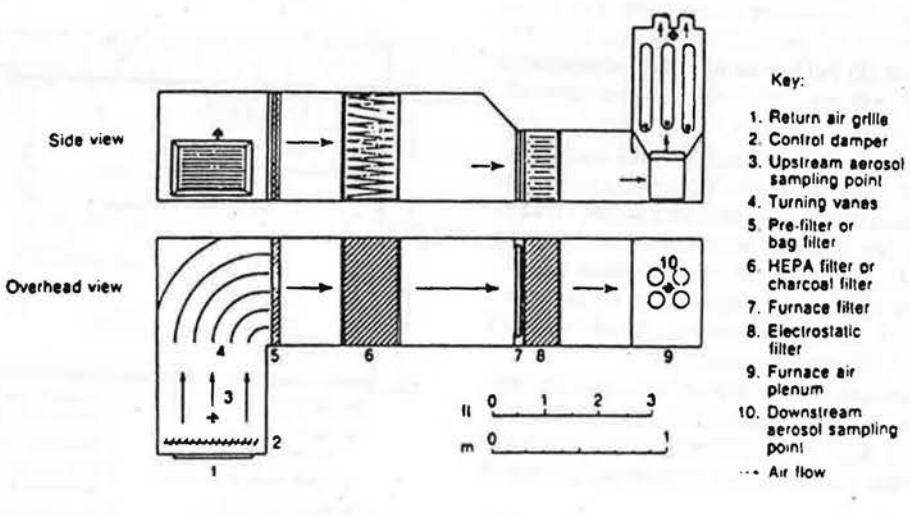
Figure 2 Drawing of the return air ductwork and furnace used for experiments at the IAQRH. Positions of the air-cleaning devices and particle-sampling locations are indicated.

Details of a portion of the return air duct and furnace system are shown in Figure 2. The maximum cross-sectional dimensions of the return duct are 24 in. by 24 in. (61 cm by 61 cm). Typical filter locations are indicated in the figure. The return-air duct was constructed with two sections of different heights in order to accommodate different size filters. In addition, the bag filter required 30 in. (76 cm) of unimpeded ducting downstream to accommodate the bag elements that extended horizontally during fan operation.

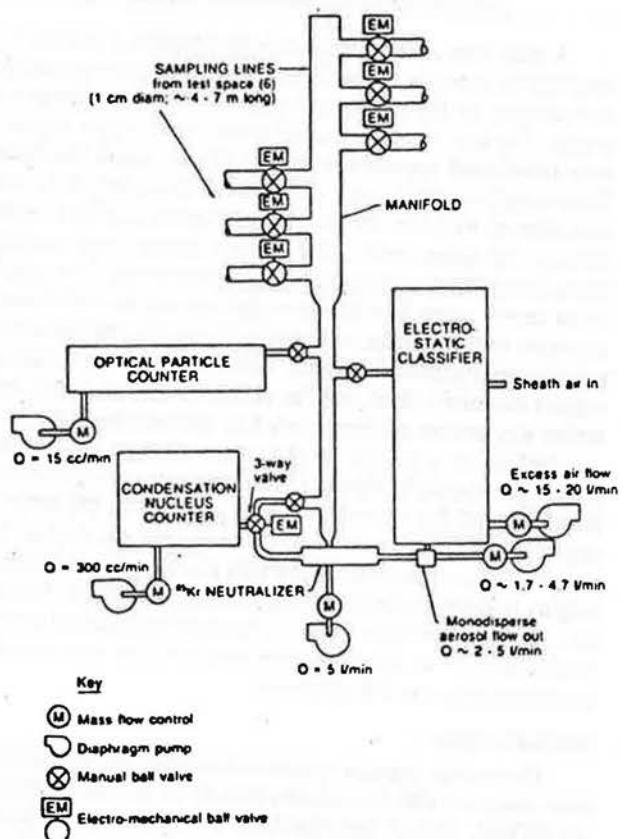
Figure 3 Drawing depicting the connections between particulate instrumentation and the sampling manifold at the Indoor Air Quality Research House.

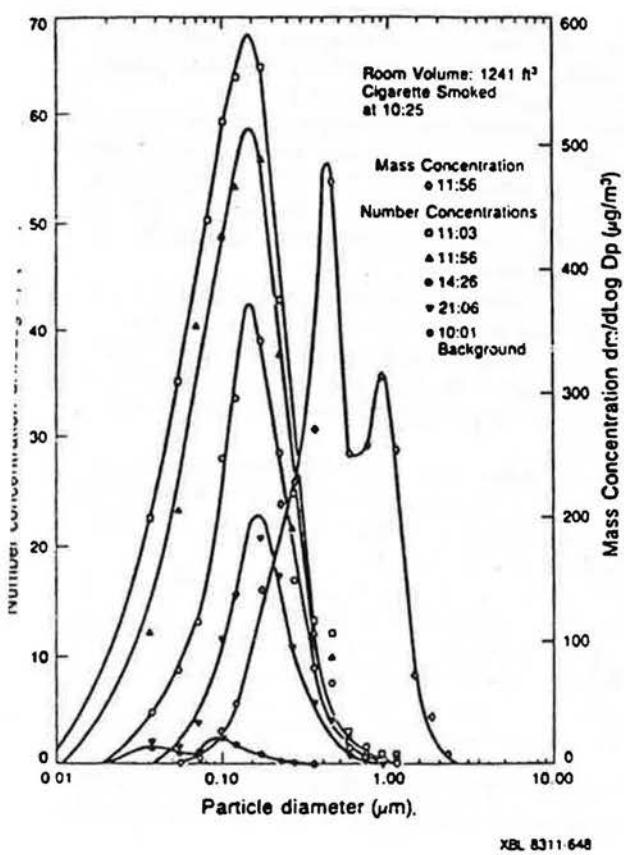
Figure 4 Size distribution of tobacco smoke particles generated from mainstream and sidestream emissions from one mechanically smoked filtered cigarette in a 1,200 ft³ room. The mass concentration was computed assuming spherical particles with a density of 1 gm/cm³.

Figure 4 shows the particle size distribution from 91-minute-old tobacco smoke generated in room 1 during a preceding series of experiments (Offermann et al. 1985). The

distribution is log normal with a number median diameter of 0.2 µm and a mass median diameter of 0.5 µm. The mass median diameter was computed assuming spherical particles with a density of 1 gm/cm³.

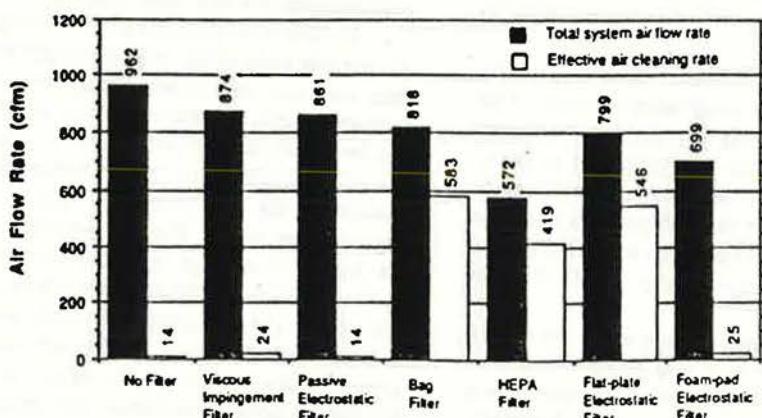
Figure 5 Graphical summary of the performance of the various in-duct air-cleaning devices. The shaded bar is the airflow rate in cfm, while the unshaded bar is the effective cleaning rate (ECR), also in cfm.

Results for the ducted air-cleaning devices evaluated in this study are tabulated in Table 1 and summarized in Figure 5.

The next best performing device was the flat-plate electrostatic precipitator, which had an ECR of 546 cfm (928 m^3/h) and a system efficiency of 69%. This efficiency on tobacco smoke particles compares to the manufacturer's reported 90% ASHRAE dust spot efficiency and is consistent with the bag filter efficiency comparisons.

The HEPA filter had the highest efficiency of 73% but an ECR of only 419 cfm (712 m^3/h). This efficiency on tobacco smoke particles compares to the manufacturer's reported 99.97% DOP efficiency. The DOP test uses an oil smoke with a mean particle size of 0.3 μm , which is slightly smaller than the 0.45 μm size particles we are using for comparison. This discrepancy in measured efficiencies was indeed surprising. We believe, as Hanley (1990) reported in his evaluation of the performance of an electronic air cleaner, that "sneakage" can be an important consideration for high-efficiency air filtration devices. In this case, we believe that air leakage occurred be-

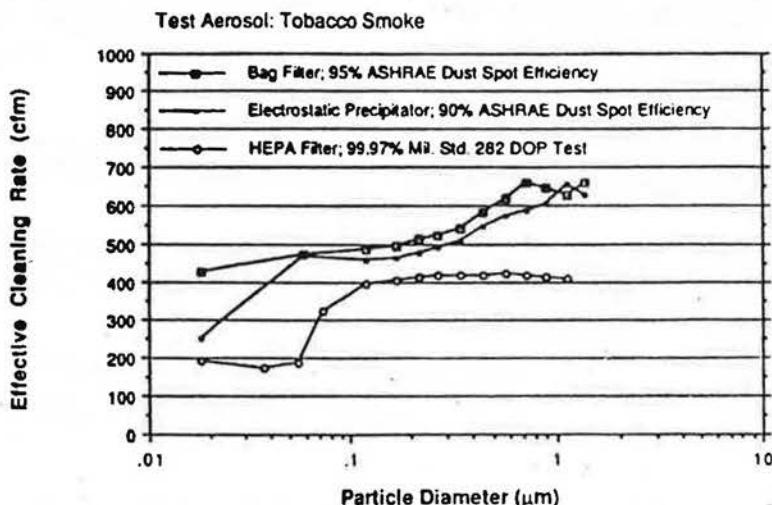
Figure 6 Plot of the effective cleaning rate (ECR) as a function of particle size for the three particle-removal devices that had a significant impact upon the indoor concentrations of particles.

Figure 6 is a plot of the effective cleaning rates as a function of particle size for the three particle-removal devices that had a significant impact upon the indoor concentrations of particles: the bag filter, the flat-plate electrostatic precipitator, and the HEPA filter. For all three devices, the particle-removal rates dropped significantly below $0.1 \mu\text{m}$. This phenomenon is surprising, since particle-removal theory for both mechanical and electrostatic filters predicts a minimum particle collection efficiency at $0.3 \mu\text{m} \pm 0.2 \mu\text{m}$.

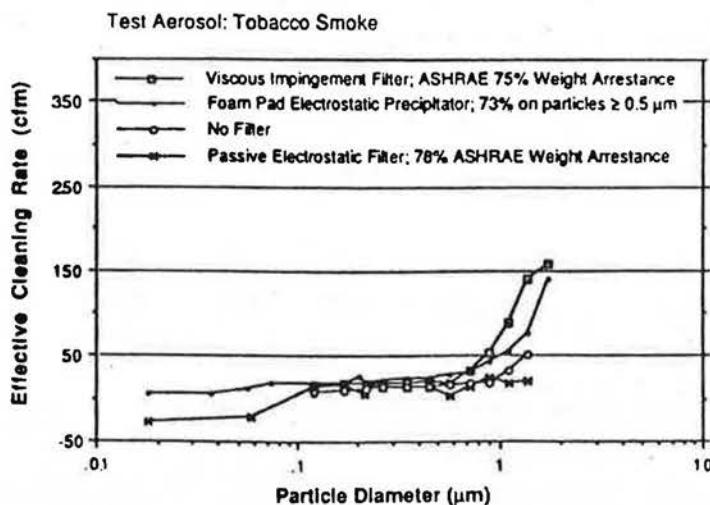
Figure 7 Plot of the effective cleaning rate (ECR) as a function of particle size for the three particle-removal devices that had no significant impact upon the indoor concentrations of particles.

Figure 7 is a plot of the effective cleaning rates as a function of particle size for the three particle-removal devices that had no significant impact upon the indoor concentrations of particles:

the viscous impingement filter, foam pad electrostatic precipitator, and the passive electrostatic filter. Also included in this plot are the results for the test with no filter. As can be seen from this figure, these devices have a negligible impact upon the concentrations of particles less than $1.0 \mu\text{m}$ in diameter. Above $1.0 \mu\text{m}$, the viscous impingement filter, which is a standard furnace filter, outperforms the much more expensive foam pad electrostatic precipitator and passive electrostatic filter.

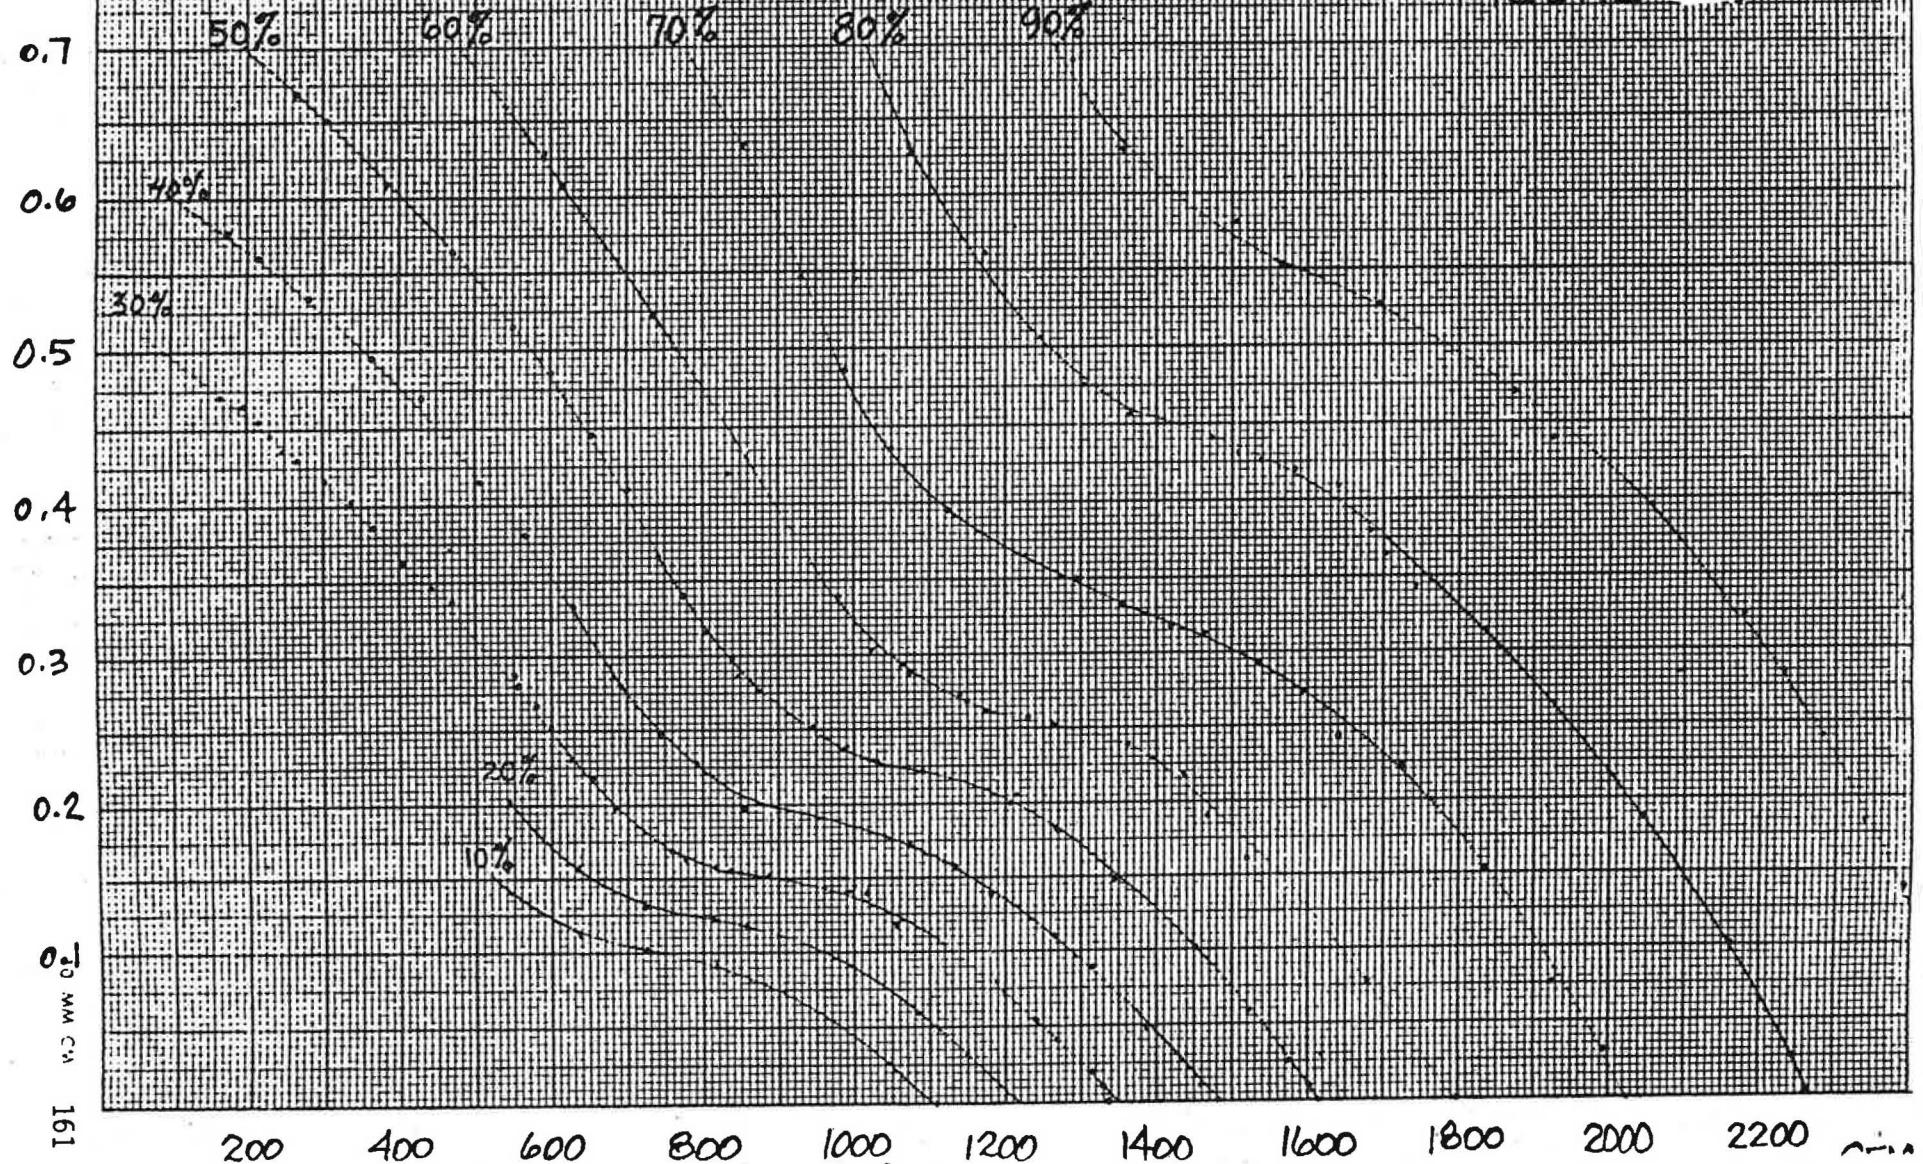
P_s STD
(po.d'eau)

CEM_{STD} VS P_s POUR DEPRESSURISATION

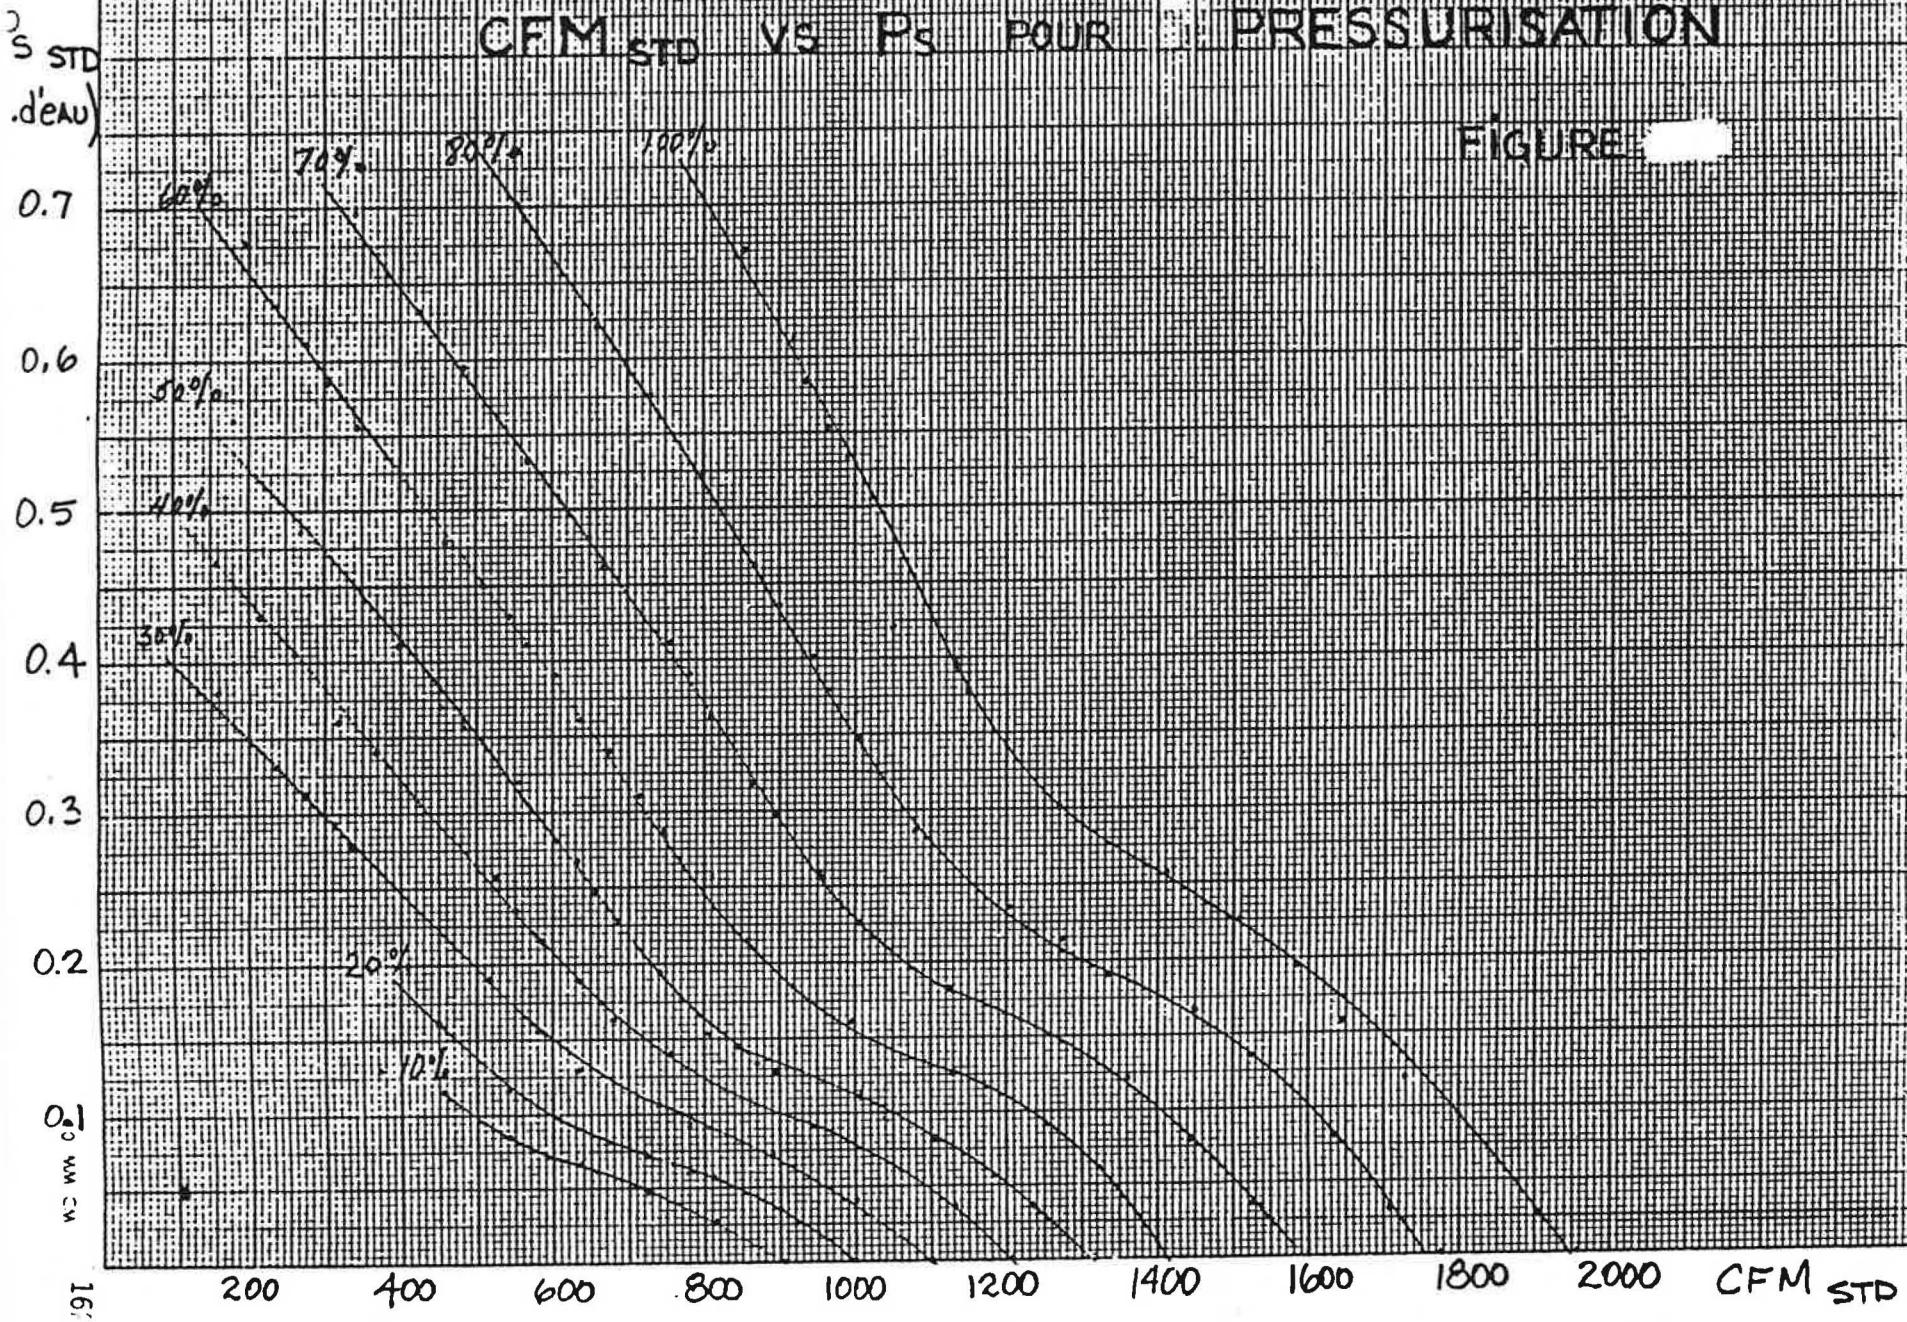
FIGURE

CFM STD VS Ps POUR LA PRESSURISATION
