**AIRTIGHTNESS OF CONCRETE BASEMENT  
SLABS**

**REPORT FOR  
CANADA MORTGAGE AND HOUSING CORPORATION**

**FILE: M91001**

**G.K. YUILL & ASSOCIATES (MAN.) LTD.**

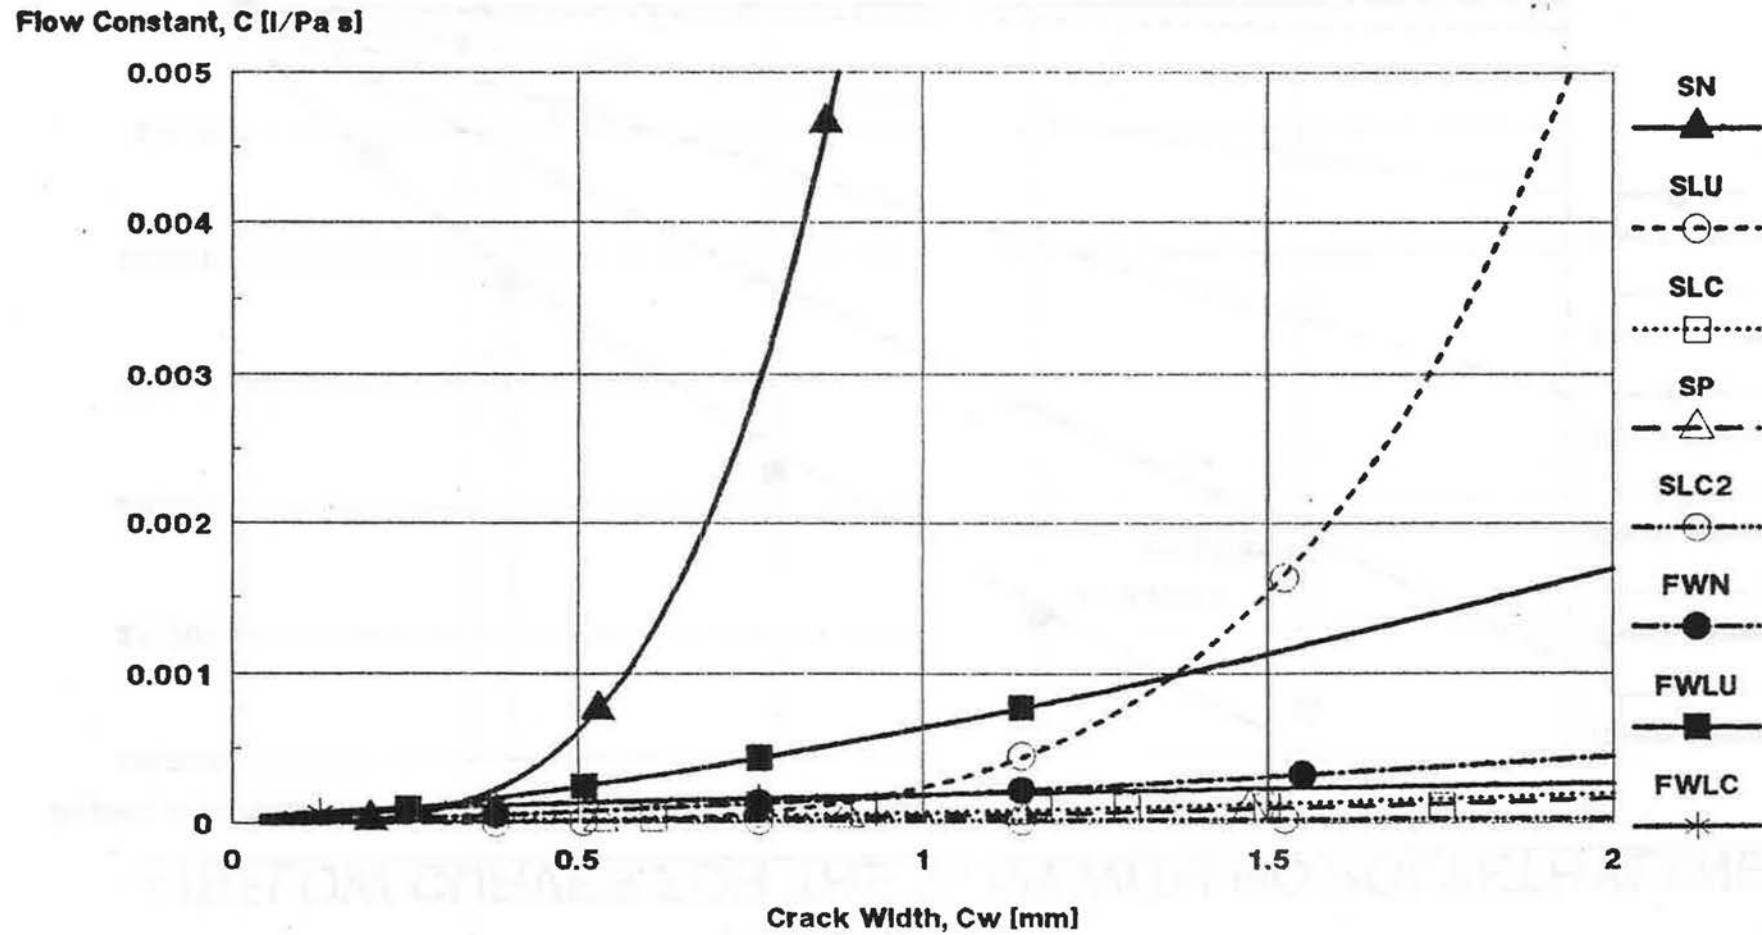
# FIGURE 4

## Flow Constant vs Crack Width for All Test Specimens

Fig. 4 shows the flow coefficient,  $C$ , as a function of crack width, for all the cases tested. As can be seen, the slab without polyethylene was much leakier than the other cracked slabs, followed by the slab with uncaulked polyethylene.
