AIR INFILTRATION THROUGH VARIOUS TYPES OF WOOD FRAME CONSTRUCTION

BY G. L. LARSON¹, D. W. NELSON² AND C. BRAATZ³, MADISON, WIS.

The results of cooperative research between the University of Wisconsin and the AMERICAN SOCIETY OF HEATING AND VENTILATING ENGINEERS

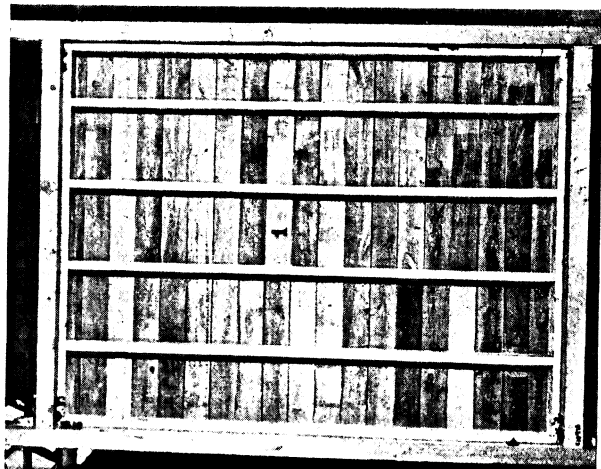
FIG. 4. INTERIOR OF PANEL NO. 1A1—GREEN SHEATHING

The leakage through green side matched sheathing, Panel 1A1, was 78.6 cfh per square foot at 15 mph. This is slightly less than the leakage through air dried end and side matched sheathing of like material. The comparatively low leakage secured indicates that even with green lumber the shrinkage is not ordinarily enough to pull the tongues and grooves apart and allow the free passage of air. A photograph of Panel 1A1 is shown in Fig. 4.
