## AIR LEAKAGE THROUGH VARIOUS FORMS OF BUILDING CONSTRUCTION

By F. C. HOUGHTEN,<sup>a</sup> (MEMBER), CARL GUTBERLET,<sup>b</sup> (NON-MEMBER), AND C. A. HERBERT,<sup>c</sup> (NON-MEMBER), PITTSBURGH, PA.

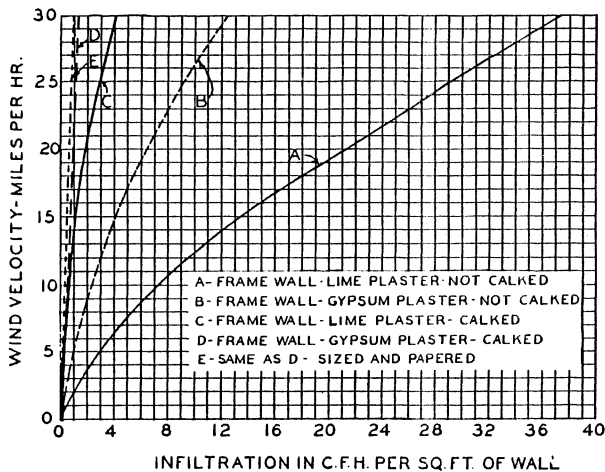
The interior of the wall was lathed and plastered with two coats of rough lime plaster and one lime skim coat. After aging, the frame wall with this plaster showed the leakage indicated by curve *A*, Fig. 4. However, a considerable portion of this leakage took place through the joint between the plaster and the surrounding wood frame as indicated by the infiltration shown by curve *C*, found after sealing the joint. Fig. 5 is a cross section of the construction showing this crack. The frame construction on which the lath and plaster was applied was built in a 1 1/2 x 8-in. board frame placed in the channel iron frame forming part of the apparatus. The joint between the wood frame and the channel frame was carefully calked so that no leakage took place

through this joint. The leakage through the frame wall with gypsum plaster before sealing the crack between plaster and wood frame is given by curve *B* and that taking place after this crack was sealed is given by curve *D*. This wall was then sized and papered and again tested giving the leakage indicated by curve *E*.

FIG. 4. INFILTRATION THROUGH FRAME WALLS

The curves in Fig. 4 show the effect of the air circulating back of the plaster and finding an outlet around the edges of the plaster. Curve A shows the leakage through a frame wall with lime plaster, the crack between the plaster and wood frame not calked. Curve C shows the leakage through the same wall with the cracks calked. The difference in these two curves may be called the infiltration around the edges of plaster. Such edges would occur in actual installations at the base boards, window frames and door casings. At 15 miles wind velocity the difference in infiltration is shown as 12.5 cu ft per hour per square foot of wall. When estimating the leakage through a wall of this construction, should the wall area be multiplied by 13.5 cu ft

The leakage through the finished frame walls was less than  $\frac{1}{2}$  cu ft per square foot per hour at 15 mph. The values secured in Pittsburgh as shown in Fig. 4 are about 1.10 and 0.75 cu ft. These leakages are extremely small and in either case would be neglected in ordinary heat loss calculations. This difference, though negligible, may be due to a difference in method of calking. At Wisconsin, a recess was made in the 2 x 4s against the 4 x 8 wood members of the frame into which the walls were built. This was filled with calking compound. In addition a space of  $\frac{1}{8}$  to  $\frac{1}{4}$  in. was left on the 4 sides of the outer wall against the frame and this space was filled with calking compound against the siding, paper and sheathing down to the 2 x 4s, so that air could not enter at the ends of the test panel.

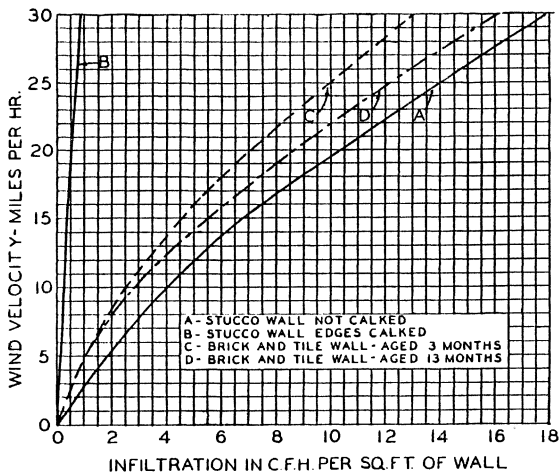
The stucco wall was built in the same board frame discussed under the plastered wall and curve *A* (Fig. 7) gives the leakage after aging but before the crack between the stucco and the wood frame was sealed up while curve *B*

gives the leakage for the same wall after this crack was sealed. Hence curve *B* represents the leakage per square foot of stucco wall.

FIG. 7. INFILTRATION THROUGH FRAME STUCCO, AND BRICK AND TILE WALLS

a manner similar to common practice. The leakage for this wall three months after construction is given in Fig. 7 by curve C, and the leakage after 13-months aging is given by curve D.

The 13-in. brick and tile wall reported in this paper had an air leakage of about 5.0 cu ft per hour per square foot of wall at 15 mph arrived at by taking an average from the 2 curves shown in Fig. 7. An 8-in. hollow tile wall tested at Wisconsin had a leakage of 9.8 cu ft per square foot per hour at 15 mph. The tile itself then seemingly allows the passage of twice the air that the combined brick and tile wall does. There seems to be a great variation in workmanship on tile walls and some would have a much greater leakage than the foregoing figures would indicate.
