# NBS BUILDING SCIENCE SERIES 77

## Acoustical and Thermal Performance of Exterior Residential Walls, Doors and Windows

# Acoustical and Thermal Performance of Exterior Residential Walls, Doors and Windows

## Abstract

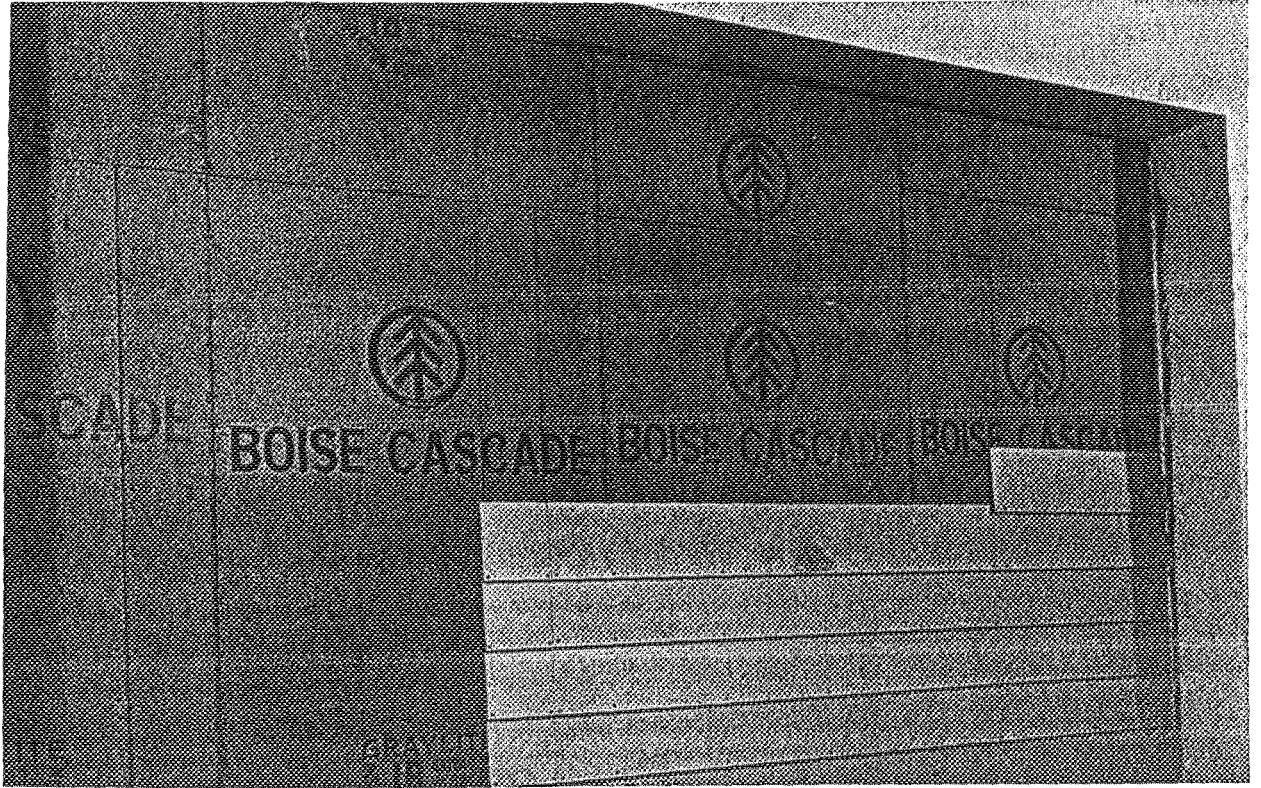
Figure 1. Application of wood siding to frame wall installed in sound transmission facility.

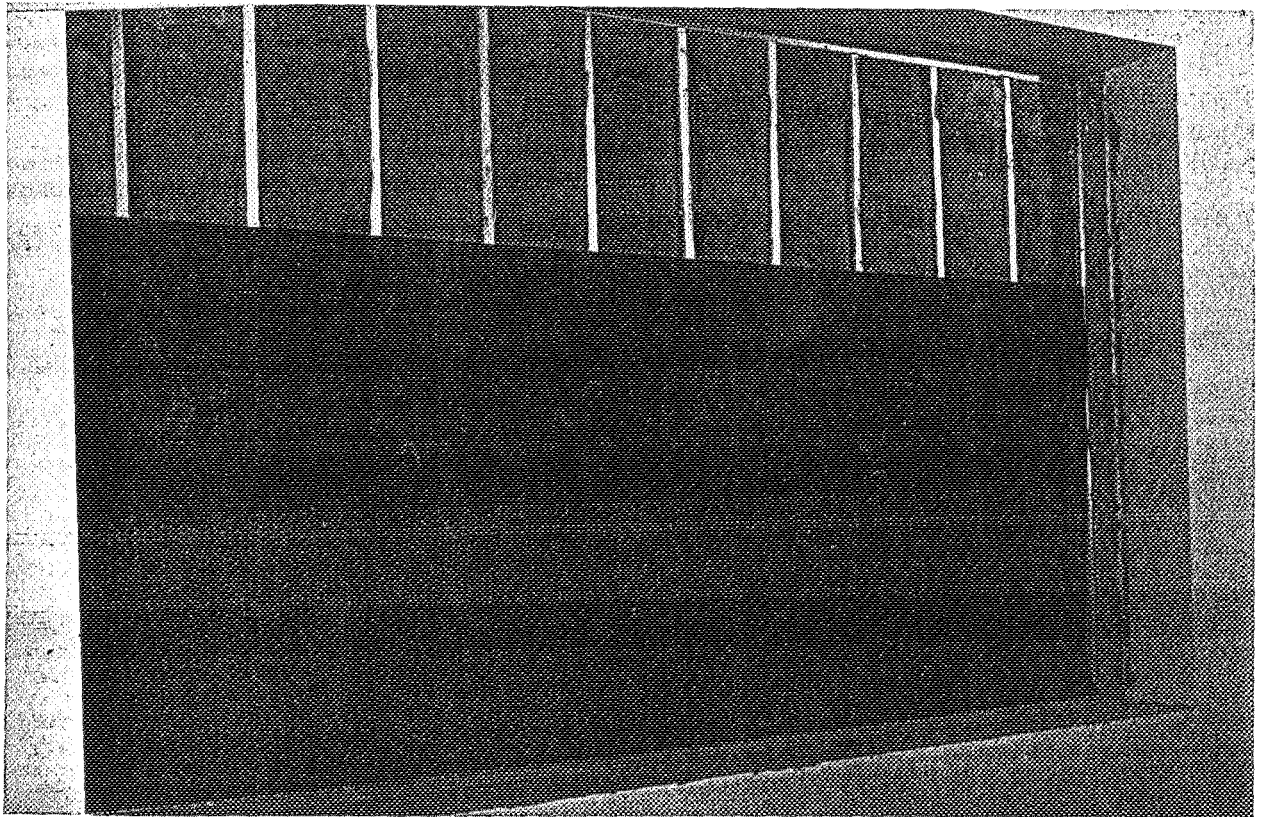
Figure 2. Application of building felt and wire mesh prior to stucco application.

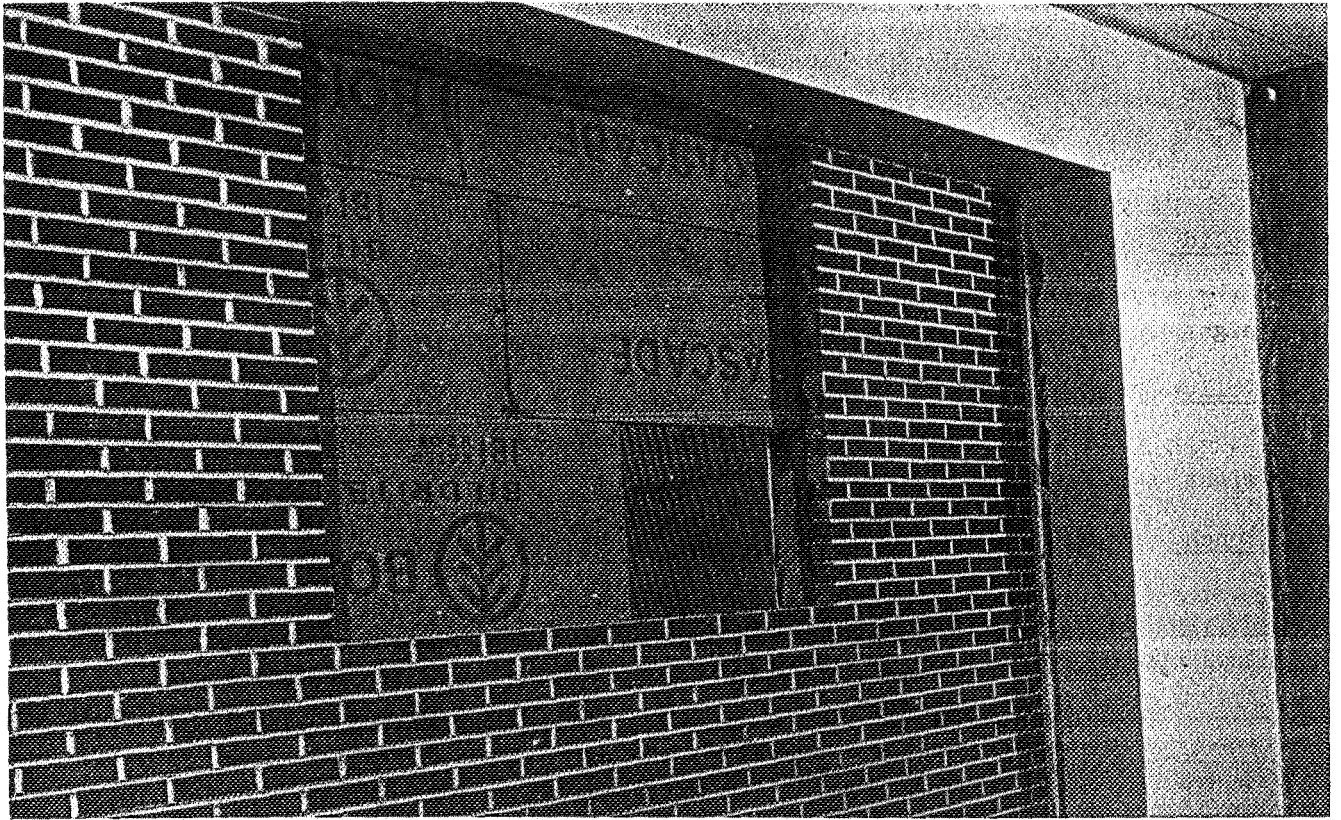
Figure 3. Brick veneer wall with opening cut for picture window.

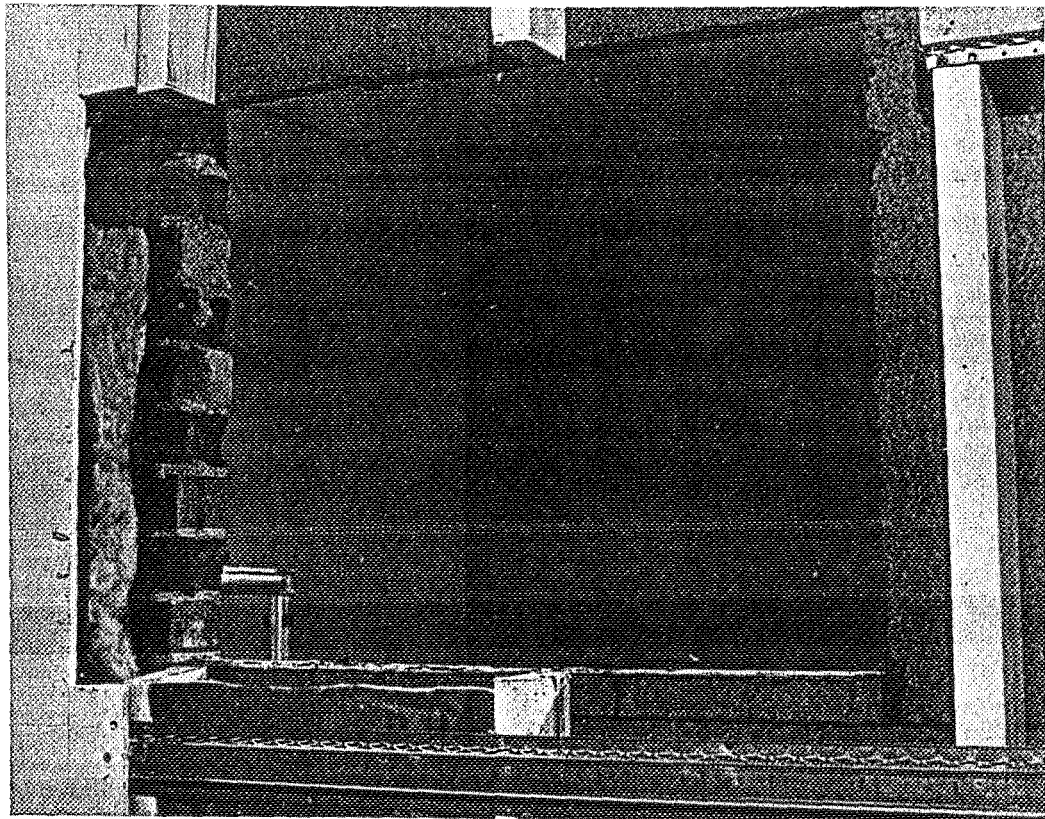
Figure 4. Detail of brick veneer wall construction with resilient channel and cavity insulation.

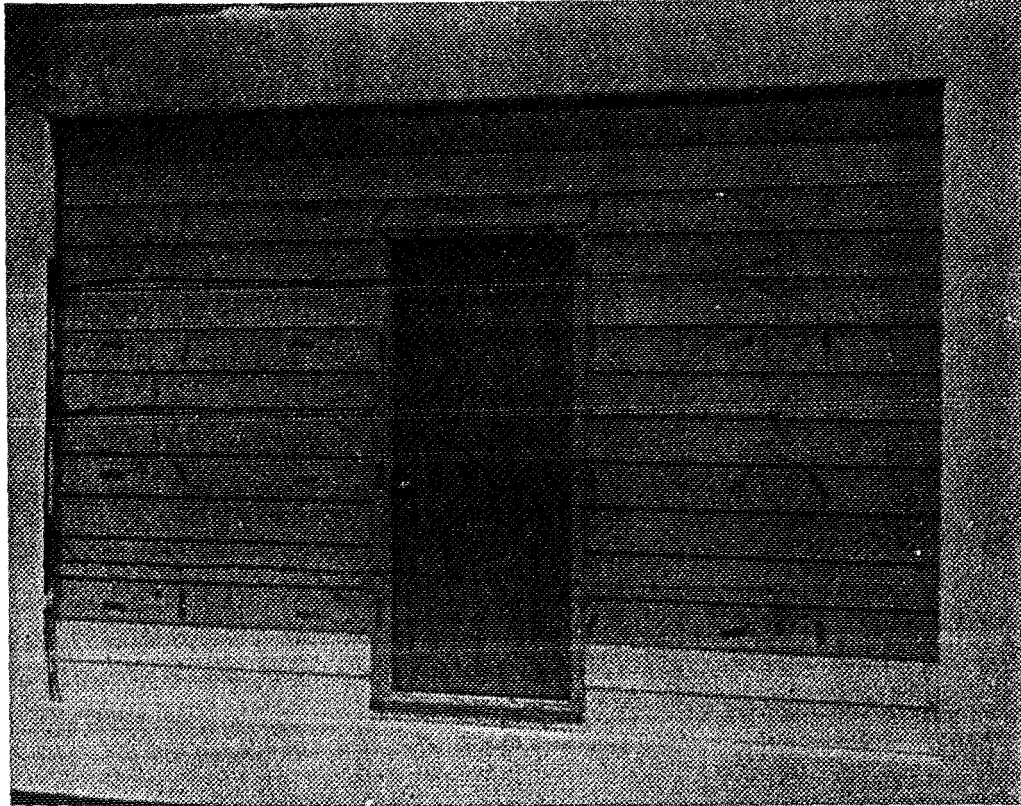
Figure 5. Solid core flush wood door mounted in wood siding wall for thermal test.

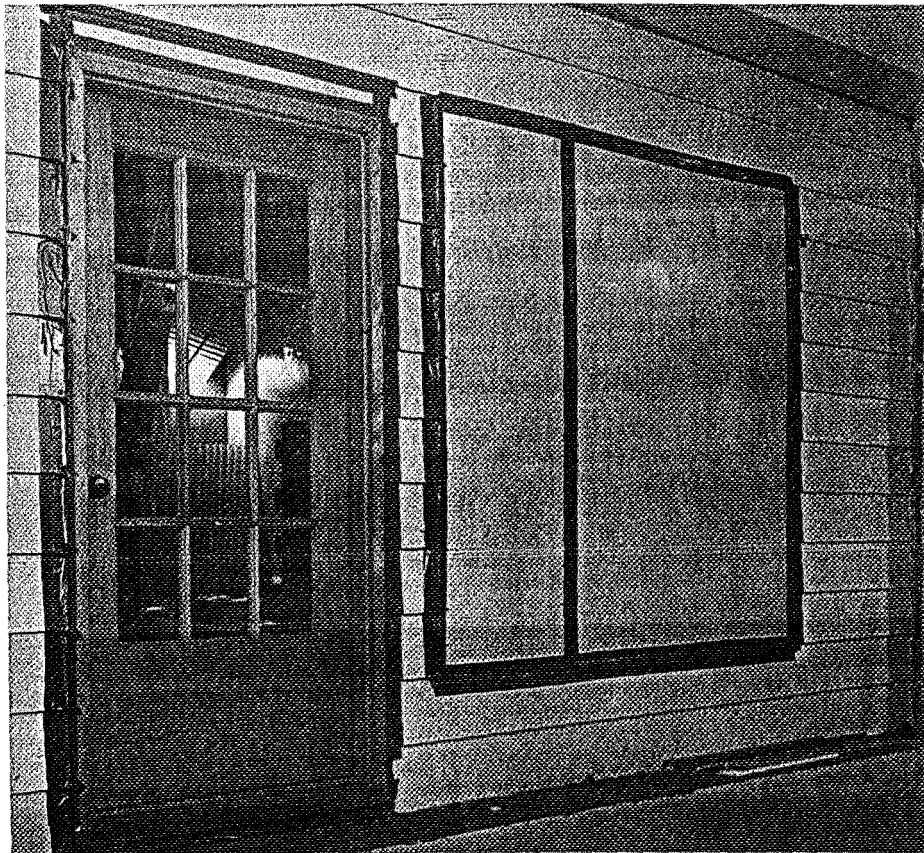
Figure 6. Wood french door mounted in wood siding wall for sound transmission and air infiltration test. Auxiliary construction on opposite side eliminates significant flanking sound transmission.

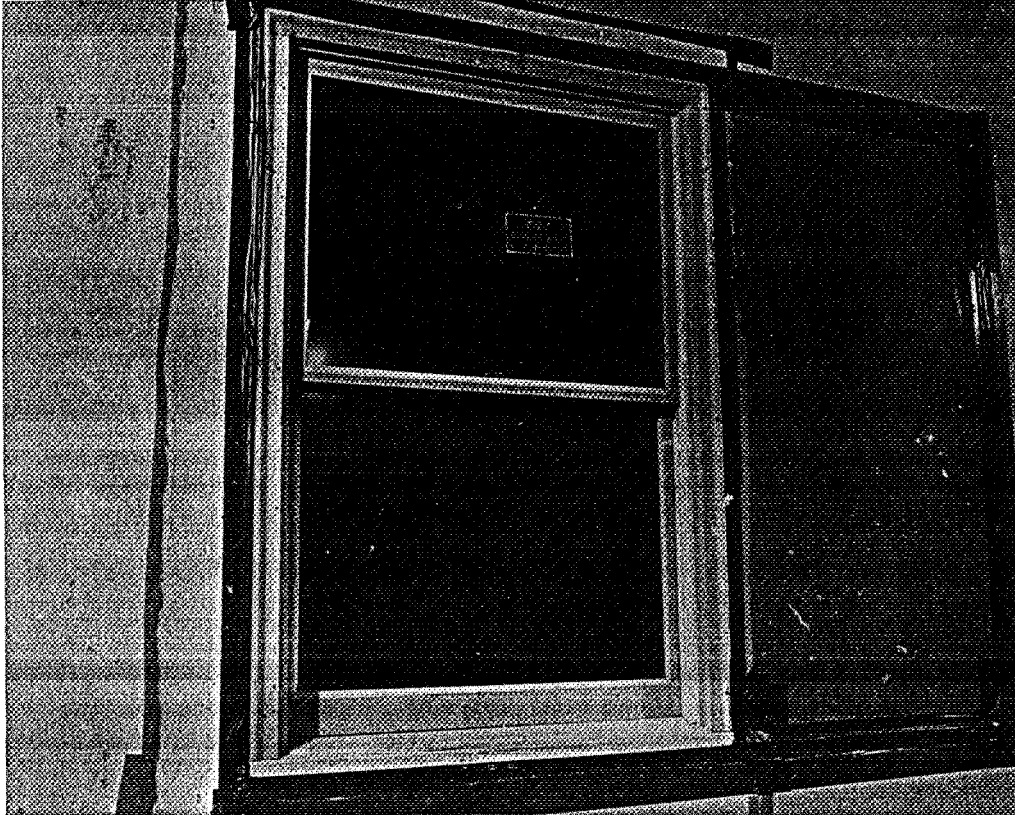
Figure 7. Wood double-hung window installed in filler wall.

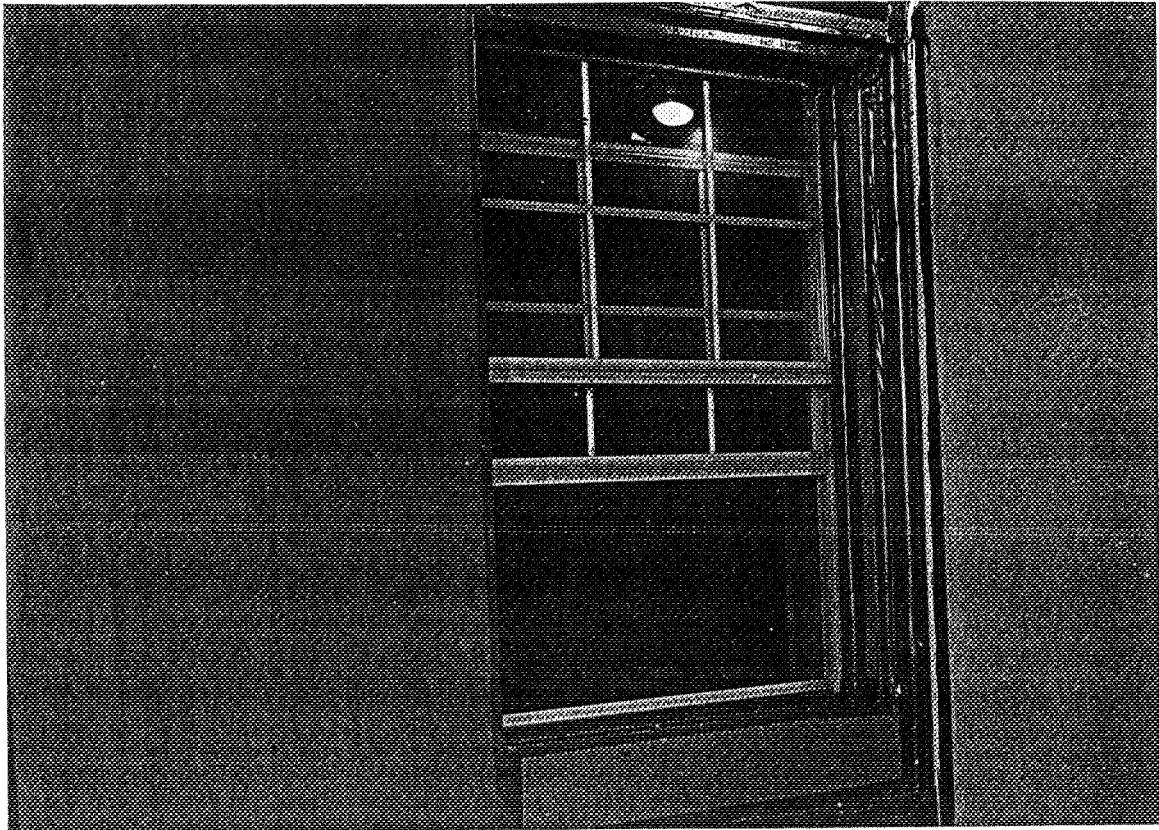
Figure 8. Aluminum single hung window.

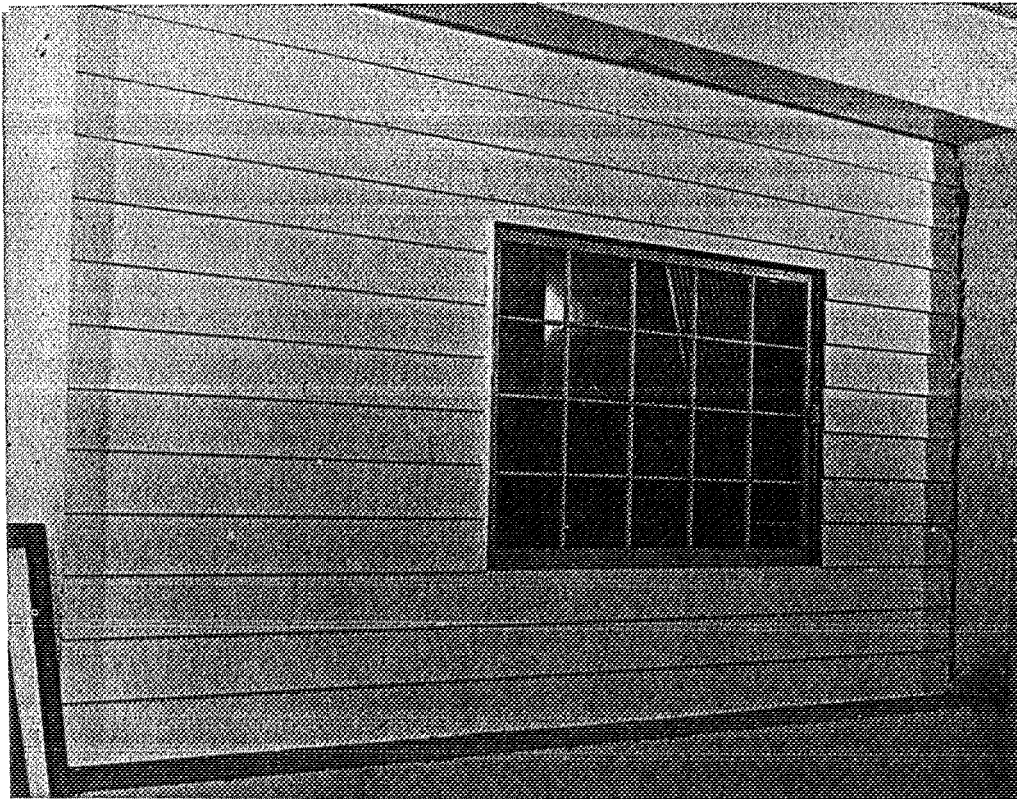
Figure 9. 6 x 5 ft picture window installed in wood siding wall.

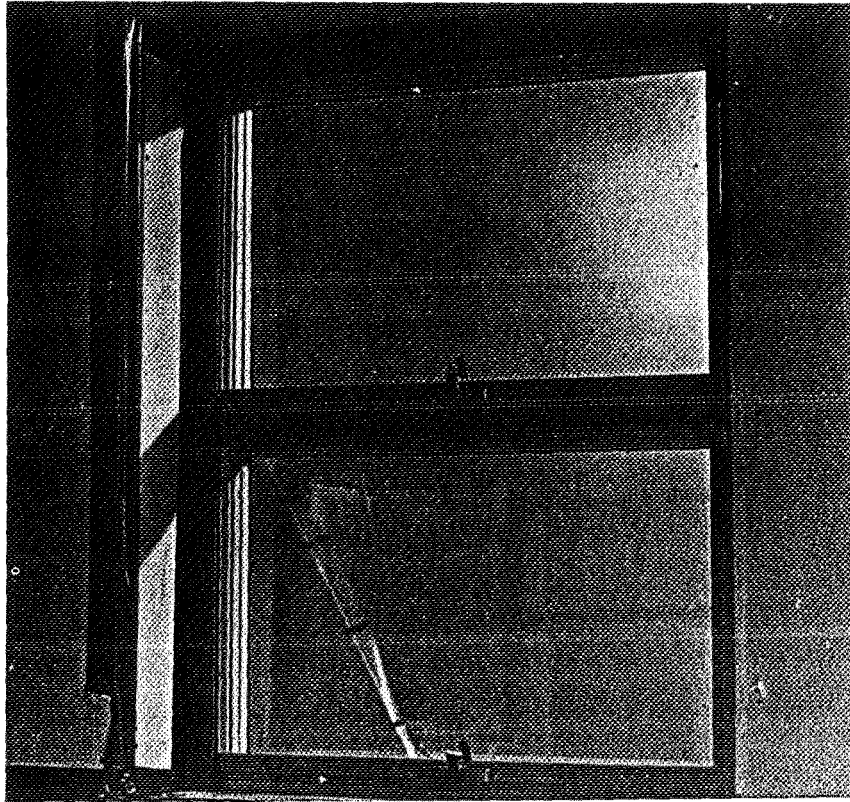
Figure 10. Auxiliary construction erected on interior side of wood siding wall for sound transmission testing of window.

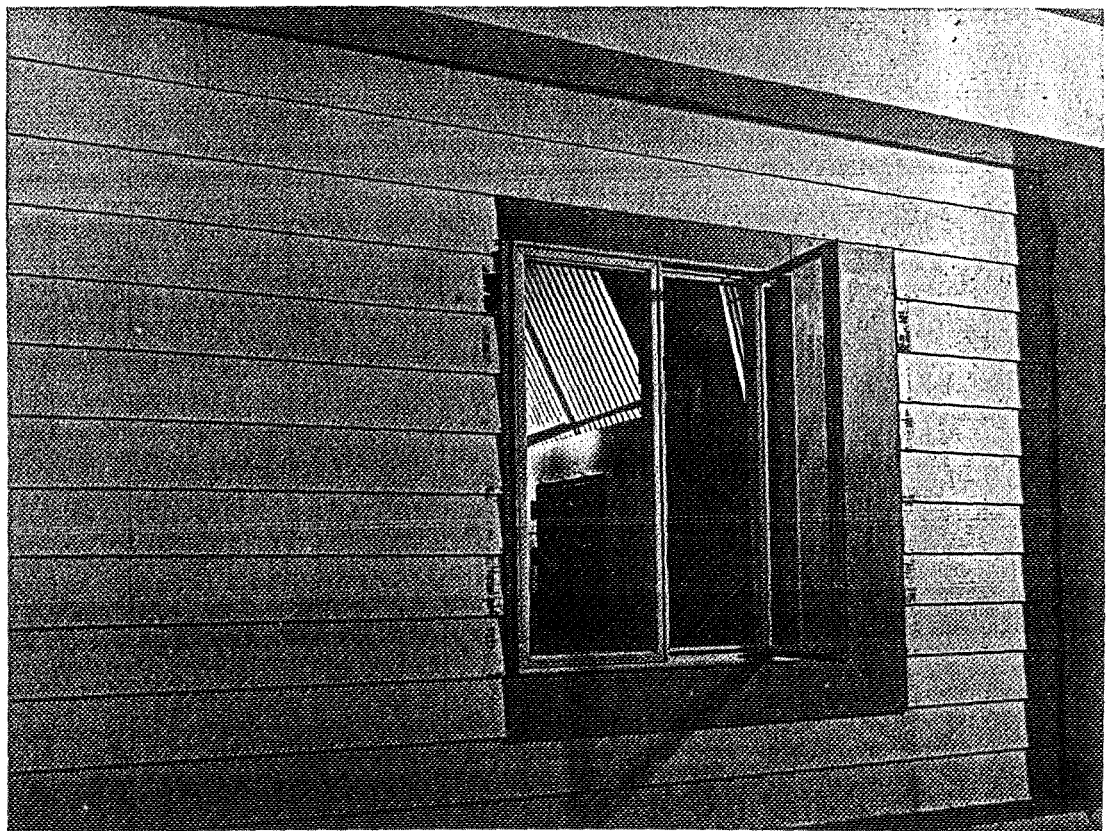
Figure 11. Plastic coated wood operable casement window.

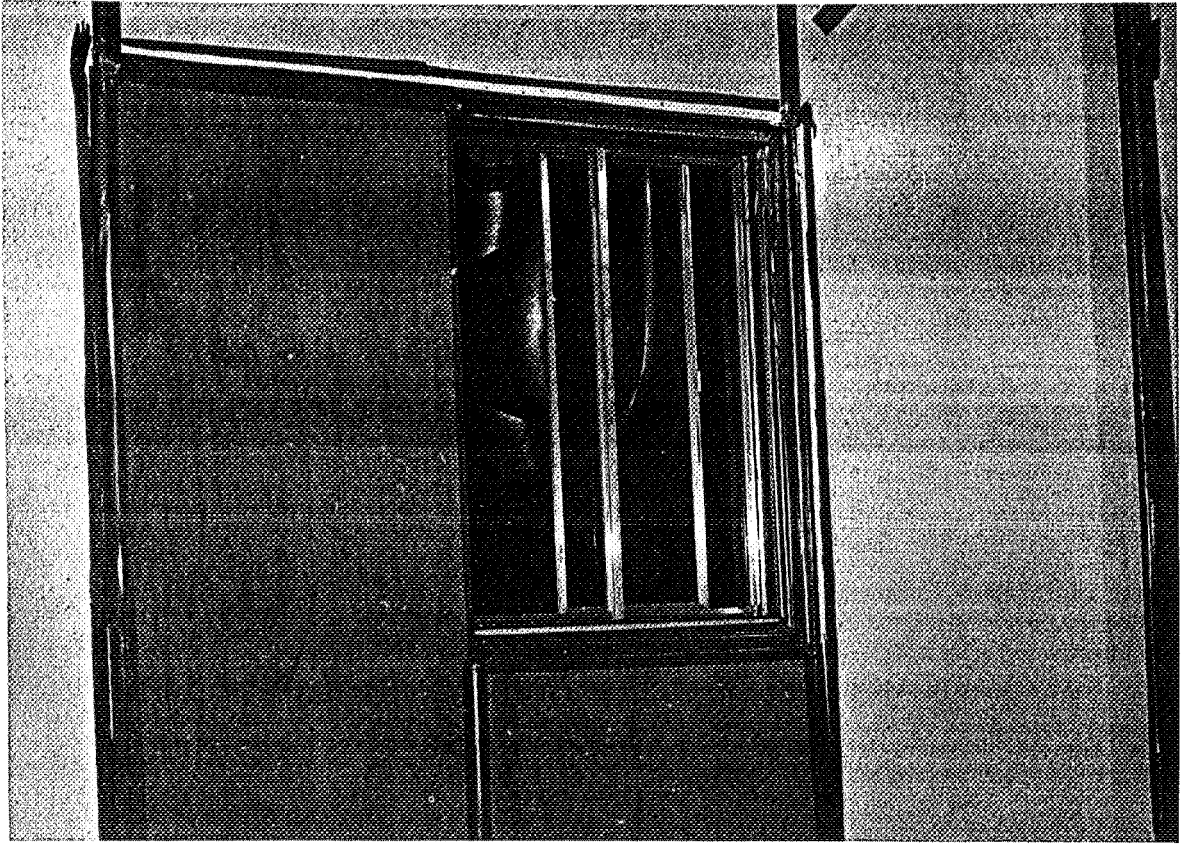
Figure 12. Aluminum Sliding window.

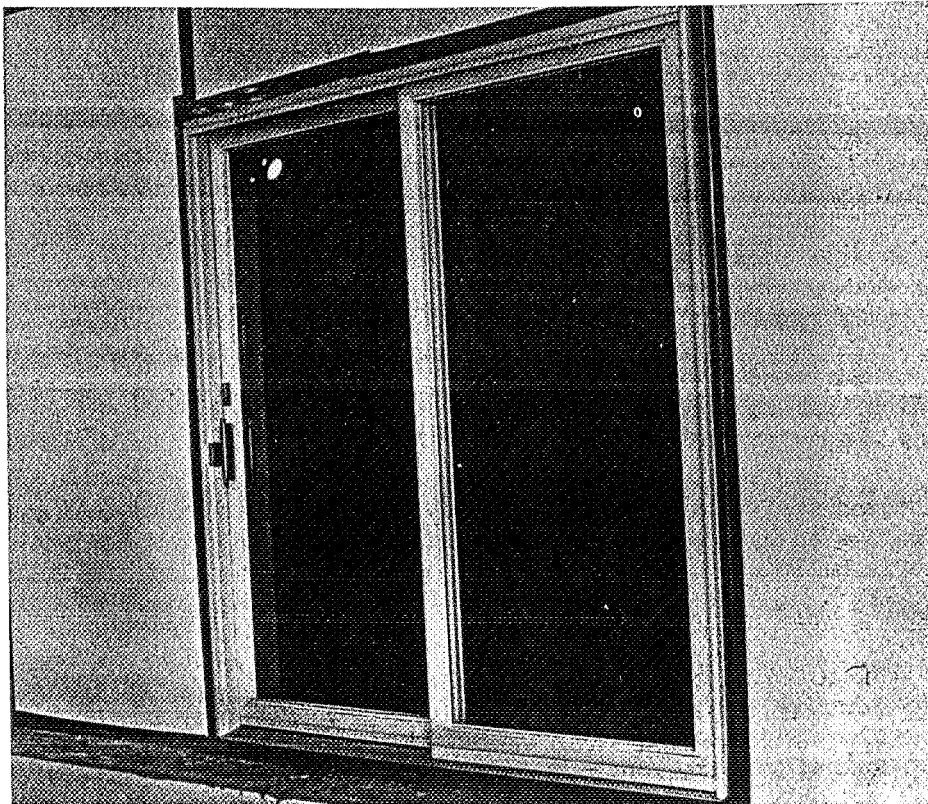
Figure 13. Plastic coated wood sliding glass door.

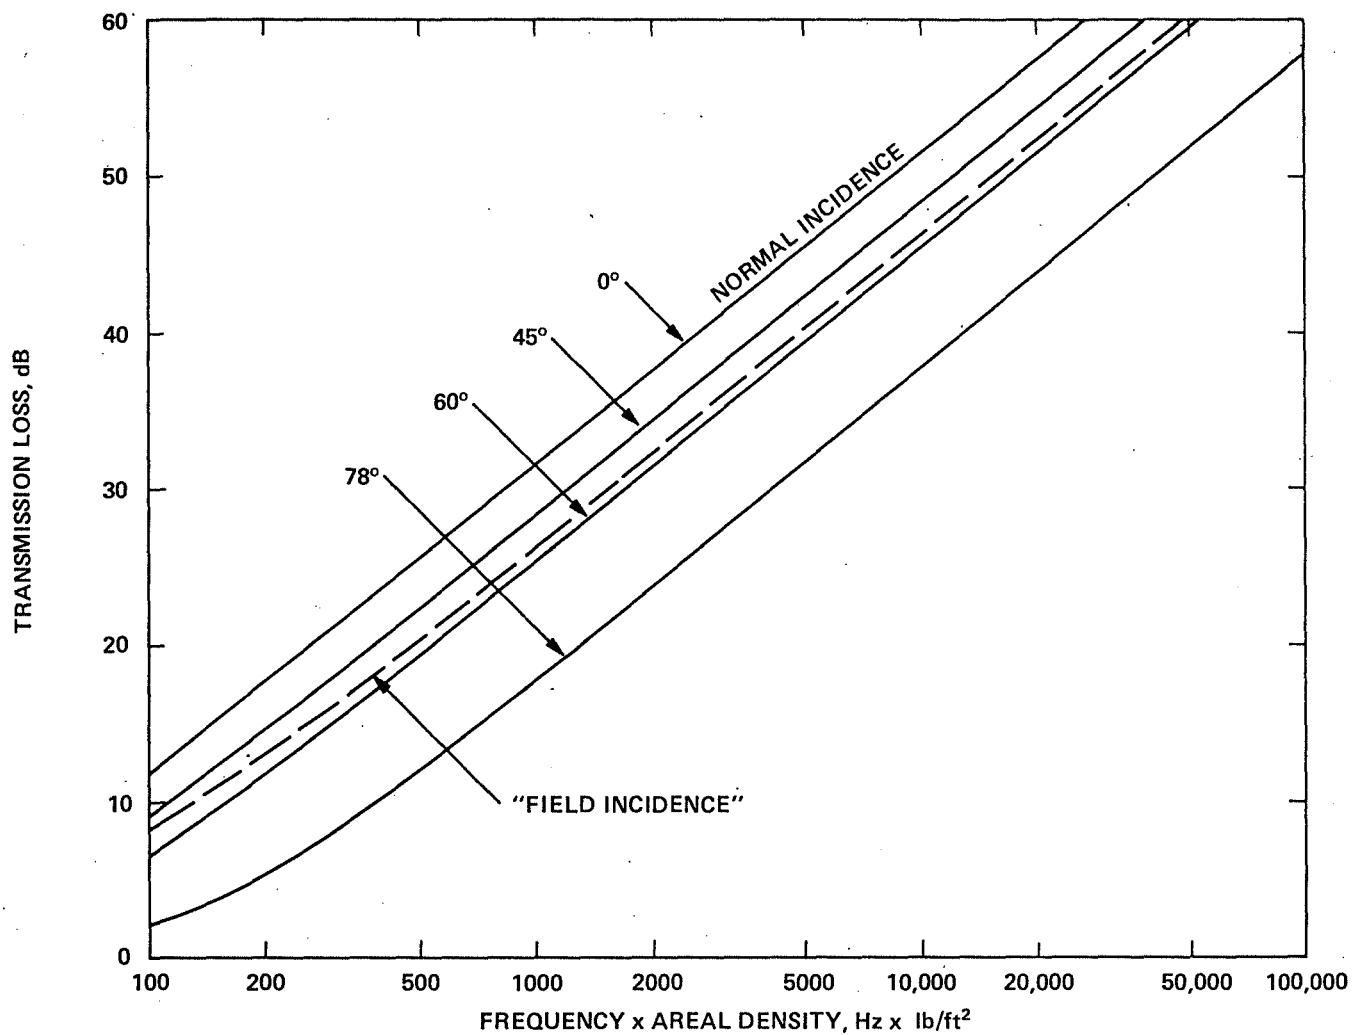
Figure 14. Limp-wall mass law transmission loss. The solid curves correspond to a plane wave arriving at a discrete angle of incidence. The dashed curve corresponds to "field-incidence mass law", a sum over all angles of incidence up to 78°.

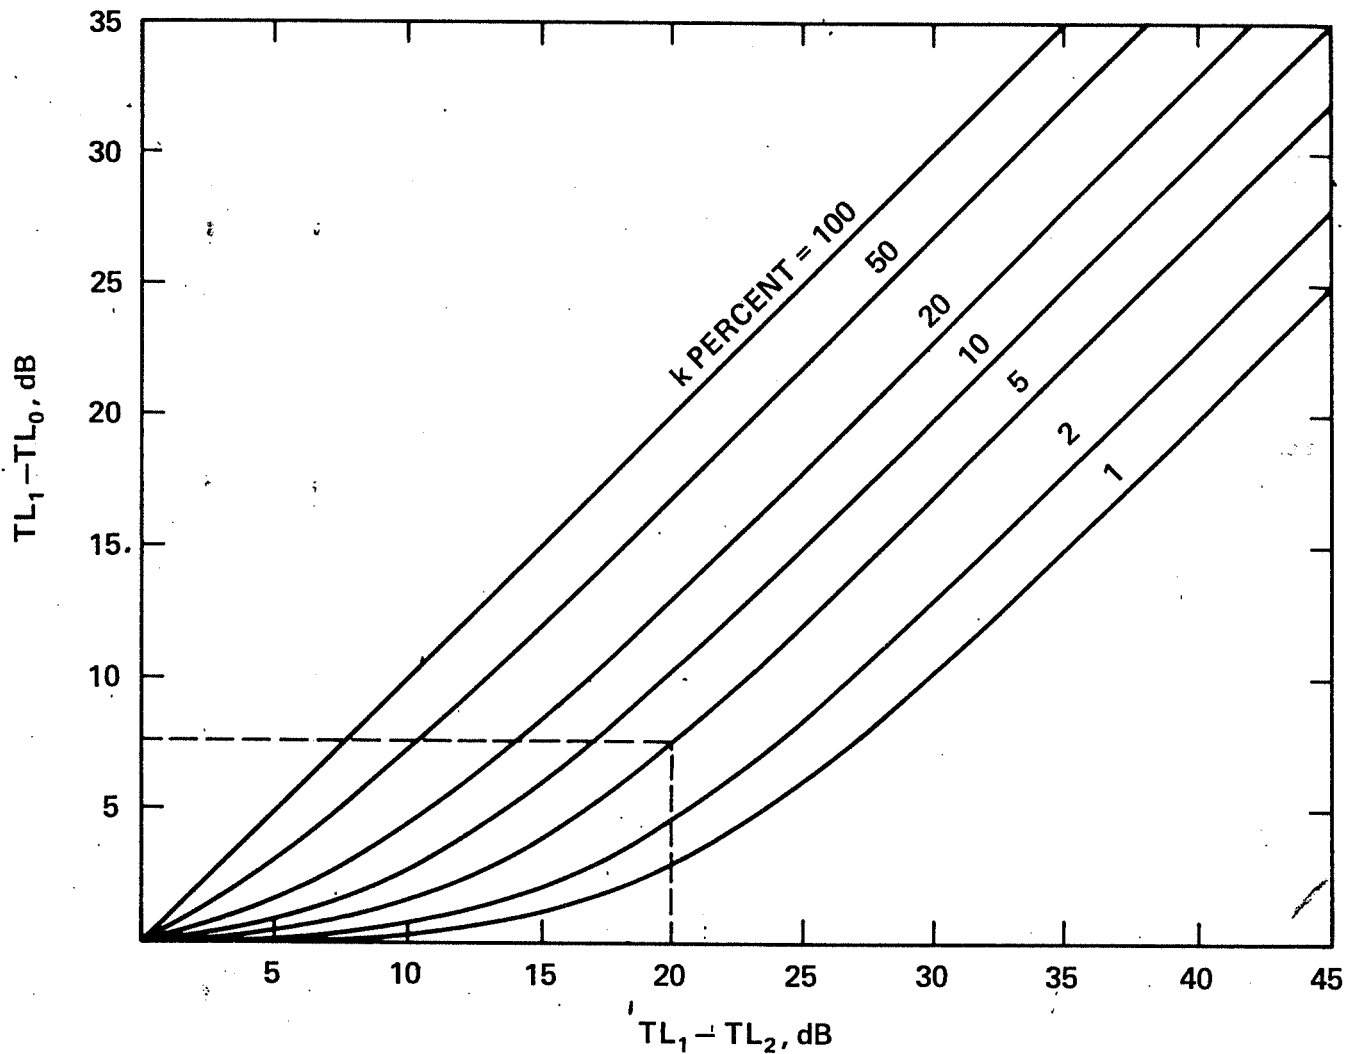
Figure 15. Chart for determining the overall sound transmission loss,  $TL_o$ , of a wall with a penetration (e.g., door or window) having a transmission loss,  $TL_2$ , less than the transmission loss,  $TL_1$ , of the basic wall construction. The penetration occupies "k percent" of the total wall area. The transmission loss of the combination is shown in relation to that of the wall as  $TL_1 - TL_o$ . Example: A window with  $TL_2 = 30$  dB occupies 5 percent of the area of a wall with  $TL_1 = 50$  dB. Then,

A chart derived from equation (4) for estimating the overall transmission loss of any combination of a wall and a single penetration such as a door or window, knowing the area and transmission loss of each component, is shown in Figure 15. The linear portions of the curves in Figure 15 correspond to situations where nearly all of the sound energy comes through the portion of the wall having the lower transmission loss so that  $TL_o \approx TL_2 + 10 \log (100/k)$ , where  $k$  is the percent of the total wall area occupied by the door, window, crack or other path of low sound transmission loss. Consideration of eq. (2) and Figure 15 reveals that even a small area having a low transmission loss can greatly reduce the overall transmission loss below that of the basic wall structure. Since cracks may have a transmission loss that is near zero, "leaky" doors, windows, and louvers can vitiate an otherwise good construction. The effect of cracks is discussed in some detail in Sections 3.6 and 6.1.

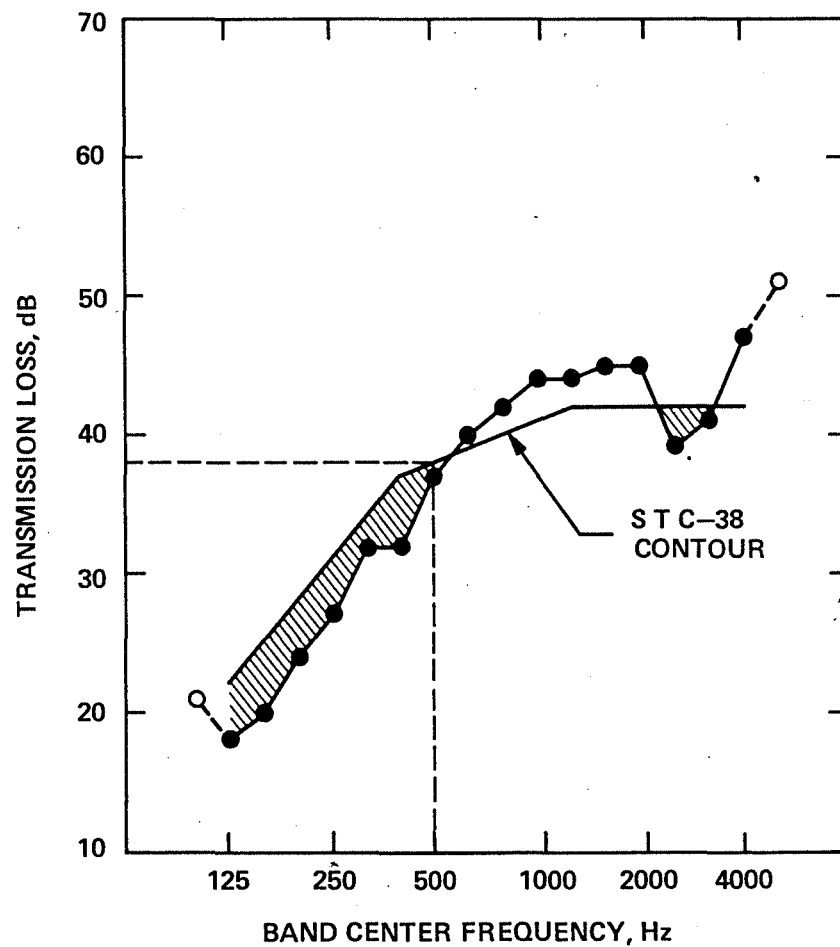
Figure 16. An example of a Sound Transmission Class contour fitted to a sound transmission loss curve. The fitting procedure is described in the text..

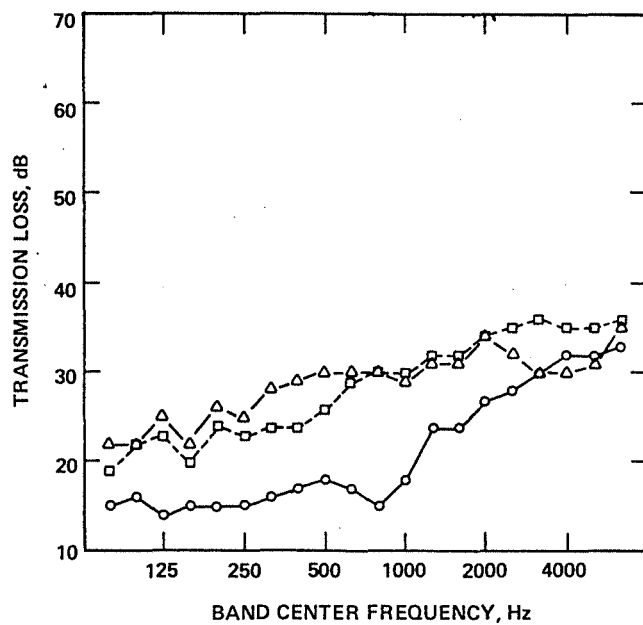
Figure 22. Sound transmission loss vs frequency data for the three wood doors sealed into the frame.

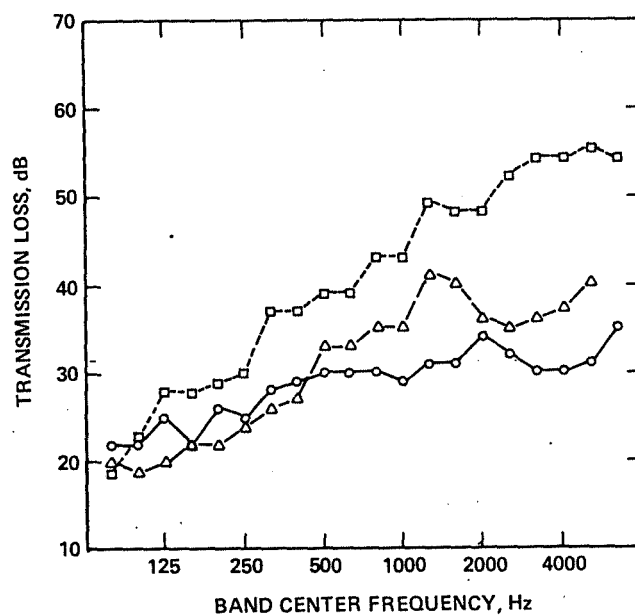
Figure 26. Comparison showing the effect of adding a storm door on the sound transmission loss vs frequency of a solid core wood door.

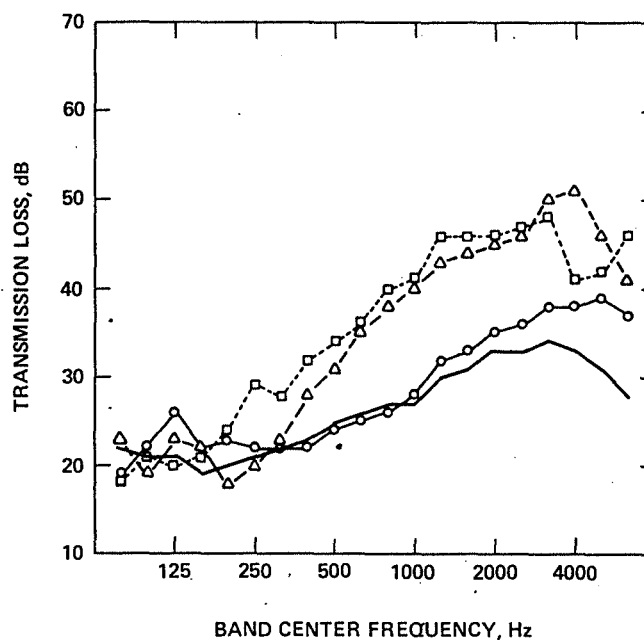
Figure 31. Comparison of sound transmission loss vs frequency data for sealed single-strength windows with storm sash (at various spacings from primary glazing) with data for sealed windows, glazed single-strength with storm sash. In the following table the spacing is the average between panes for upper and lower sash.

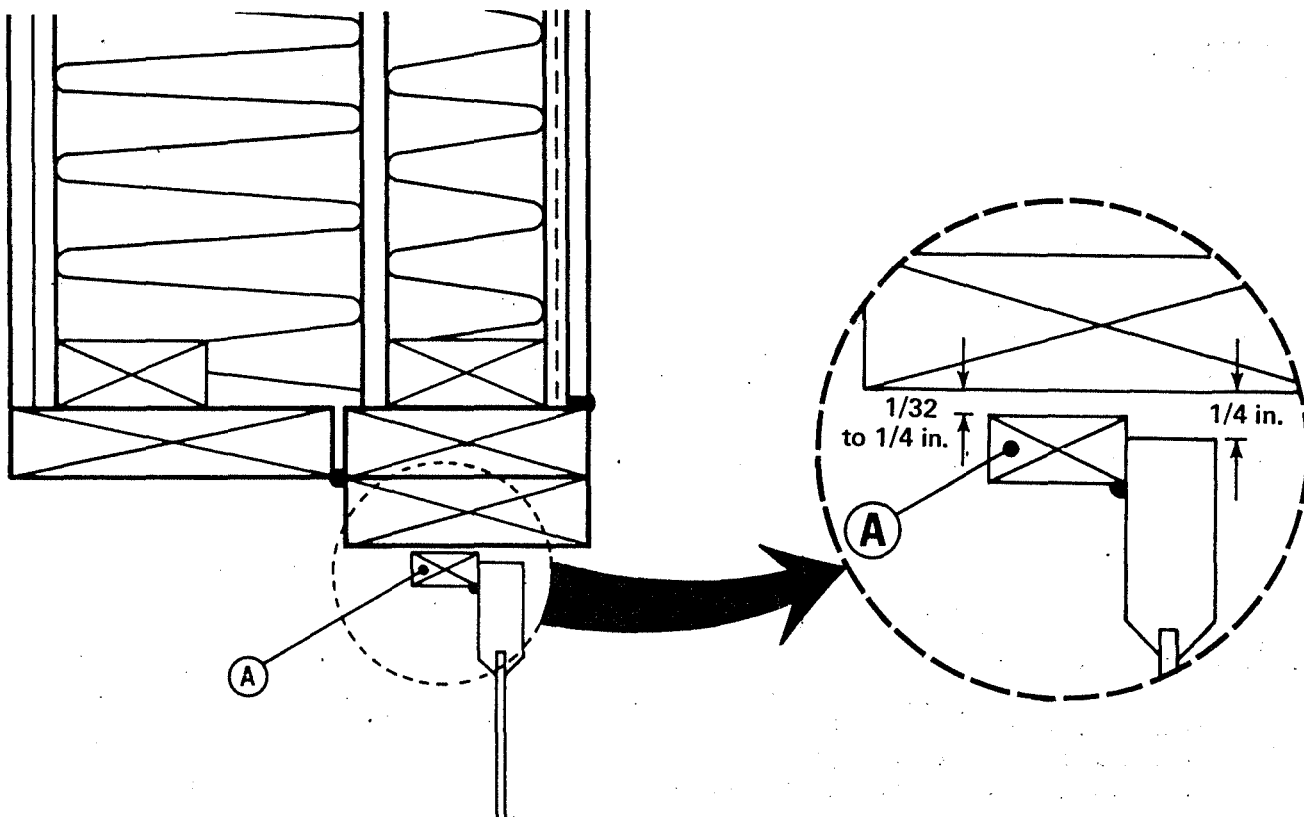
Figure 32. Detail of framing in filler wall to receive picture window sashes. Strip A was shimmed out to provide perimeter cracks ranging from 1/32 to 1/4 in.

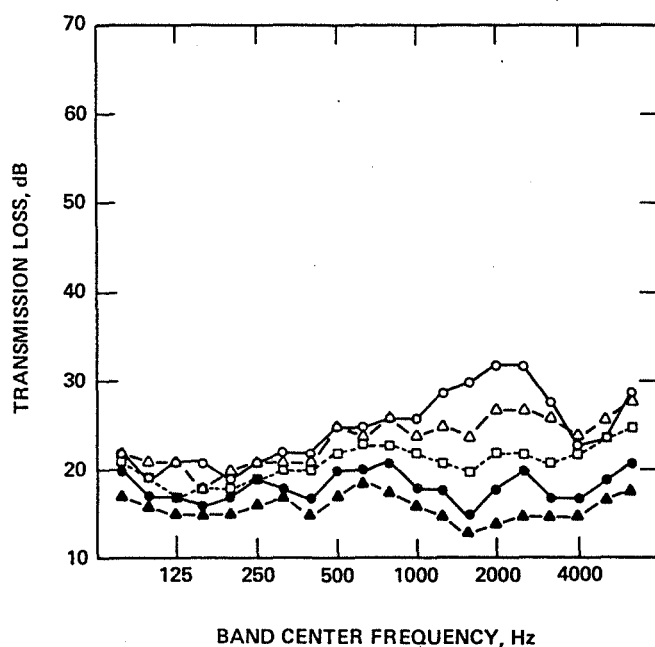
Figure 33. Sound transmission loss vs frequency data for 6 x 5 ft picture window, double-strength glazing, with perimeter cracks of controlled size.

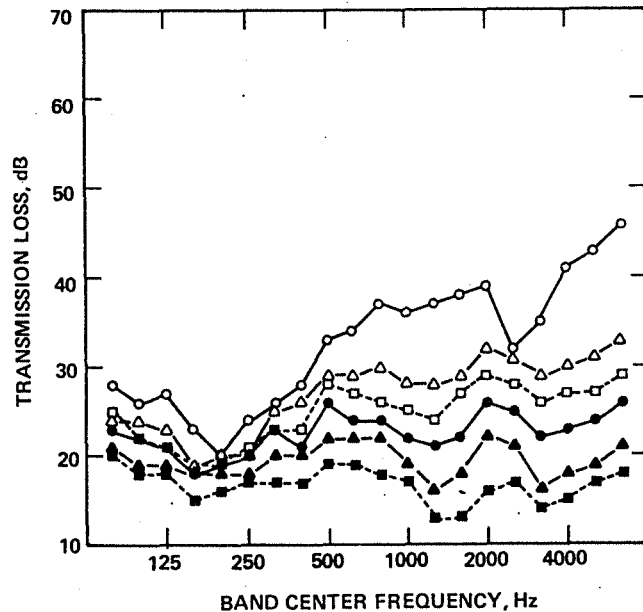
Figure 34. Sound transmission loss vs frequency data for 6 x 5 ft picture window, glazed with 1 in. insulating glass, with perimeter cracks of controlled size.

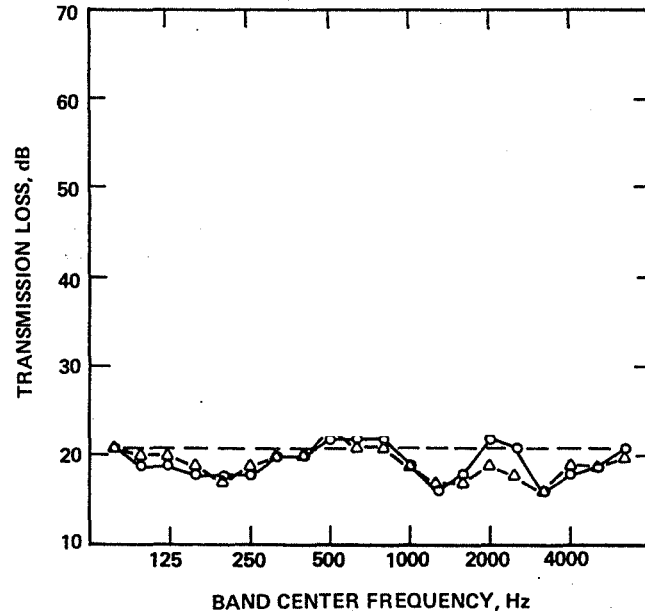
Figure 35. Comparison of effect of perimeter cracks of the same area, but different widths, on the sound transmission loss vs frequency for a 6 x 5 ft picture window, glazed with 1 in. insulating glass. The dashed horizontal line corresponds to the theoretical transmission loss, based on the ratio of crack area to window area, assuming the transmission loss of the crack is 0 dB.

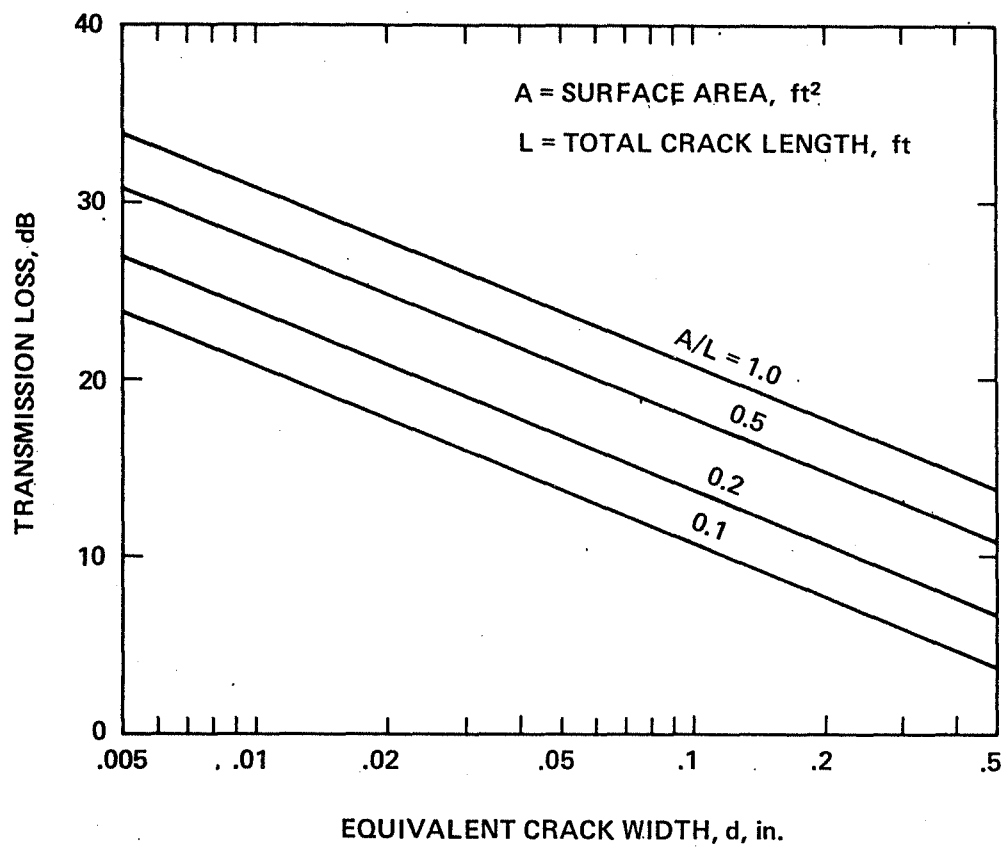
Figure 36. Theoretical sound transmission loss of surface with cracks, assuming the sound transmission loss of the sealed surface is at least 10 dB higher than that of the surface with cracks (see text).

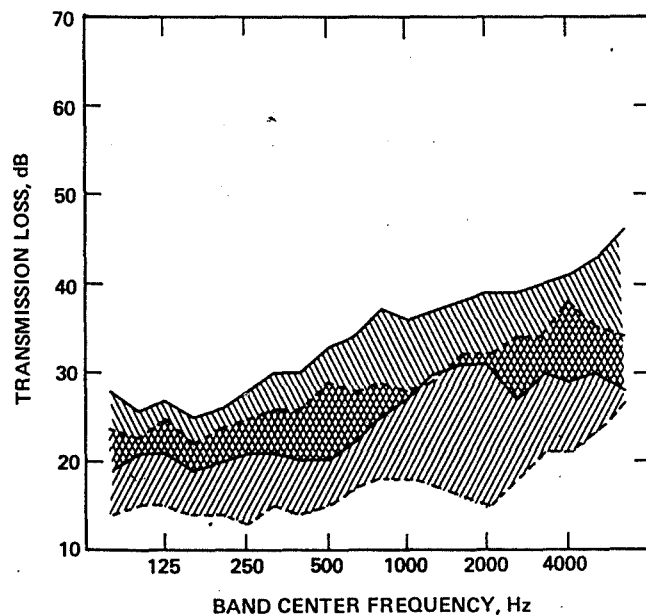
Figure 37. Comparison of the envelope (corresponding to STC 26-34) of sound transmission loss vs frequency data for all sealed windows with the envelope (STC 17-30) of data for all unsealed windows, locked and unlocked.

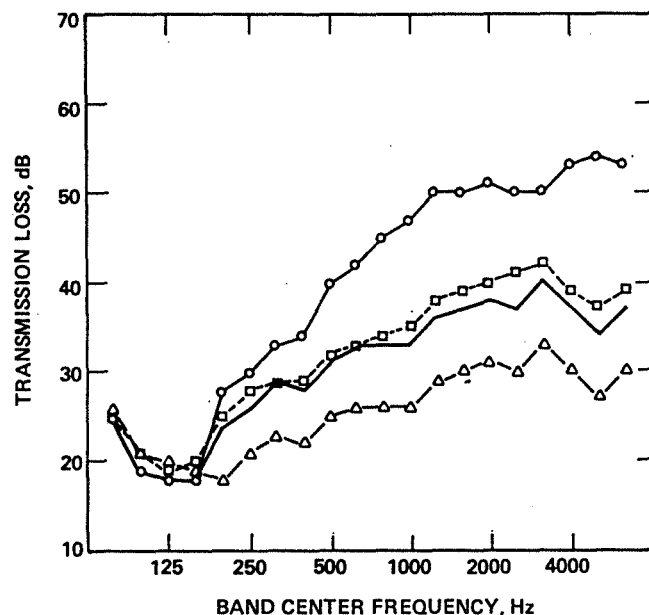
Figure 40. Comparison of measured sound transmission loss vs frequency data for a 6 x 5 ft picture window, glazed single strength, in a wood siding wall with that predicted from the transmission losses and areas of the wall and window (window area = 25.6 sq ft, wall plus window area = 126 sq ft).

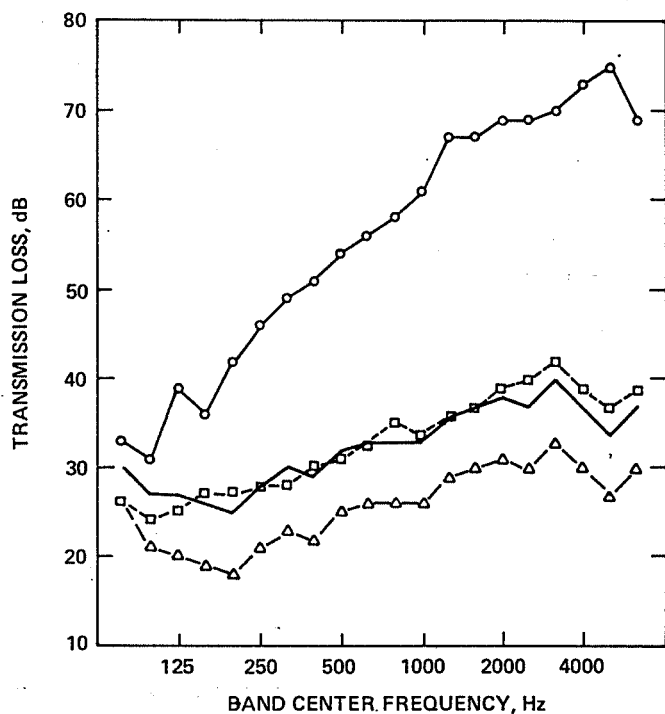
Symbol	Test No.	Specimen	STC
○	W-44-71	wall alone	56
△	W-8-71	window alone	28
□	W-49-71	combination, measured	35
---		combination, calculated	35

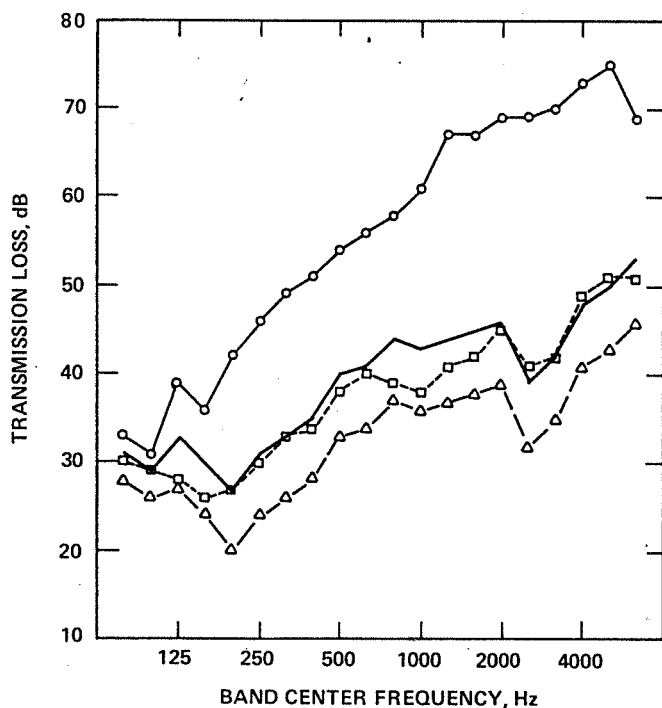
Symbol	Test No.	Specimen	STC
○	W-44-71	wall alone	56
△	W-10-71	window alone	34
□	W-48-71	combination, measured	39
---		combination, calculated	41
