# NBS BUILDING SCIENCE SERIES 77

## Acoustical and Thermal Performance of Exterior Residential Walls, Doors and Windows

# Acoustical and Thermal Performance of Exterior Residential Walls, Doors and Windows

## Abstract

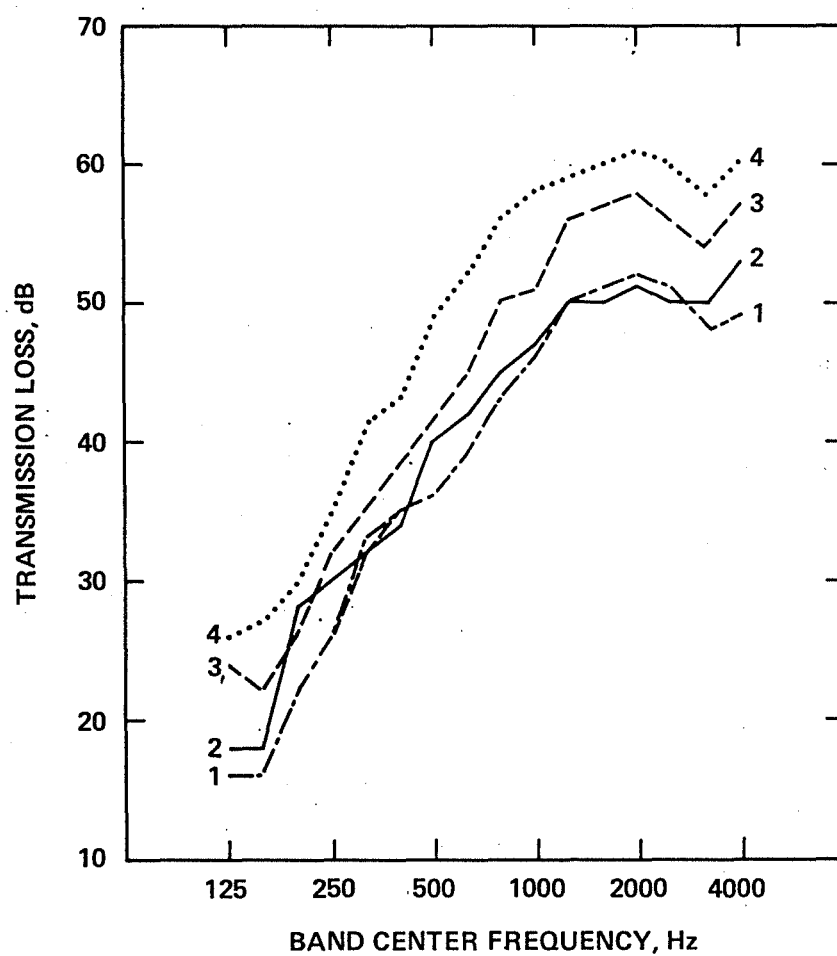
Figure 44. Sound transmission loss vs frequency data for wood-siding, wood-stud, exterior walls. The data are from the present investigation and correspond to walls with or without resilient channels and with or without cavity insulation.

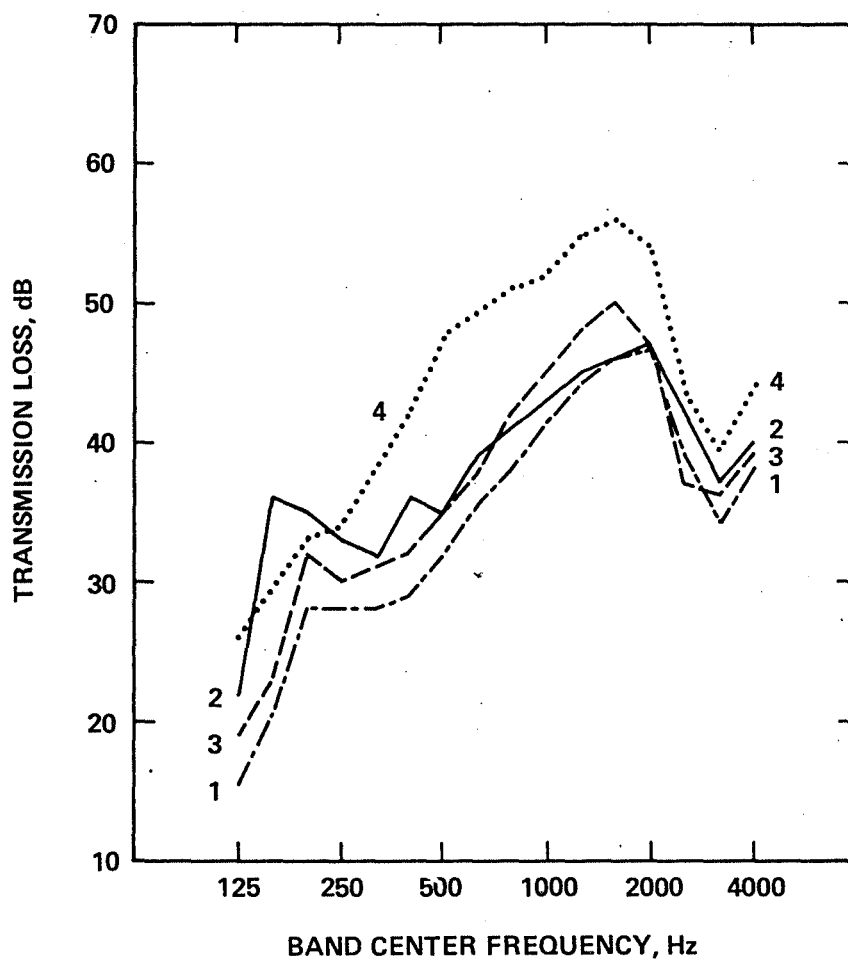
Figure 45. Sound transmission loss vs frequency data for plasterboard interior walls. The data are from Northwood [61] and correspond to walls with wood or metal studs and with or without cavity insulation.

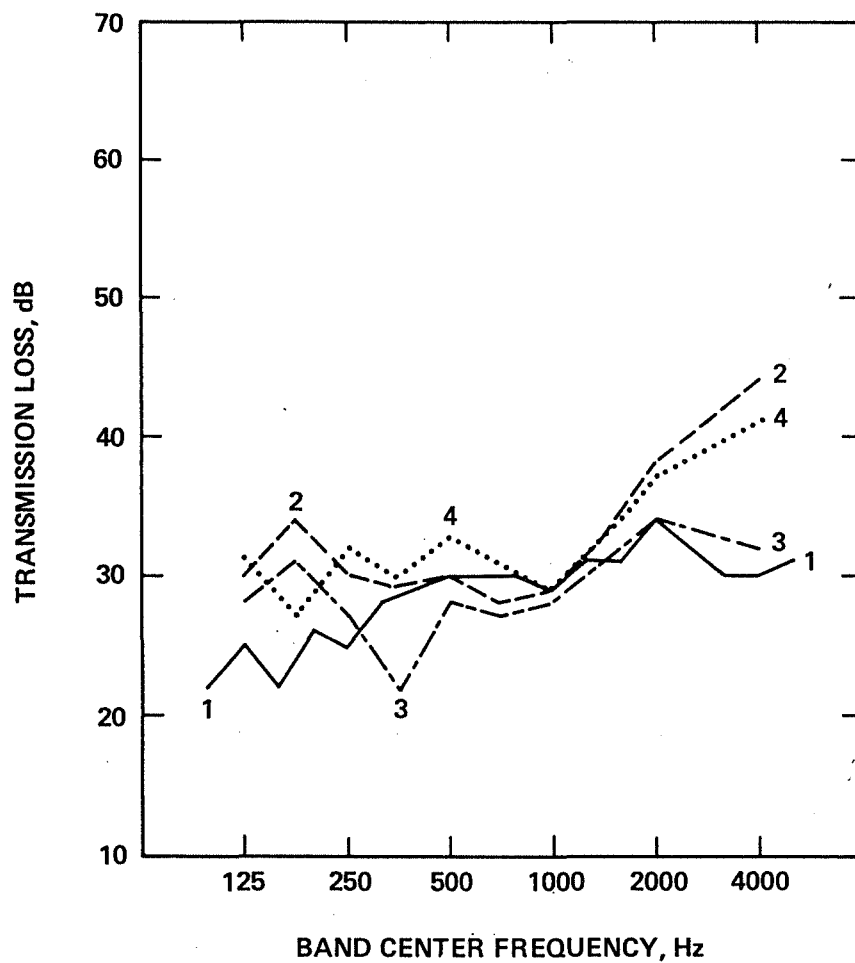
Figure 46. Sound transmission loss vs frequency data for solid core wood doors.

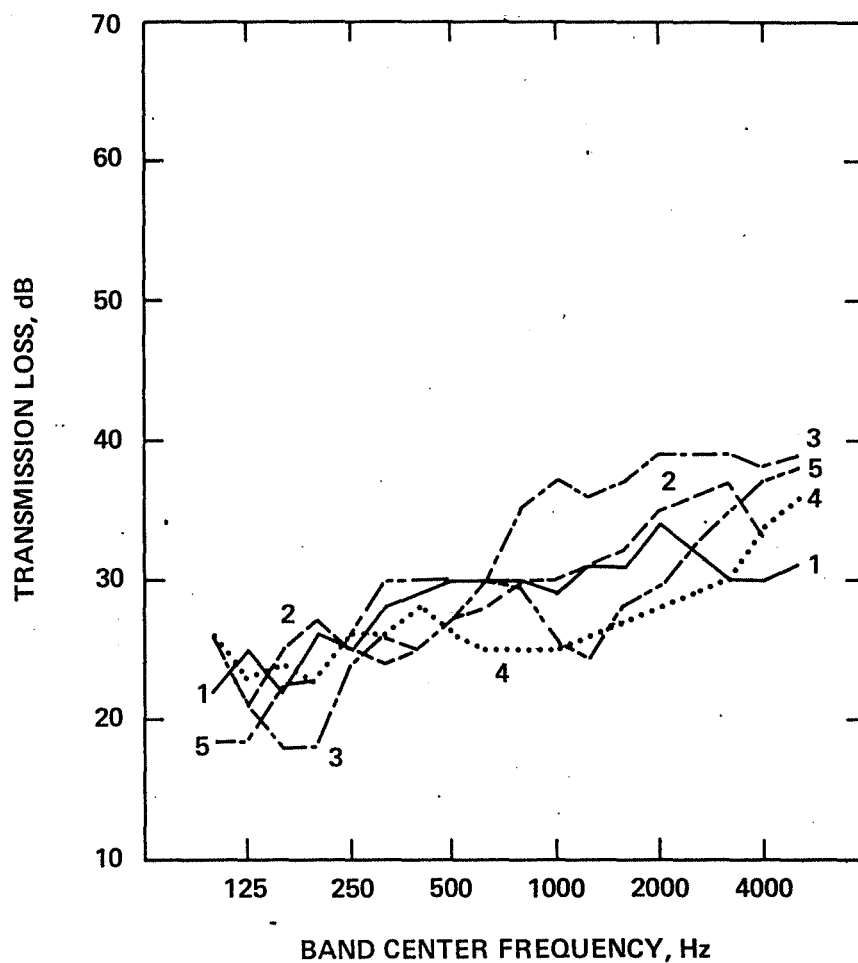
Figure 47. Sound transmission loss vs frequency data for solid core wood doors. Curve 1 is the same as in Figure 46.

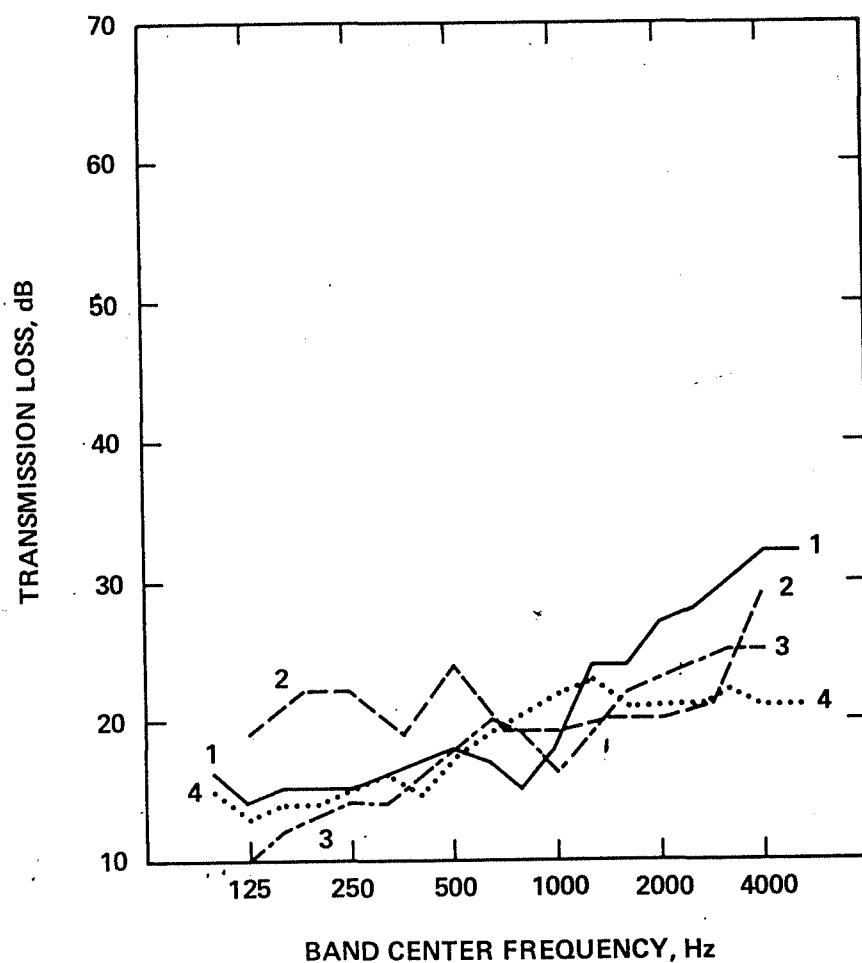
Figure 48. Sound transmission loss vs frequency data for hollow core wood cores.

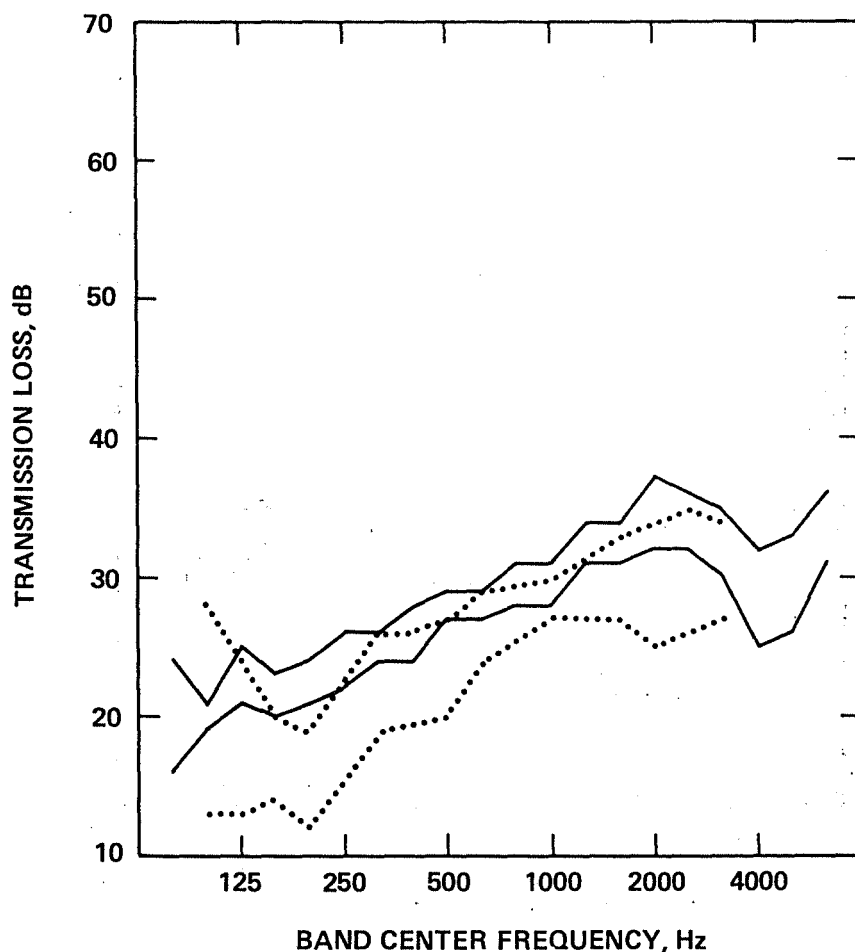
Figure 49. Sound transmission loss vs frequency data for sealed windows, of various types and sizes, with double-strength (3 mm) glazing. The solid curves represent the envelope of data obtained in the present investigation (Tests W-7-71, W-32-71, W-34-71, W-64-71, W-66-71, and W-21-72). The dotted curves represent the envelope of data, on sealed windows only, from Table A5 of Marsh [63] (the sets of data included are the 2nd and 3rd of Aston, the 1st of Wooley, and the 1st, 2nd and 4th of Saint-Gobain).

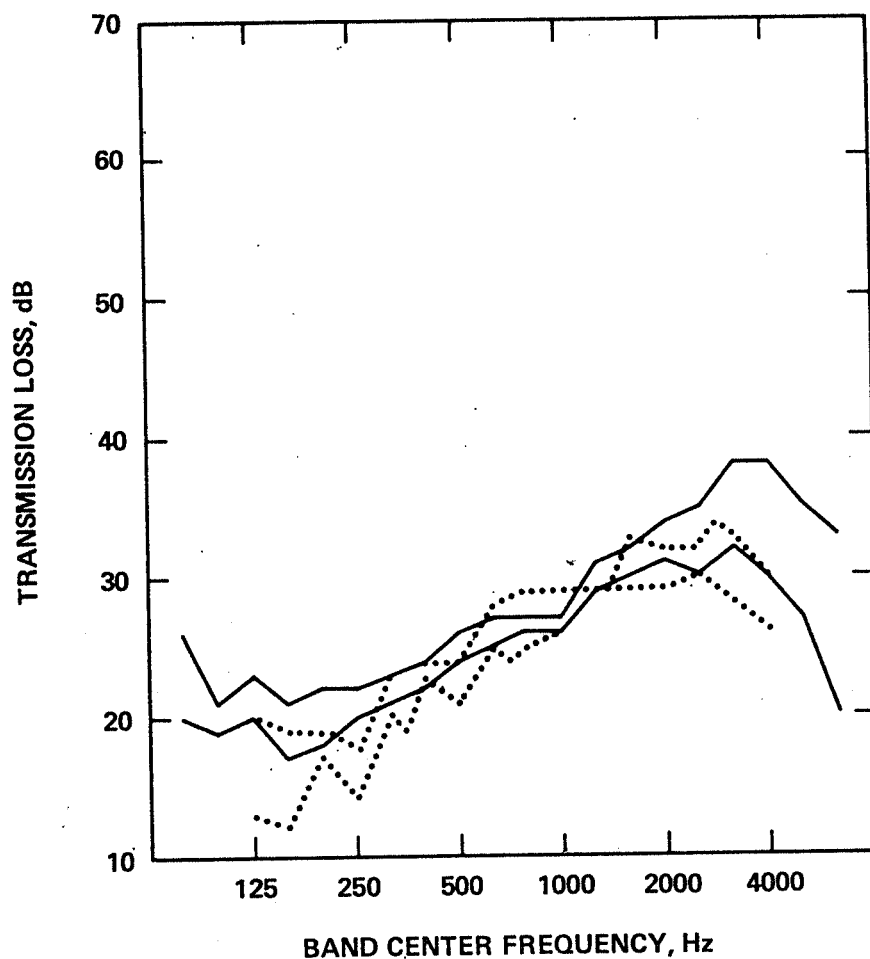
Figure 50. Sound transmission loss vs frequency data for sealed windows, of various types and sizes, with single-strength glazing. The solid curves represent the envelope of data obtained in the present investigation (Tests W-8-71, W-33-71, W-41-71, W-76-71, and W-26-72). The dotted curves represent the envelope of the following data: Brandt (2 mm glass) and Libbey-Owens-Ford (3/32 in. glass) from Table A6 of Marsh [63]; caulked steel frame casement window (3/32 in. glass) from Bishop and Hirtle [62].

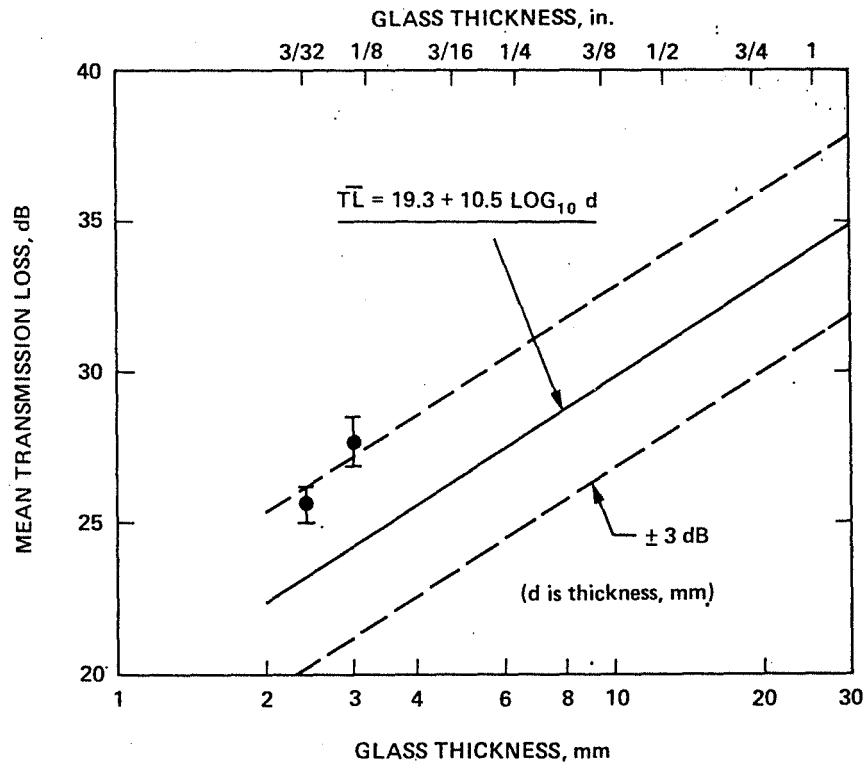
Figure 51. Mean sound transmission loss (arithmetic average of the values over the range 100 to 3150 Hz) of sealed windows vs glass thickness. The solid line is that which was fitted to literature data by Marsh [63]. The dashed lines enclose all but two of the data points she used to derive the solid line. The solid circles represent the average and range of data on single- and double-strength glazing from the present investigation.

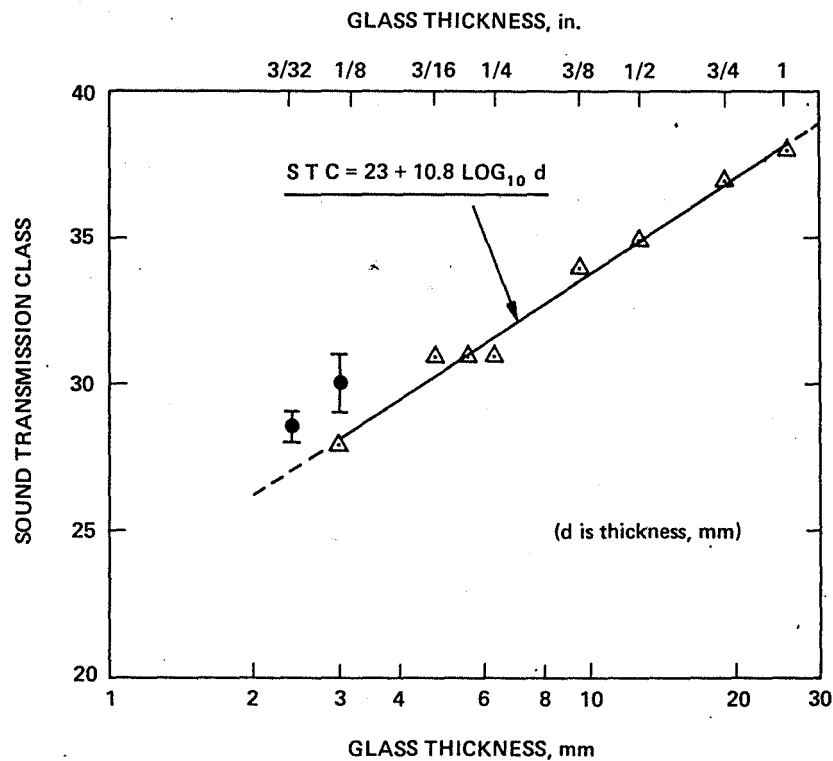
Figure 52. Sound Transmission Class of sealed windows vs glass thickness. The triangles and the line fitted through them represent the data reported by Patil [64]. The solid circles represent the average and range of data on single- and double-strength glazing from the present investigation.

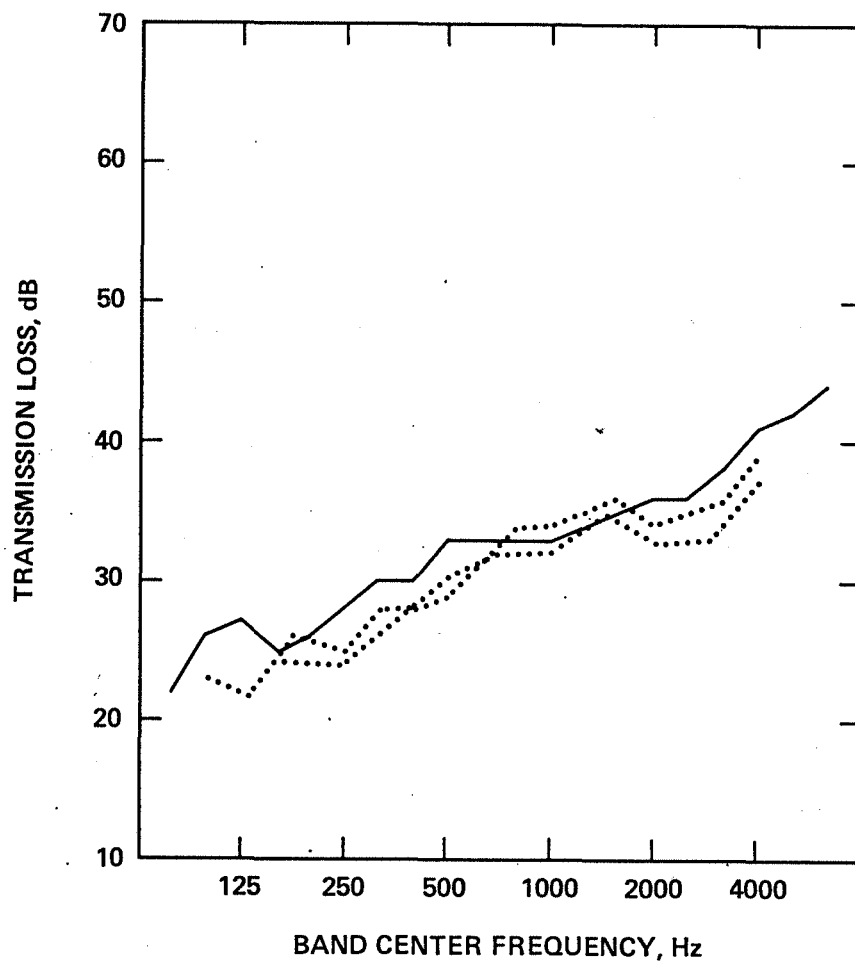
Figure 53. Sound transmission loss vs frequency data for 1/4 in. laminated glass with an internal damping layer. The solid curve represents the data from the present investigation (Test No. W-22-72) while the dotted curves represent the envelope of data from Table A8 of Marsh [63] (the two sets of data are that of Pilkington Bros. and the 1st of Libbey-Owens-Ford).

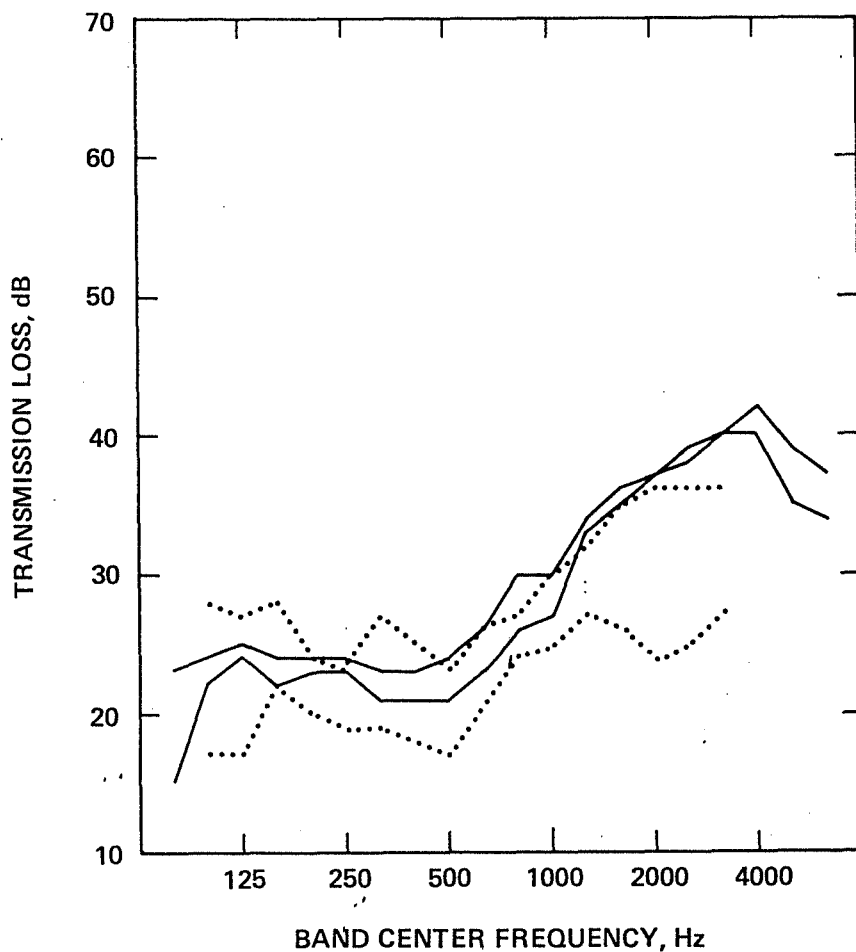
Figure 54. Sound transmission loss vs frequency data for 7/16 in. insulating glass units consisting, nominally, of two 1/8 in. panes of glass separated by a 3/16 in. air space. The solid curves represent the envelope of data obtained in the present investigation (Tests W-31-71 and W-29-72). The dotted curves represent the envelope of data from Table B1 of Marsh [63]. (the sets of data included are the 2nd of Wooley and the two of Saint-Gobain).

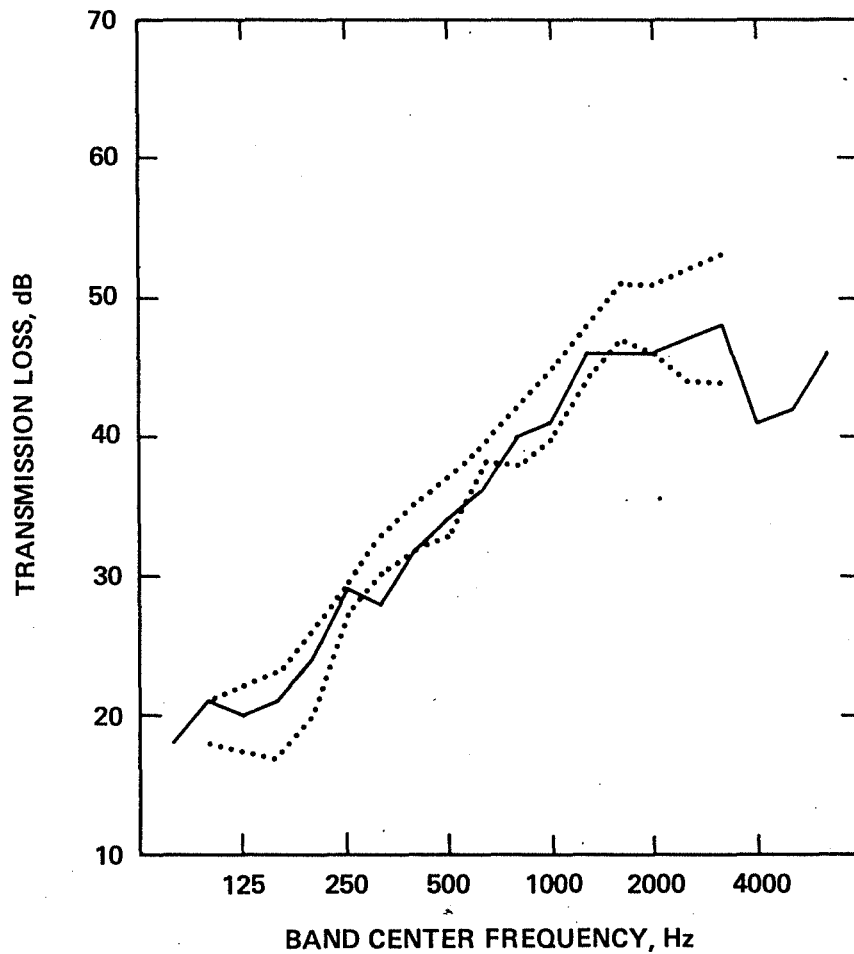
Figure 55. Sound transmission loss vs frequency data for double glazing with a nominal 4 in. separation between the two panes. The solid curve represents a 6 x 5 ft picture window glazed single strength (2.4 mm) with a double strength (3mm) storm window spaced 95 mm (3 3/4 in.) away (Test W-11-71). The dotted curves represent the envelope of data, from Table C2 of Marsh [63], for 3 mm panes separated by 100 to 102 mm (the sets of data are the first listed for each of the following: Aston, Ingemansson, and Woolley).

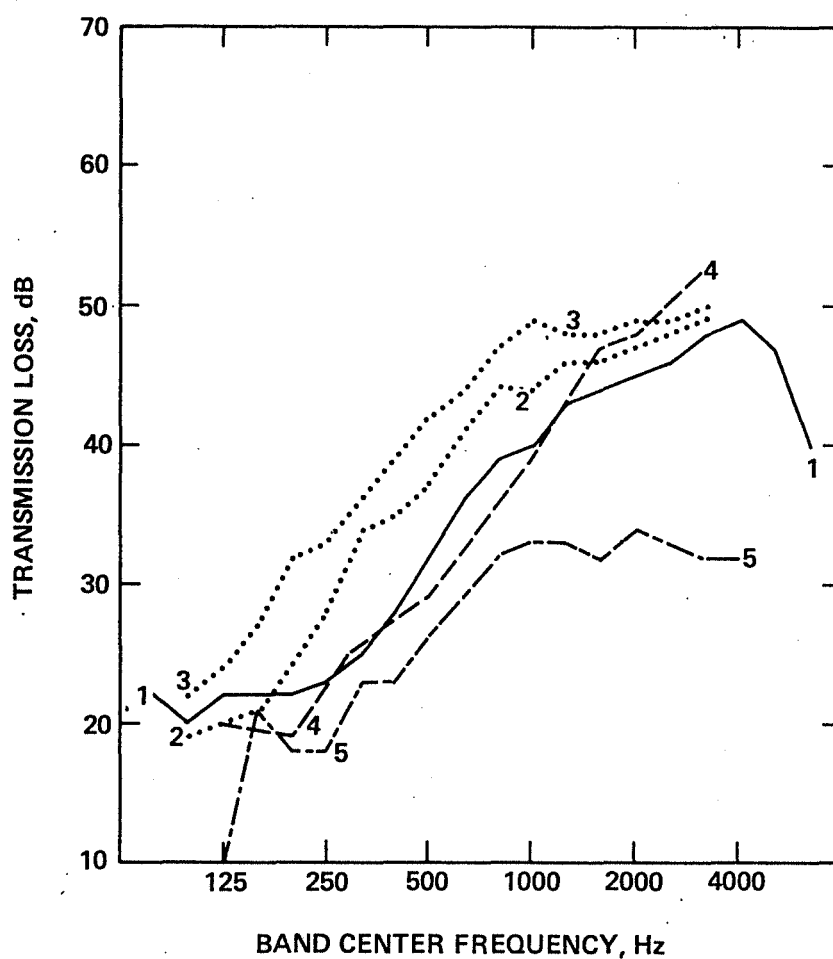
Figure 56. Sound transmission loss vs frequency data for double glazing with an average nominal spacing of about 2 to 3 in. between the two panes.

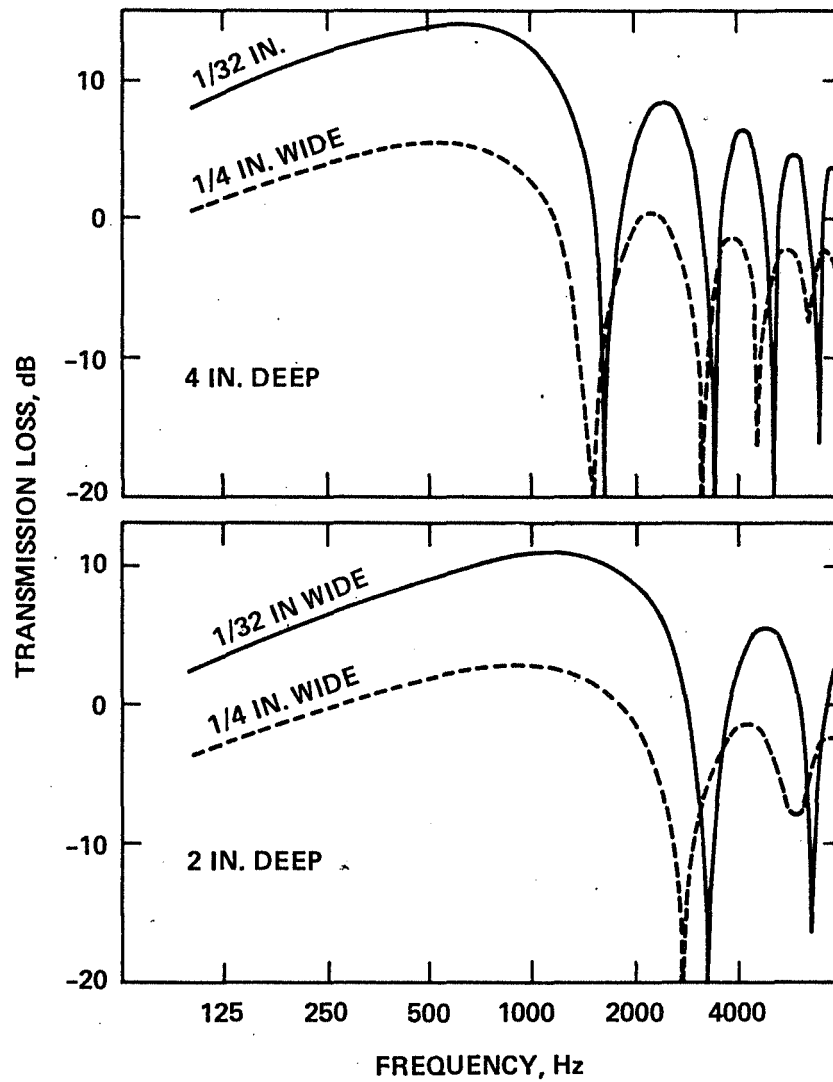
Figure 57. Theoretical sound transmission loss vs frequency data for slits in the middle of a wall between two reverberant rooms, as computed from eq. (69) of Gomperts [76].

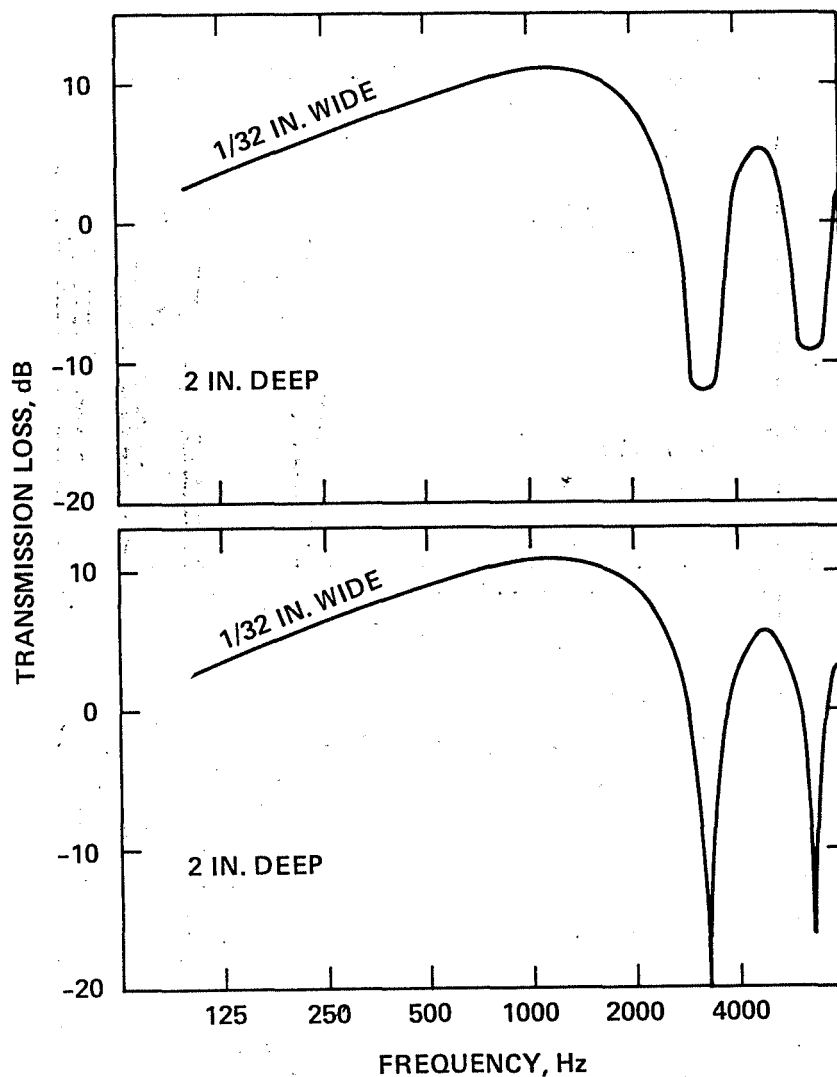
Figure 58. Theoretical sound transmission loss vs frequency data for slits in the middle of a wall between two reverberant rooms. The lower curve represents pure tone behavior while the upper curve corresponds to values averaged over a frequency band that is 1/3 octave in width. The lower curve was computed from eq. (69) of Gomperts [76] while the upper curve was derived by numerical integration of the transmission coefficient corresponding to the lower curve.

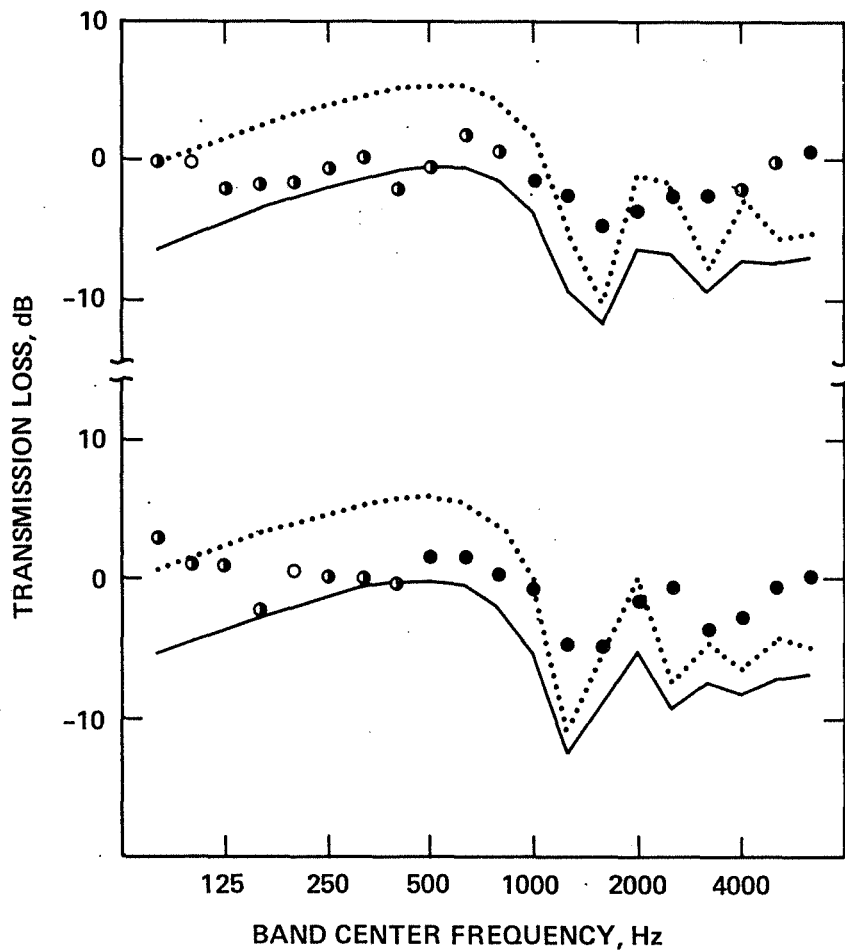
Figure 59. Comparison of experimental results and theoretical predictions for the sound transmission loss of 1/4 in. cracks around picture windows. The data points in the upper portion of the figure are from Test W-16-71 and the average of Tests W-7-71 and W-9-71; those in the lower portion are from Tests W-12-71 and W-10-71. Solid symbols indicate that the transmission loss of the sealed window was at least 9 dB greater than that of the leaky window, while half-filled symbols indicate a 6 to 9 dB difference and open symbols a 3 to 6 dB difference. If the effect of the crack was less than 3 dB for a given frequency band, the data are not plotted. The dotted curves were calculated from equation (69) of Gomperts [76] averaged over a 1/3 octave band, for a slit in the middle of a wall; the solid curves were calculated in a similar manner but correspond to a slit at the edge of a wall between two reverberant rooms. The effective depth of the slit was taken as 4.5 in. for the theoretical calculations in the lower figure and as 4.0 in. for those in the upper figure.

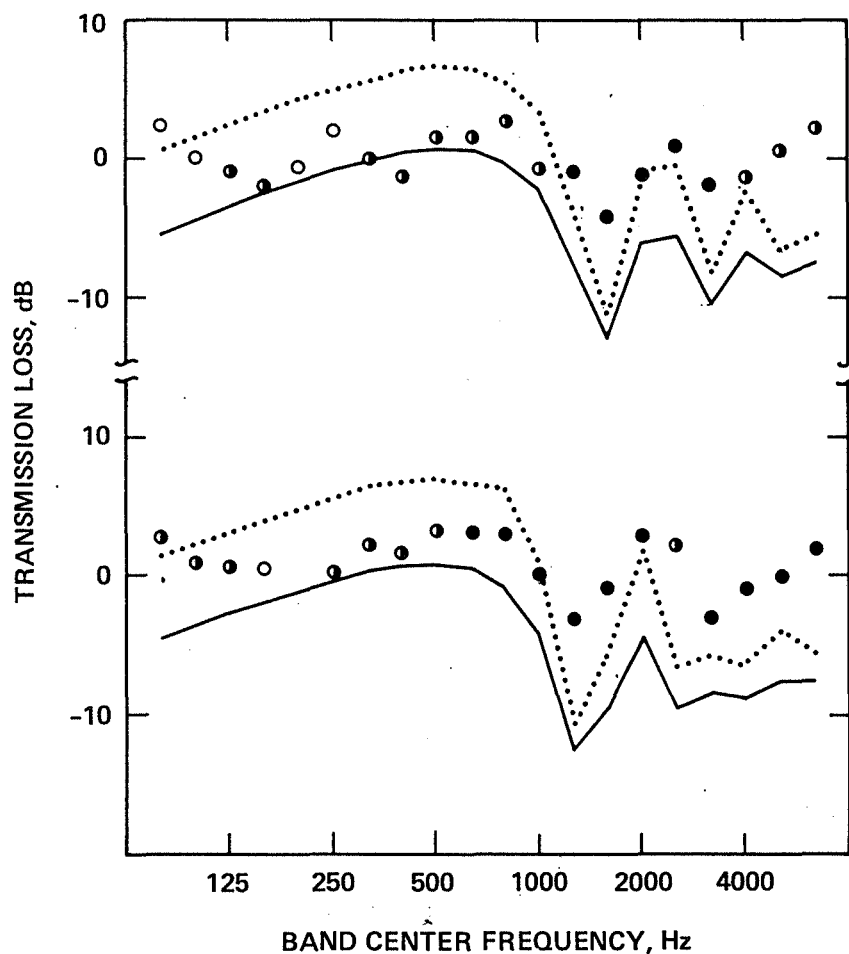
Figure 60. Comparison of experimental results and theoretical predictions for the sound transmission loss of 1/8 in. cracks around picture windows. The data points in the upper portion of the figure are from Test W-15-71 and the average of Tests W-7-71 and W-9-71; those in the lower portion are from Tests W-18-71 and W-10-71. The effective width of the slit was taken as the uniform width which would contain the same mass of air as the actual slit (which consisted of two segments of different widths. (Otherwise, as in Figure 59).

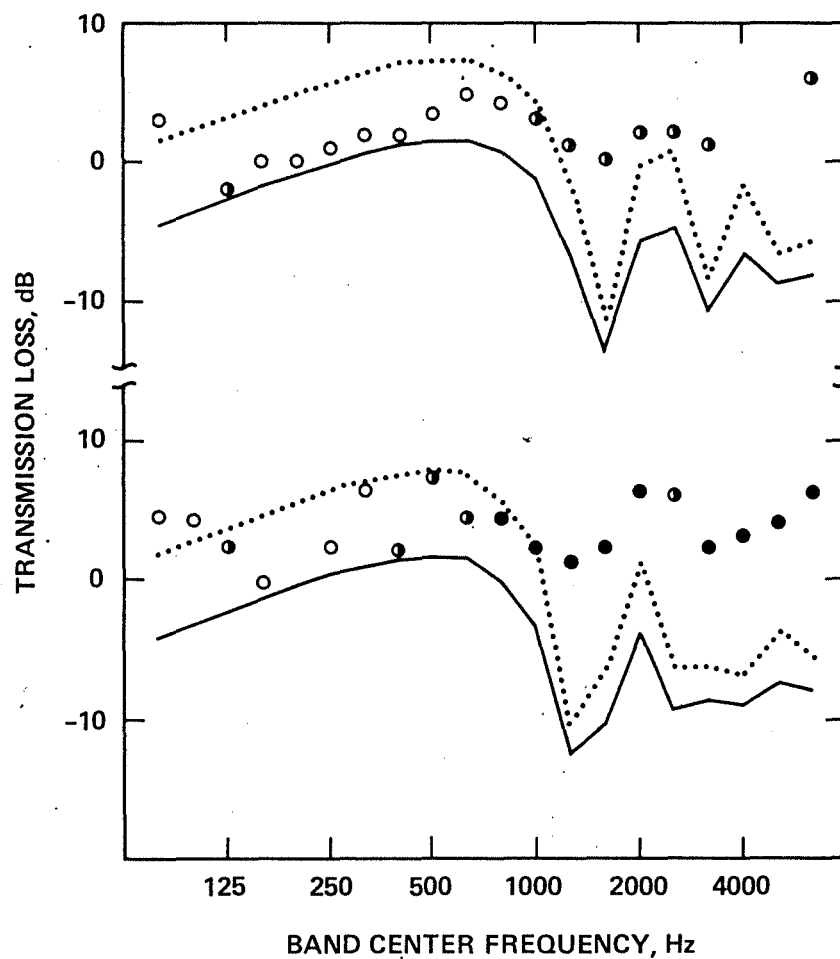
Figure 61. Comparison of experimental results and theoretical predictions for the sound transmission loss of 1/16 in. cracks around picture windows. The data points in the upper portion of the figure are from Test W-17-71 and the average of Tests W-7-71 and W-9-71; those in the lower portion are from Tests W-18-71 and W-10-71 (Otherwise, as in Figure 60).

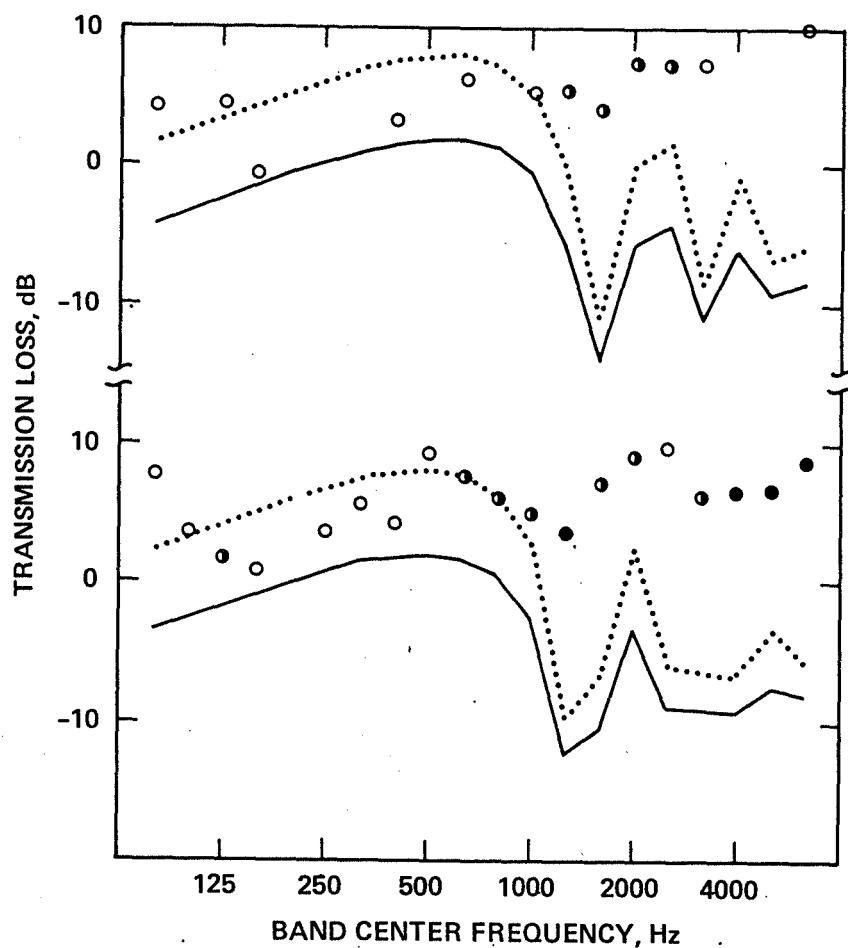
Figure 62. Comparison of experimental results and theoretical predictions for the sound transmission loss of 1/32 in. cracks around picture windows. The data points in the upper portion of the figure are from Test W-21-71 and the average of Tests W-7-71 and W-9-71; those in the lower portion are from Tests W-19-71 and W-10-71. (Otherwise, as in Figure 60).

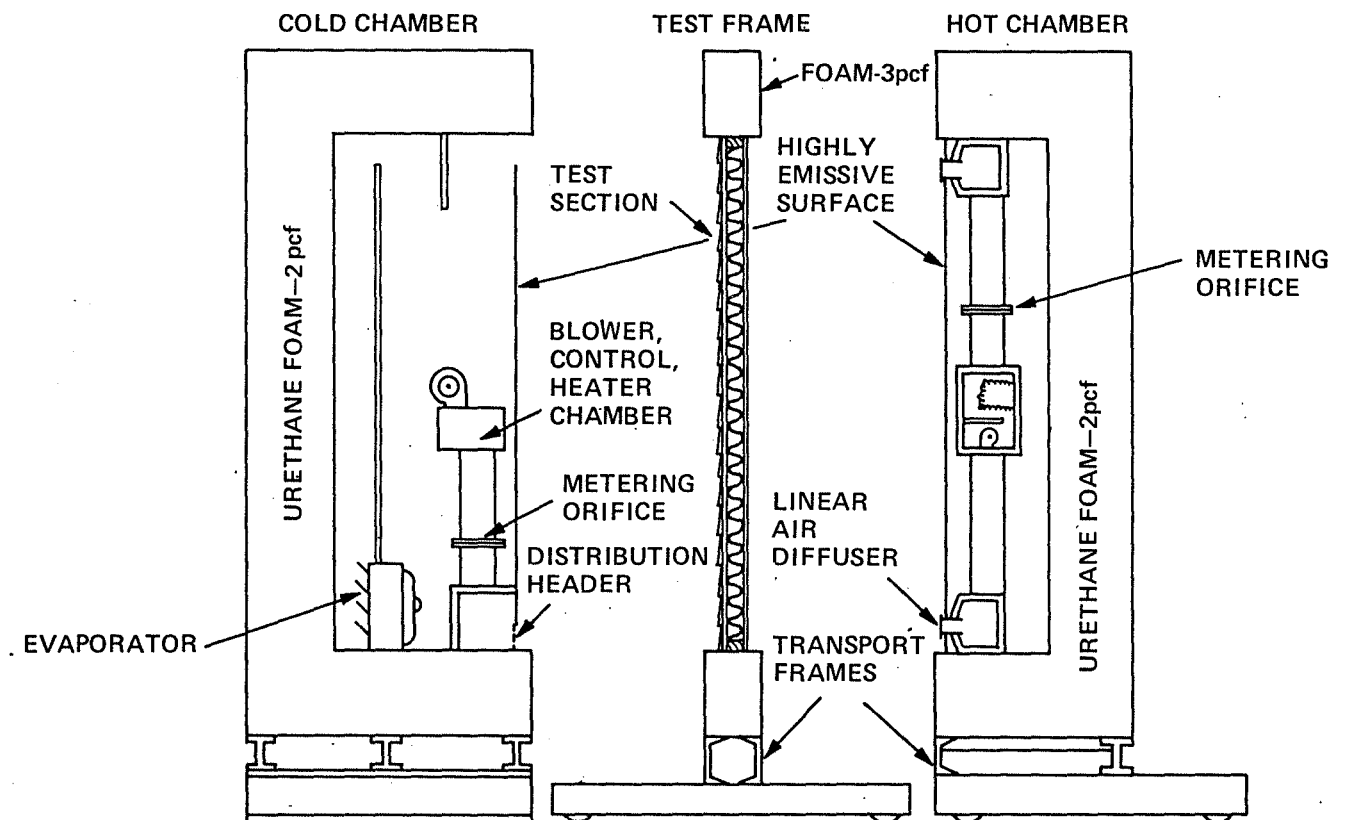
Figure 63. Schematic section of calibrated hot box facility used for thermal tests. Components are described in the text and by Mumaw [119].

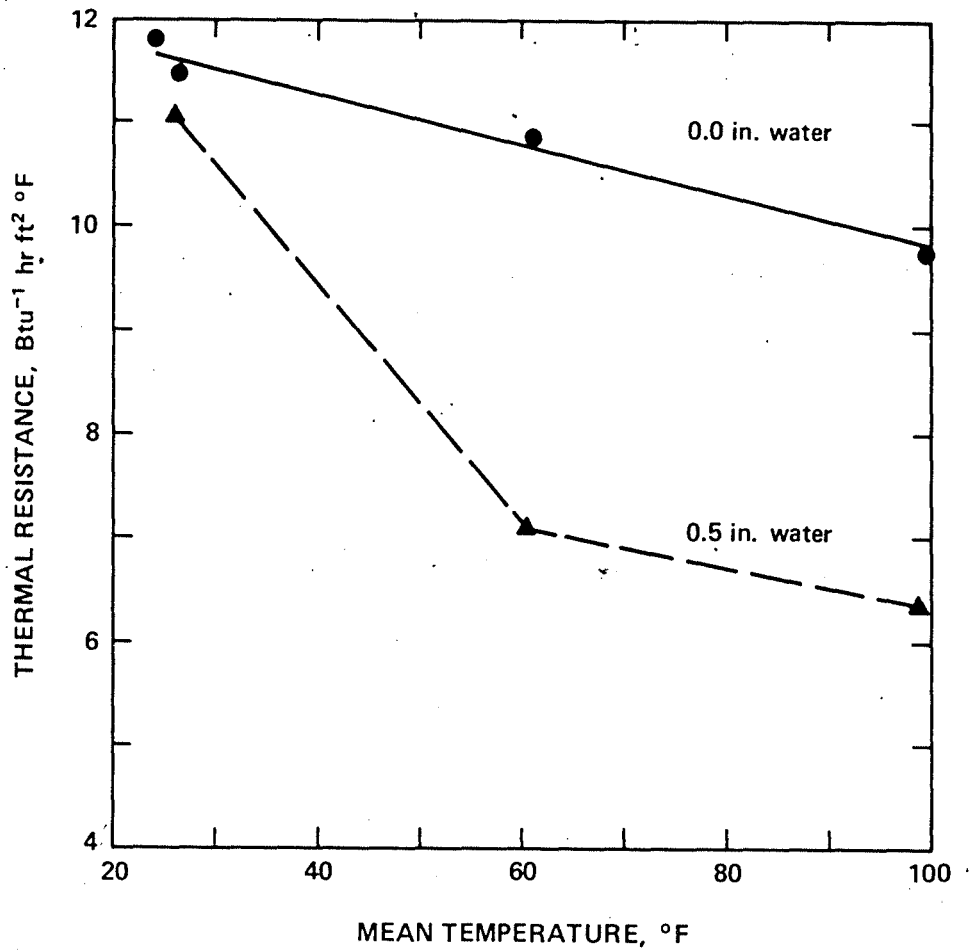
Figure 64. Thermal resistance vs mean temperature data for a 2 x 4 in. stud wall with 1/2 in. gypsum board on the interior surface, redwood lap siding over 1/2 in. wood fiber sheathing on the exterior surface, and 3 1/2 in. Fiberglas Friction Fit Building Insulation plus a polyethylene vapor barrier in the cavity.

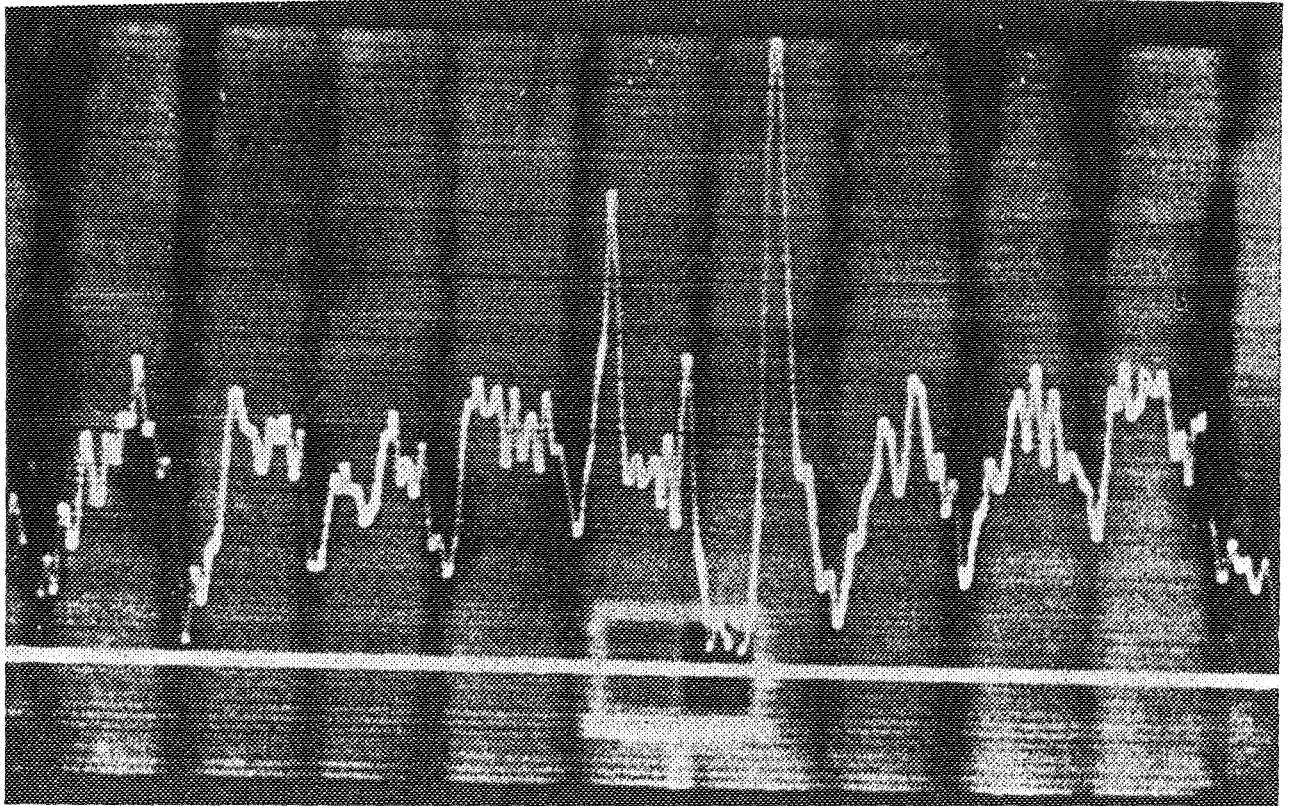
Figure 65. Infrared thermograph of warm side of wall insulated with 3 1/2 in. Fiberglas Friction Fit Insulation. Comparator temperature difference: 2.1 °F.

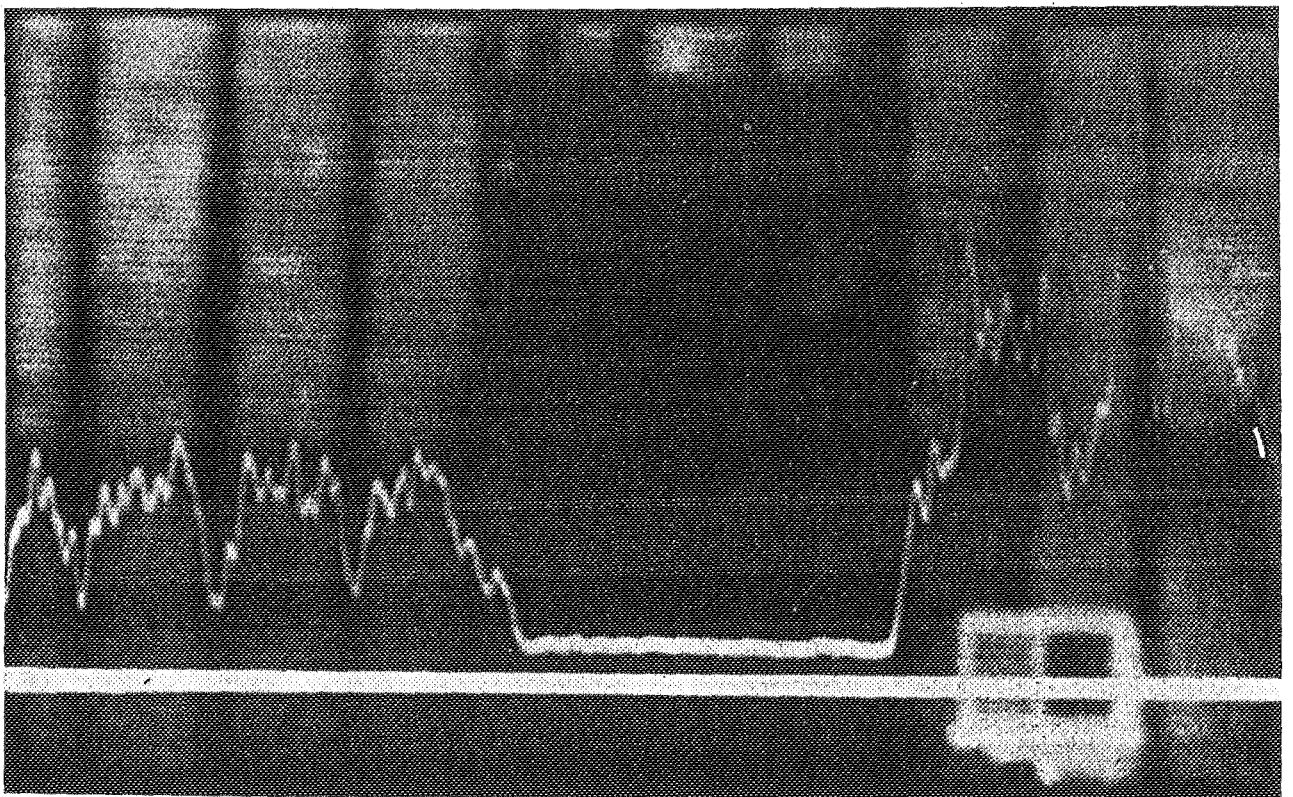
Figure 66. Infrared thermograph of warm side of wall insulated with 3 1/2 in. Fiberglas Friction Fit Insulation, penetrated by a double-hung wood window, 3 x 5 ft, single-glazed, locked. Comparator temperature difference: 2.0 °F.

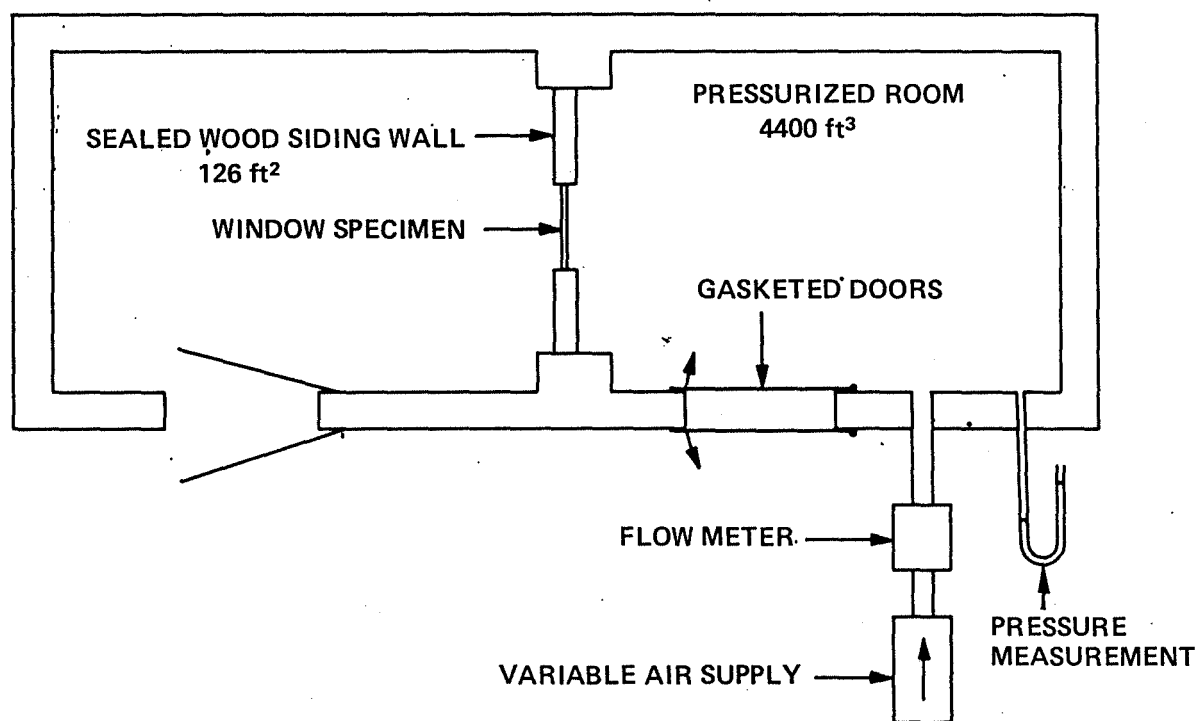
Figure 67. Experimental setup for measuring air filtration of doors and windows in the sound transmission facility.
