# NBS BUILDING SCIENCE SERIES 77

## Acoustical and Thermal Performance of Exterior Residential Walls, Doors and Windows

# Acoustical and Thermal Performance of Exterior Residential Walls, Doors and Windows

## Abstract

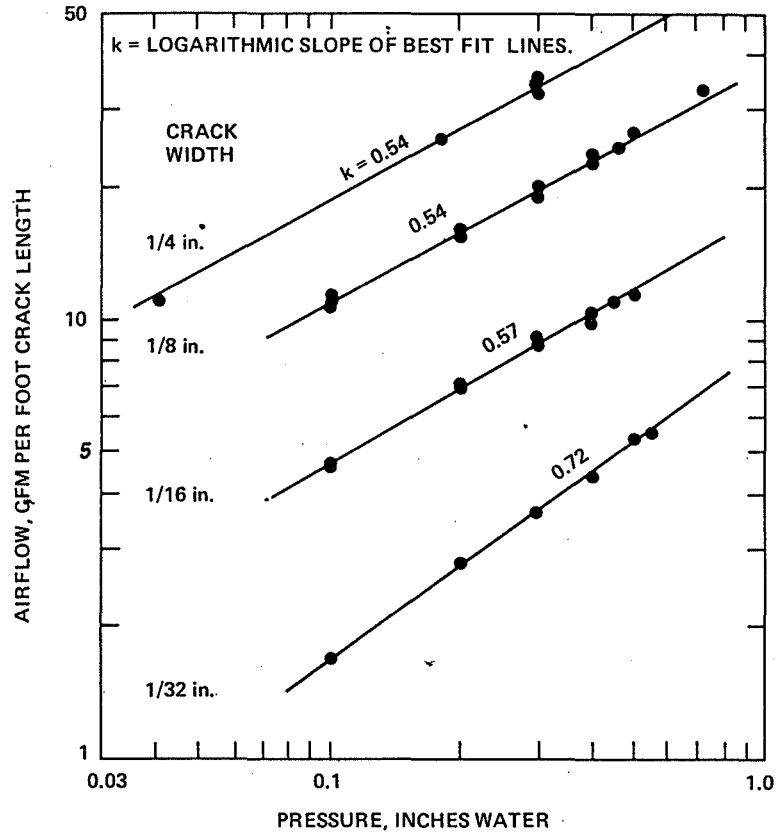
Figure 68. Air infiltration through gauged cracks around picture window. Multiple points at the same pressure and crack width represent crack lengths varying from 2 to 20 ft.

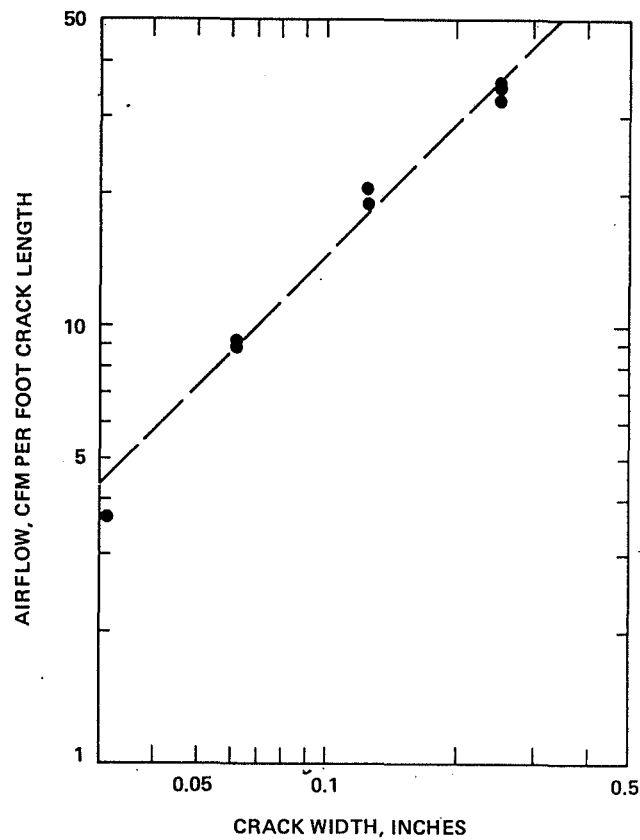
Figure 69. Air infiltration, as a function of crack width, through gauged cracks around picture window at 0.3 in. water pressure.

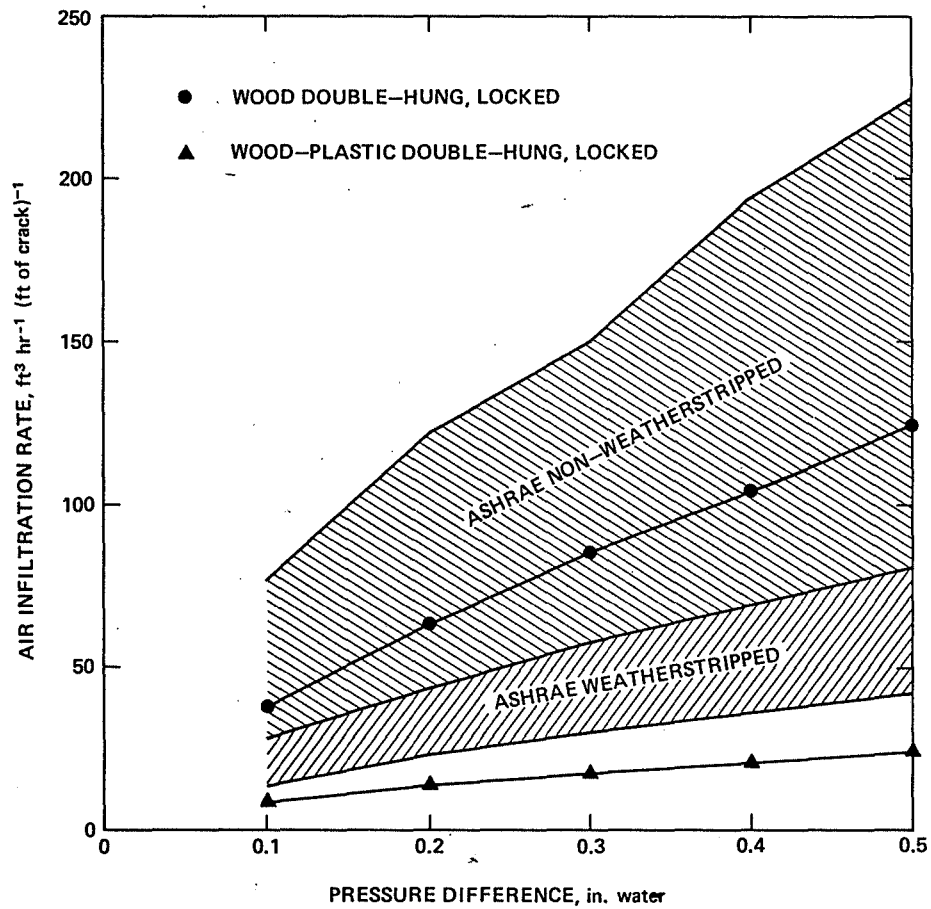
Figure 70. Air infiltration, per foot of crack, for locked wood (Test W-24-71) and wood-plastic (Test W-74-71) double-hung windows compared with ASHRAE design values.

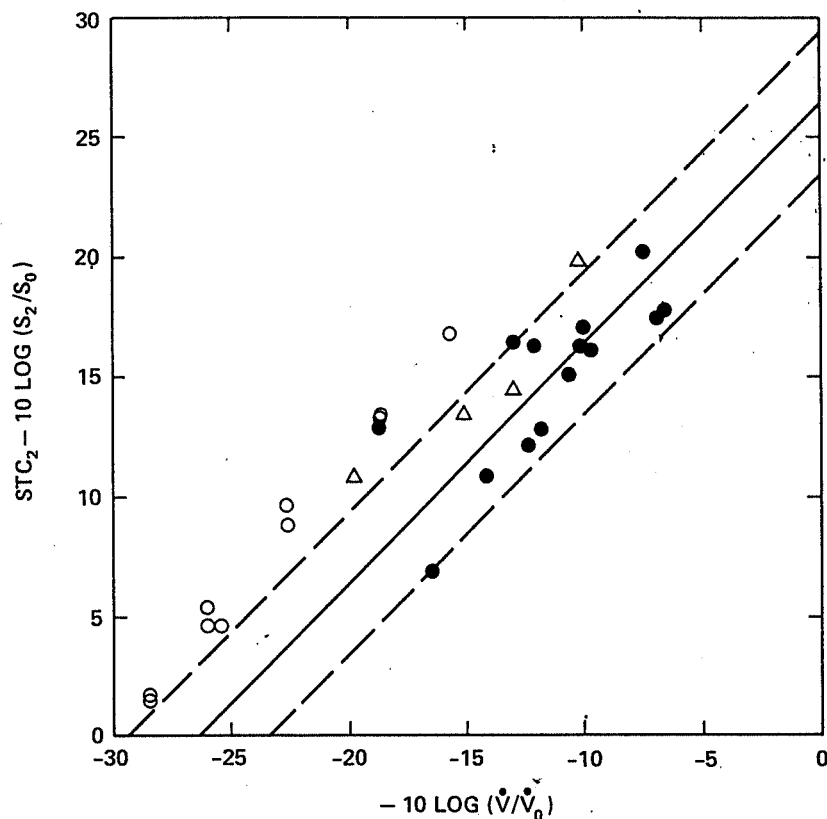
Figure 71. Experimentally determined values for  $STC_2 - 10 \log (S_2/S_0)$  plotted vs experimentally determined values for  $-10 \log (\dot{V}/\dot{V}_0)$ ; see text.

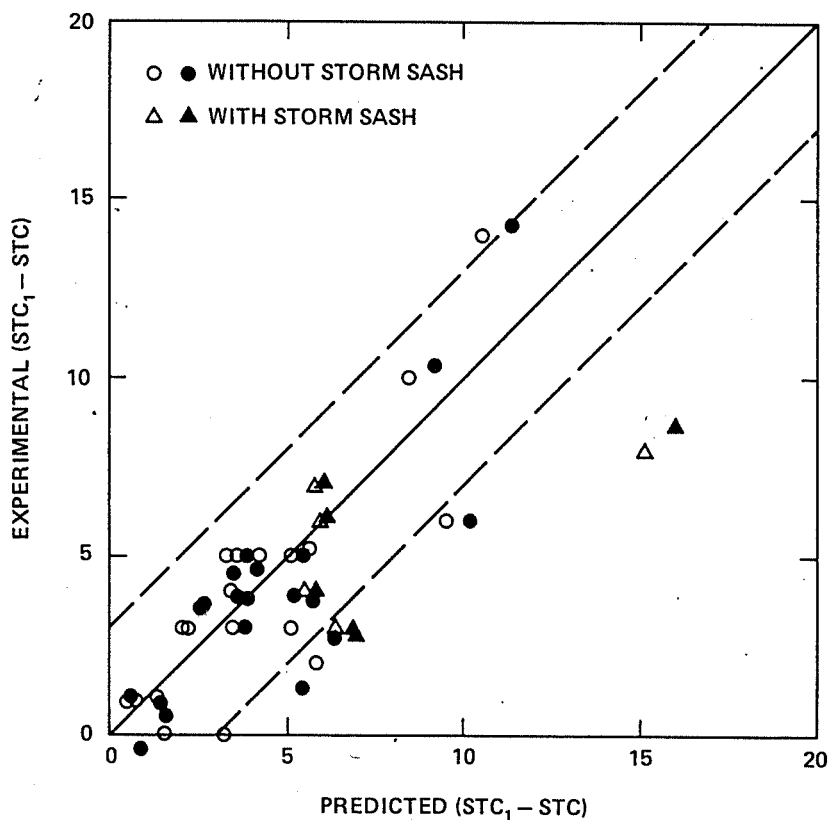
Figure 72. Experimental values for the decrease in sound transmission loss due to leaks around windows or doors versus values predicted using equation (22). The open symbols represent conventional calculations [22] of the Sound Transmission Class. Closed symbols correspond to STC-values computed exactly (rather than to the next lowest decibel) and without invoking the "-8 dB rule".

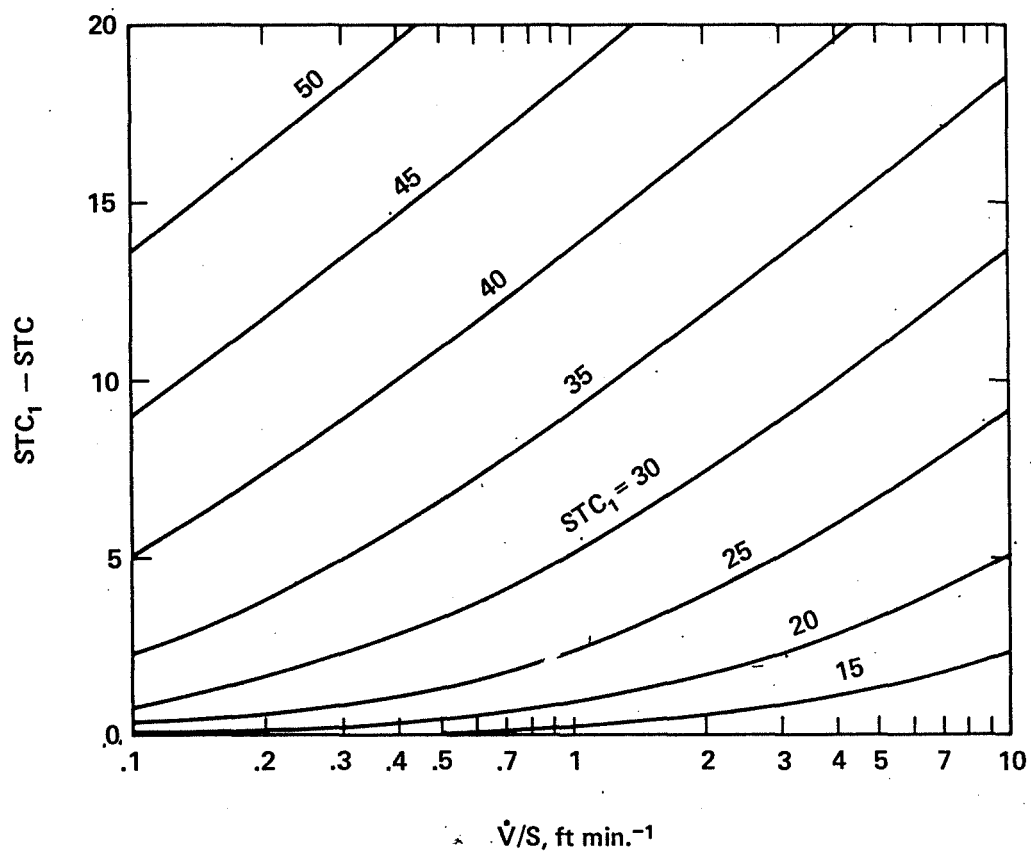
Figure 73. Expected decrease in Sound Transmission Class as a function of air leakage rate divided by area. The air leakage rate,  $\dot{V}$ , measured according to ASTM E283-73 [125] is expressed in scfm at a pressure difference of 0.3 in. water. The window or door area,  $S$ , is in sq ft. The parameter on the curves is the Sound Transmission Class of the sealed unit (window or door).

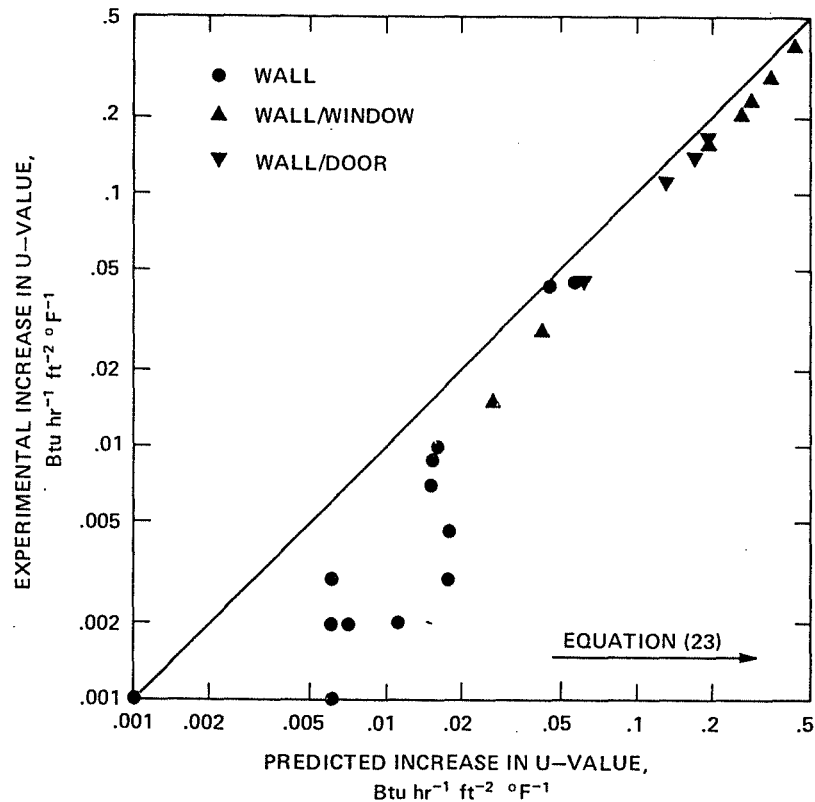
Figure 74. Experimentally observed increase in effective thermal transmittance of 9 x 14 ft walls, with and without penetrating doors or windows, vs the increase predicted by equation (23). The scatter for small values of thermal transmittance arises from imprecisions in both the thermal transmittance data and the air flow rate data (used in equation (23)).

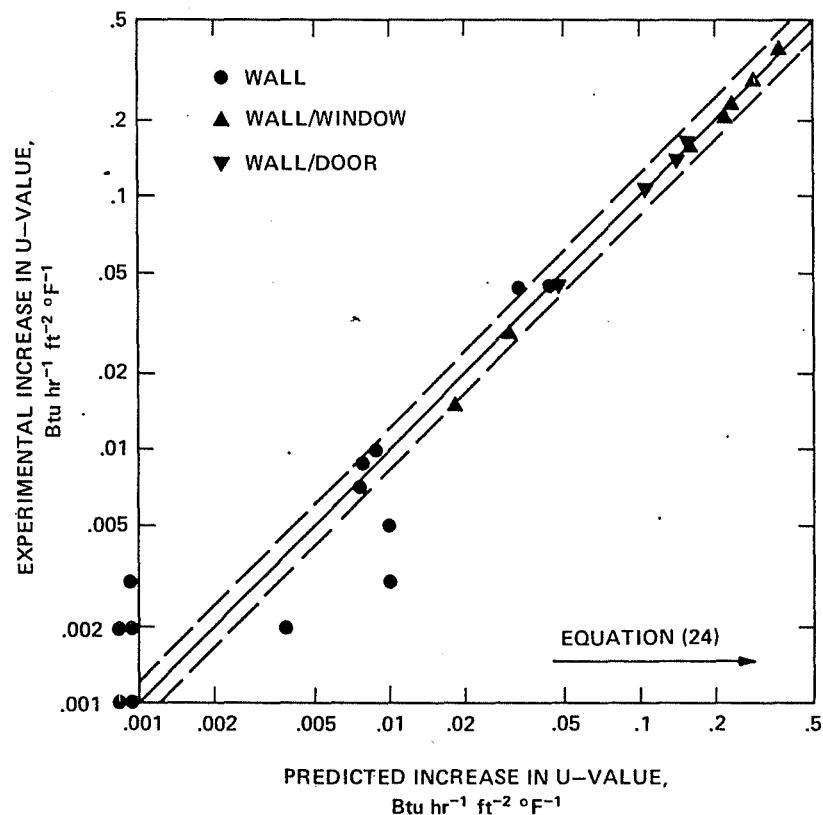
Figure 75. Experimentally observed increase in effective thermal transmittance of 9 x 14 ft walls, with and without penetrating doors or windows, vs the increase predicted by equation (24). The data points shown just to the left of the left-hand ordinate correspond to predicted values below the range of the abscissa (cf. corresponding points in Figure (74)). The dashed lines bound the region  $\pm 20$  percent around the line of perfect concordance.

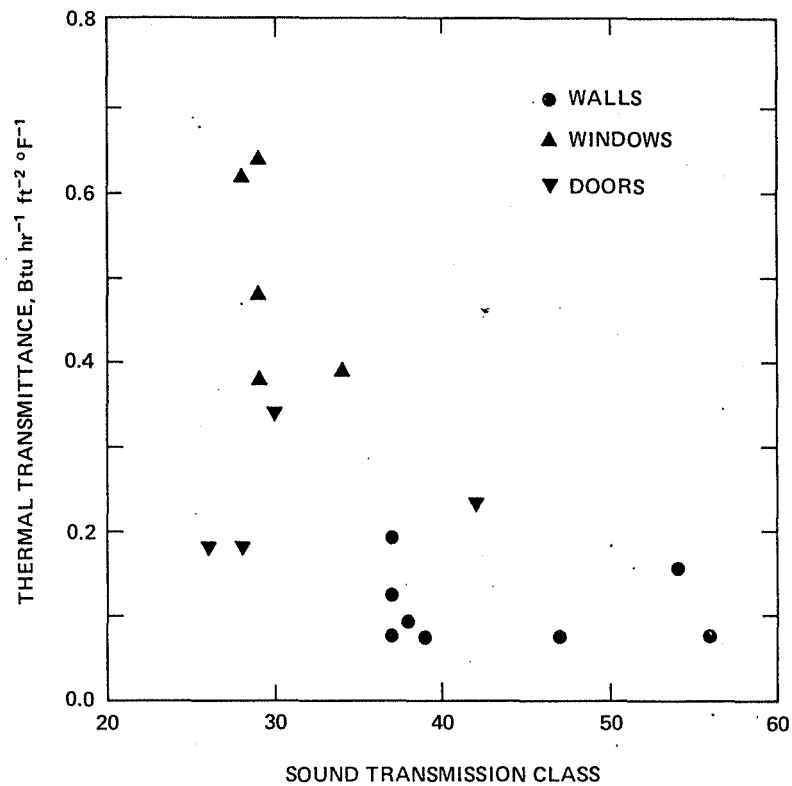
Figure 76. Comparison of Sound Transmission Class and thermal transmittance for basic walls, doors, and windows. The data plotted are listed in Table 6.

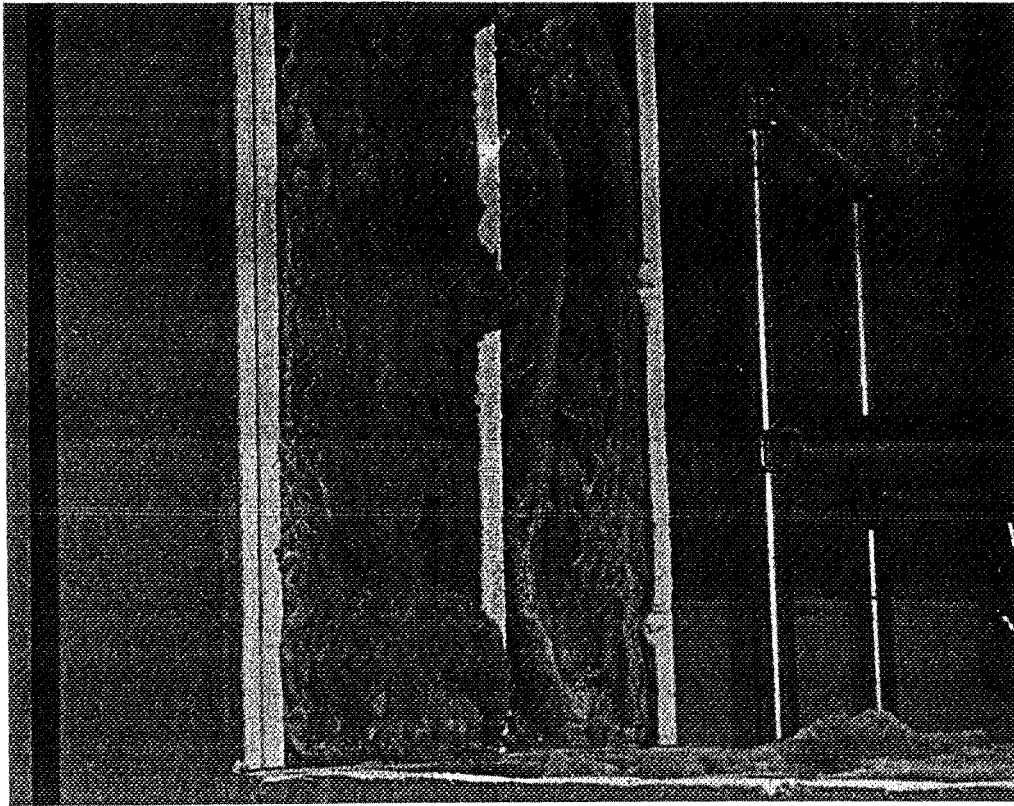
Figure B-1. Filler wall after cutting opening for picture window.

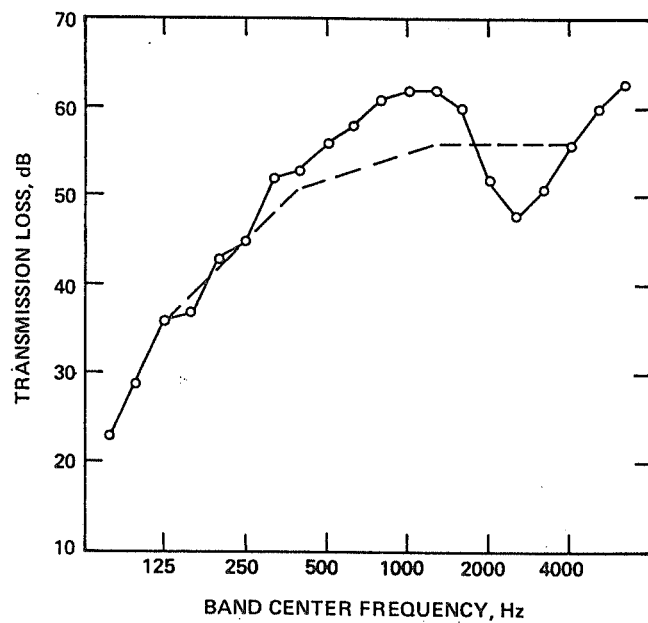
Figure B-2. Sound transmission loss vs frequency data for wood stud drywall with resilient channel and cavity insulation.

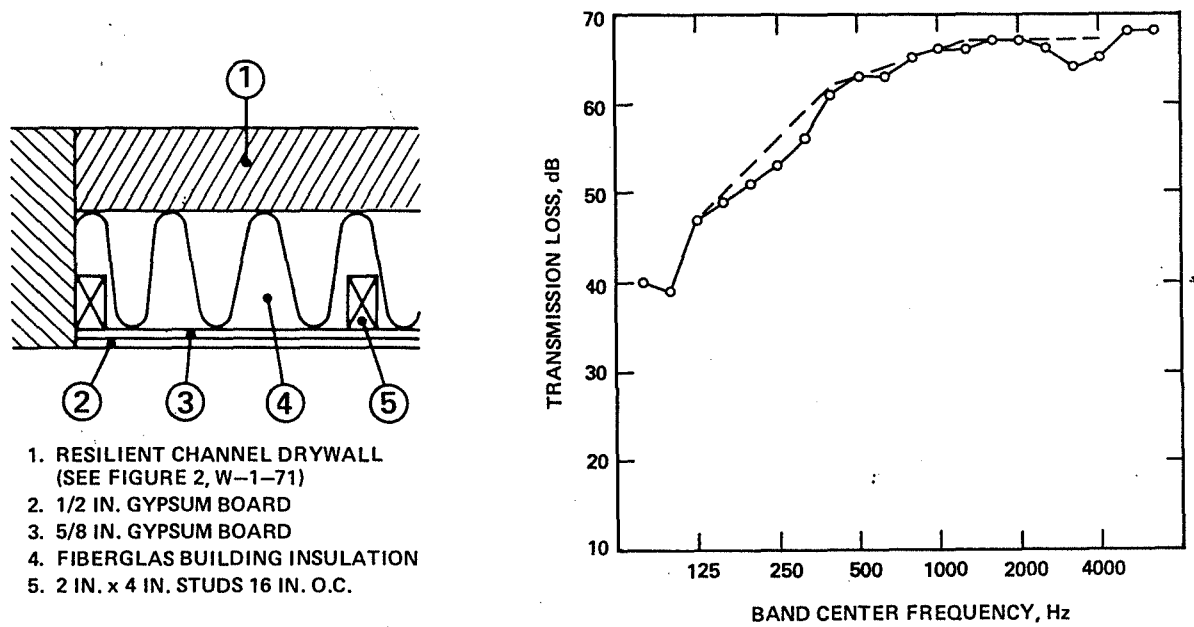
Figure B-3. Apparent sound transmission loss vs frequency data for complete filler wall, concrete surround not covered.

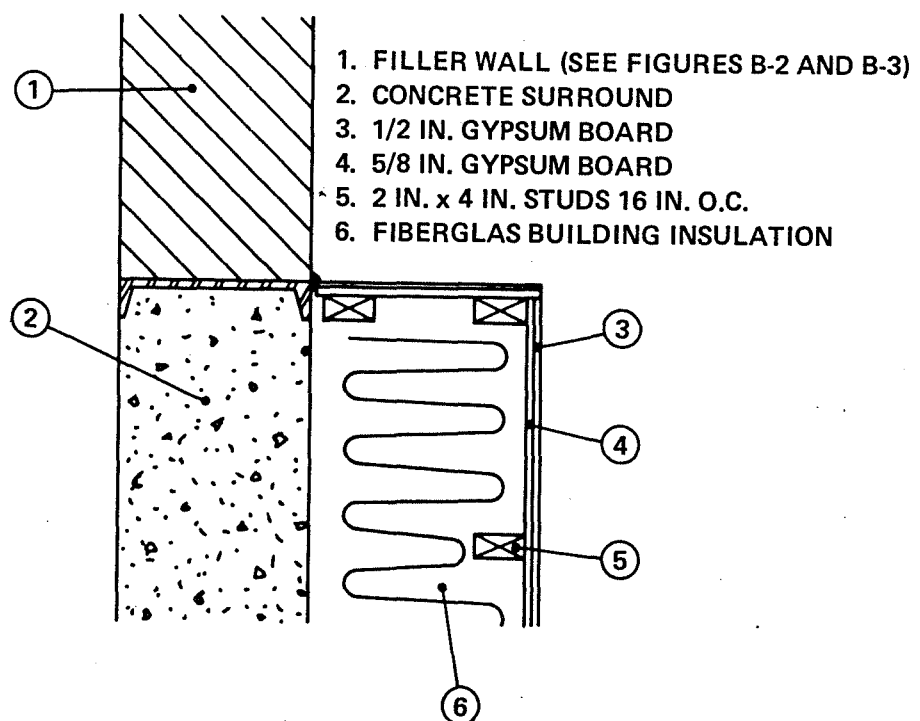
Figure B-4. Auxiliary construction added to concrete surround.

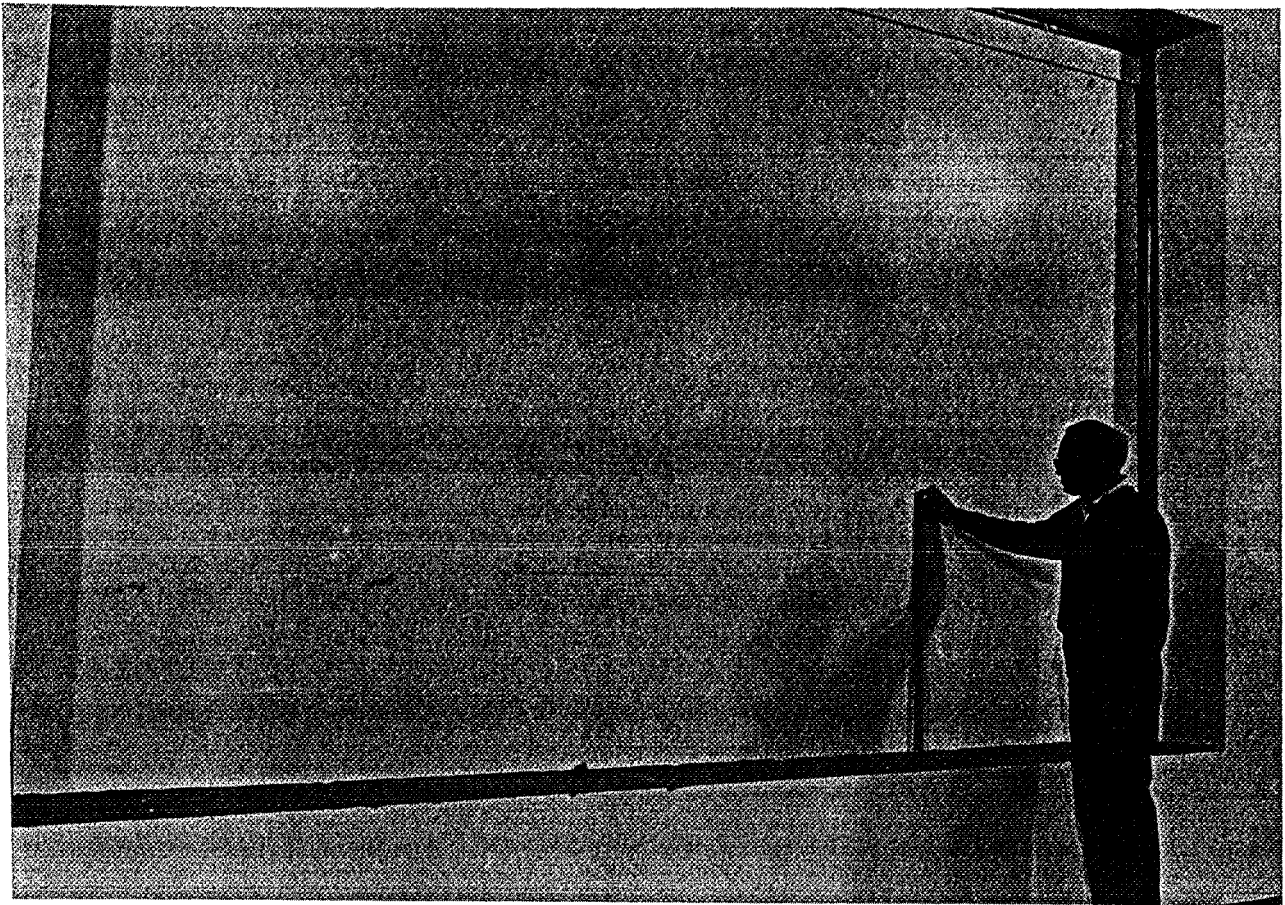
Figure B-5. Filler wall and auxiliary construction over concrete surround.

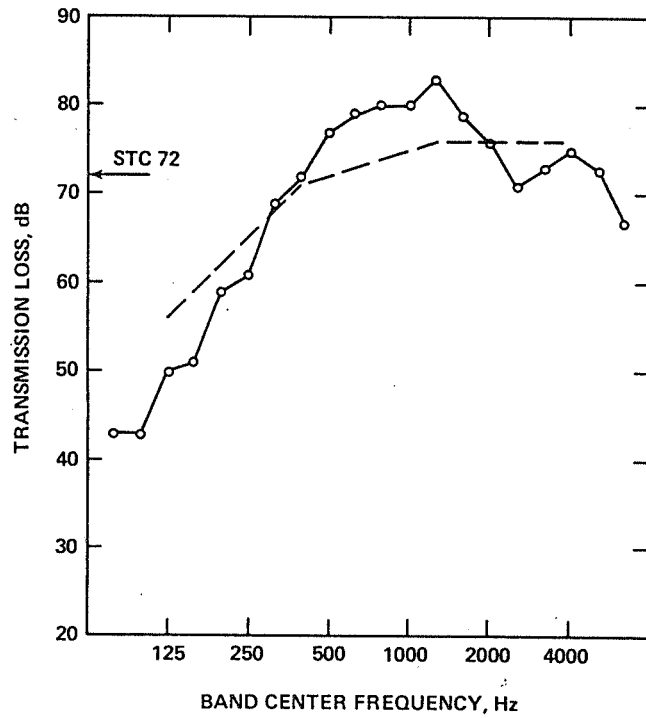
Figure B-6. Apparent sound transmission loss vs frequency data for complete filler wall with auxiliary construction added to concrete surround.

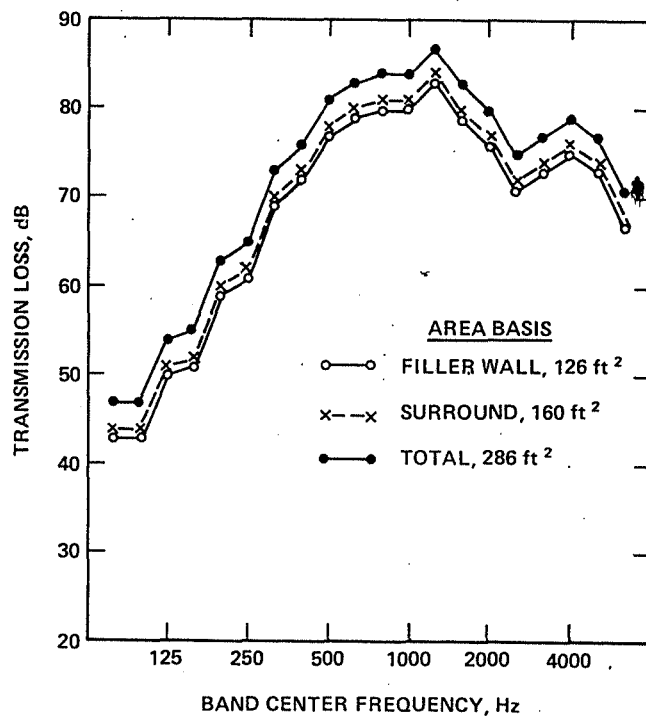
Figure B-7. Apparent sound transmission loss vs frequency data for complete filler wall with auxiliary construction added to concrete wall. The three curves represent computations based on three different values for the wall area.
