18TH ANNUAL AIVC CONFERENCE ATHENS, GREECE, 23-26 SEPTEMBER, 1997

K. TSIKOURIS and A. YOUNG

NATURAL VENTILATION AND THE ROLE OF PASSIVE STACK CHIMNEYS IN TRADITIONAL EXCAVATED AND SURFACE DWELLINGS IN SANTORINI, GREECE

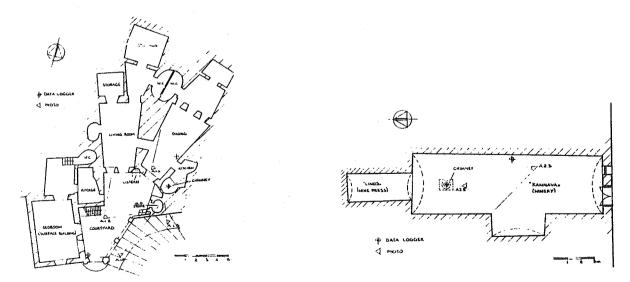
Fig. 1 Building 1: Floor Plan

In building 1 the chimney is round and has been built in the kitchen above the stove (fig. 1). Half of it is excavated from the ground. When reaching the surface it forms a part of the adjacent public stair's parapet. The rear space of the house is not ventilated at all. In building 2 the chimney is actually a 60cm diameter hole on the roof, which brings light and fresh air into the deep-plan excavated space (fig. 2). Considering that the roof is in reality the ground above, the chimney is a 2.7m high excavated cylinder. The chimney in building 3 is partially excavated, with its main body built on the surface of the ground (fig. 3). In building 4 the chimney is located at the rear of the house, in the room which was probably initially a kitchen (fig. 4). It has an open top and the blowing winds (regardless of their direction) create a negative pressure and support an air movement in the chimney, even when the difference between the external and internal temperature is very low.

In order to demonstrate the effectiveness of chimneys as a means of natural ventilation an experimental study was carried out. Four buildings were selected for monitoring in terms of their environmental conditions. "Smart Reader" data loggers were used, together with the "Trend Reader" [9] software package to record and download readings for temperature and relative humidity. Monitoring took place for one week. For each of the four buildings a data logger was positioned in the middle of the height of the chimney and another was hung in the internal space, at head height. Another logger for monitoring the external conditions, was positioned so that it was always in shade. The location of the loggers in each building is shown on the floor plans (fig. 1-4).

Four buildings were selected for study from the many traditional buildings on the island, see figures 1 to 4, and were representative of the basic types to be found. They have all maintained their original layout with almost no damage or alteration to the original materials and architectural elements. An original chimney exists in every one of the selected buildings, without any significant change to its initial shape and materials. Buildings 1 and 2 are excavated into the ground whereas 3 and 4 are surface buildings.

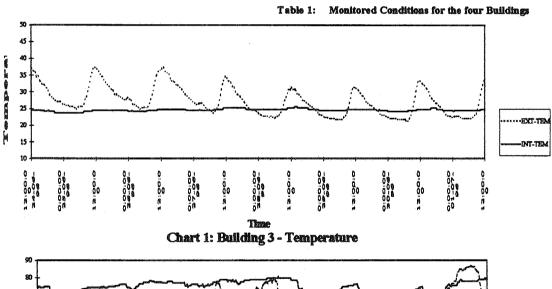
A summary of the results of the monitoring procedure is presented in Table 1 and sample graphs representing the monitored conditions in building 3 are given in Charts 1-2. In all cases the internal temperature is very stable, at relatively low levels, primarily due to the high thermal mass of the surrounding ground, or the thick walls (in the case of the surface dwellings) which are made of lava rock. The solar and internal heat gains are absorbed by the thermal mass at daytime and given back during the night, when the ambient temperature is lower.

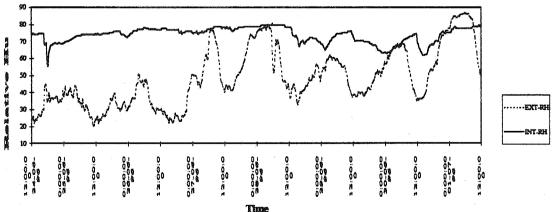
Chart 2: Building 3 - Relative Humidity

The internal relative humidity is also relatively stable compared to the external one, although it follows the fluctuation of the external conditions by a time lag and it is very common for it to reach very high figures, see Chart 2. The monitored values for relative humidity and temperature for the four buildings were converted to absolute moisture content values, with the use of the equations suggested in [6]. Chart 3 shows the calculated moisture content for the external air and the internal ambient air for building 3, where it can be seen that the moisture content inside is at all times greater than the simultaneous moisture content outside but shows similar trend. This would seem to indicate that the moisture content inside is not determined purely by infiltration and natural ventilation from outside. In Building 3 it appears that other major sources are affecting the moisture content, such as moisture

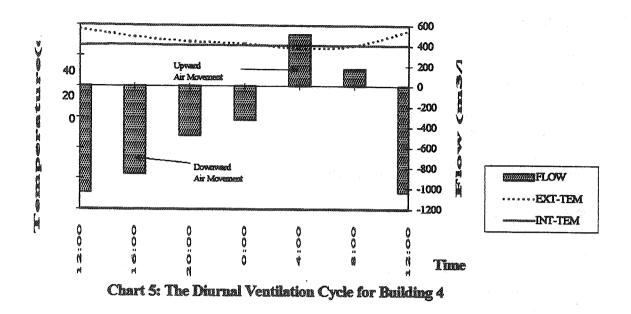
Chart 5 shows the performance of Building 4, in terms of air flow rate and direction through the chimney, and their change over time and with internal/external temperature difference. The external and room temperatures were those recorded over one day in the building during the monitored period, and the air flow rates are those predicted by BREEZE, using these temperatures. It can be seen how the direction of flow changes when the room temperature becomes greater or less than the external temperature. Table 2 shows that the buildings experience quite high ventilation rates. Although these fairly high ventilation rates maintain acceptable air quality in those rooms which experience the ventilation, humidity levels are generally unacceptably high in rooms isolated from the main air movement paths, and it is this aspect of these buildings which makes their rehabilitation most problematic.

Initial consideration of the differences in the recorded temperature between the chimney and the external air would suggest that the chimneys operate on a diurnal cycle in the following way: the outside air temperature in the early afternoon is at its highest and is considerably higher than the inside, resulting in a downward air movement in the chimney. Direct gains from the sun and heat from the incoming air are absorbed by the walls and the roof of the house and from the chimney walls. The thermal mass gives back the heat at night, keeping the room temperature higher than the external which has decreased. Now the air flows in the chimney in the reverse direction, moving upwards. The temperature outside gradually increases as the day progresses and at some time the inside and outside temperatures become equal. At this instant, theoretically, there is no air flow in the chimney. In the early afternoon the outside temperature comes to its maximum again and the cycle repeats itself (See chart 5).

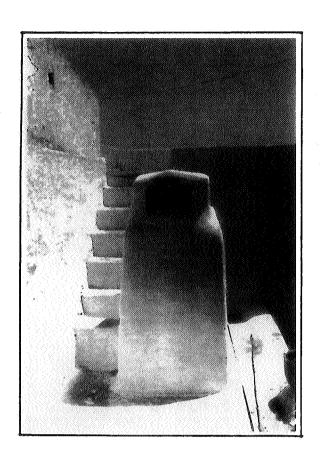
the chimney in Building 3

It is difficult to improve a problematic chimney. Sometimes chimneys are in small, separate rooms, like the one in building 3. In this case, opening a large passage to the other rooms might improve the performance of the chimney and its contribution to the overall ventilation. In the case of a chimney built lower than the surrounding buildings, the height of it should be increased. In vernacular buildings this is not always acceptable, because it alters the form of the house. However, it has been shown from this study that a well-designed chimney can be used as a means of improving natural ventilation, offering an alternative to cross ventilation, wherever the later is difficult to achieve.
