Evaluation of Ventilation and IAQ Parameters Measured in Social Housing in Madrid

Within this paper, an evaluation of Indoor Air Quality in residential buildings, and the experience after a building retrofit is shown. One residential building in a Madrid social housing neighbourhood serves as case study and base for the monitoring.

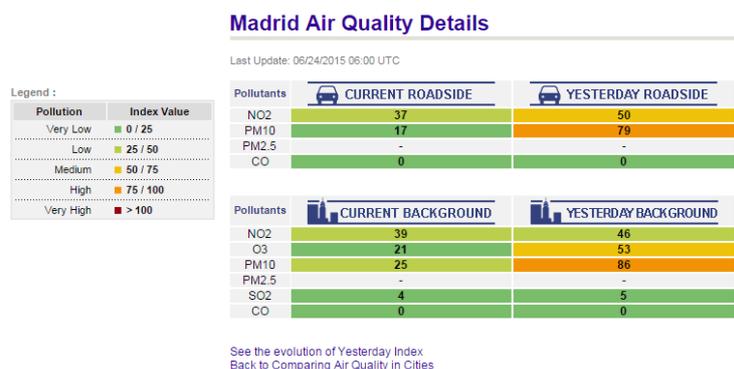
Figure 3: Daily pollutant monitoring extracted from Madrid City Council sources in web <http://www.airqualitynow.eu/>

As it can be seen in figure 3, target limits would be overcome in daily basis quite frequently, though they are not on yearly basis. The annual report for 2014 "Air Quality in the Madrid city area" [Madrid region government, 2014] viii shows that the general concentrations are below the target limits, and still the perception of the air quality within the population is not satisfactory. In general all the values have decreased, excepting those from Troposphere Ozone (during summer) since 2005 but the traffic and the use of fossil energy sources produce high levels outdoors and indoors that have to be reduced. Most of the pollutants, but specifically NO₂, NO_x, CO and benzene concentrations indoors are highly related with the concentration outdoors.

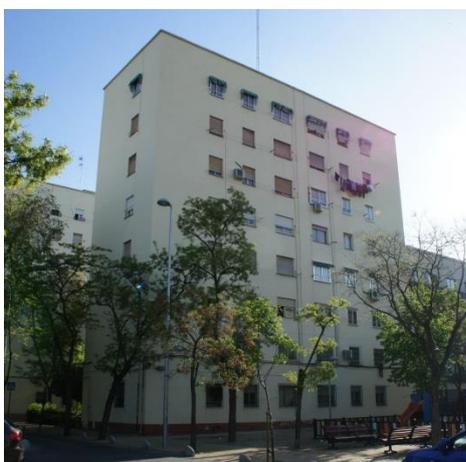
Figure 1: south façade of the demo case

Within the SIREIN research project, a demonstration building was insulated by injecting glass wool inside the wall cavities. The demo is an 8 stories building, with a representative typology within the area and the Spanish residential stock. 16 dwellings, elevator, utility rooms below the first floor and stairs are the main spaces in the building. The housing units surface is around 70 m² each, and have cross ventilation due to the three orientations of the facades on each apartment. Fig 1 and 2 show the configuration of the demo-building. The building was built during the sixties, on a concrete matrix structure and a double layer façade. These are the main features:

- Opaque envelope formed by a double brick layer with a 6 cm wide void cavity between them. The finishing to the inside is gypsum tiling and concrete layering painted to the outside.
- Windows are aluminum framed with single glass pane and no thermal bridge break.
- Some of the houses have solar shading elements to south, east and west orientation.
- Heating and hot water is provided by gas boilers excepting one of all the 16 which uses an electric boiler, and other which uses no heating.
- Some of the housing units installed Air conditioning with a divided system.
- Housing units have installed water and electricity, although these utilities are old and should be renovated.

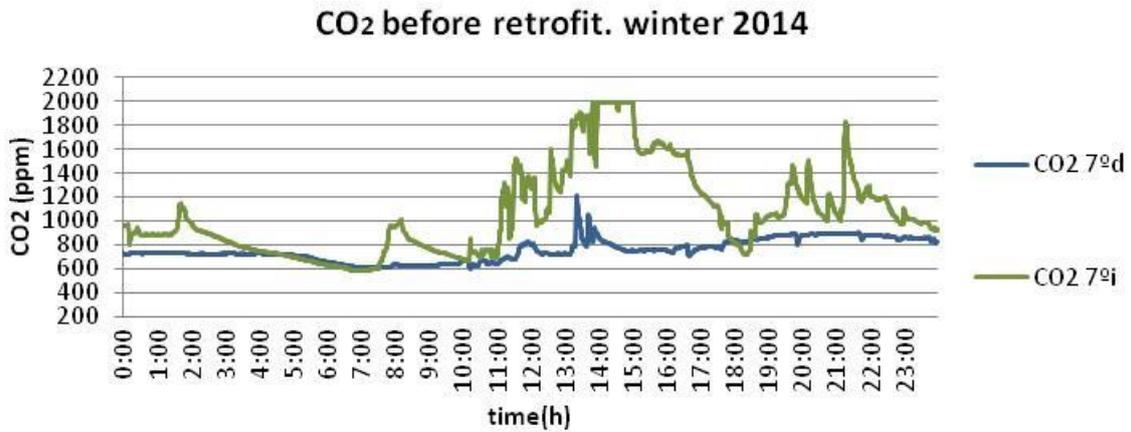
Figure 10: CO₂ concentration measurement from the occupied apartments before the retrofit

We have compared two monitoring days, with similar outdoor and indoor conditions. Before the retrofit process, the concentration of CO₂ found inside of the apartments was unusually high in some of the apartments, as only two inhabitants were present in the residence. This can be seen in figure 10. CO₂ concentration in apartment 7°i reached values above 2000 ppm. After retrofitting, we can observe in figure 11 values not only are still above 2000 ppm at some point but the time above this limit is longer. This increased value of CO₂ levels after the renovation was a not expected side effect. Searching for an explanation, for these high levels, we consider the existence of fewer ACH (air changes per hour) due to the improved envelope properties and less associated leakiness. The improvement of the wall cavity has some benefit in the infiltration, reducing it, so that the renovation of air through the leaks is less important, showing up in the CO₂ levels. We could expect that the users, being able to control the thermal environment, due to the façade improvement, would tend to open the windows more
