Roof Ice Dams

It's Not Really a Roofing Problem!

by Joe Sartor

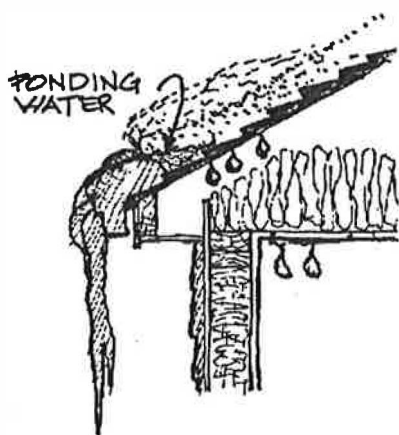
Ice dams are caused when heat from the attic melts the accumulated snow on the shingles above the outside wall, while the snow on the eaves overhang and in the eaves trough does not melt because it is surrounded by cold outside air. The melting water then freezes as it runs down over the cold overhang, and forms a dam that prevents the water from the melting snow getting down and away in the eaves trough.

As the level of the dammed melt water rises, water starts to run up and under the shingle tabs. The water then enters the vertical joints between the shingles, and spills down onto the roof sheathing, where it spreads out, finding joints or holes in the sheathing, and dripping down onto the insulation over the ceiling near the outside wall. If the water does not go any farther, nobody notices, and it is not a problem. However, when enough water accumulates, it spills over or soaks the insulation, and wets the ceiling drywall or plaster below—becoming a built-in leak problem.

A close look at a typical wall/roof/ceiling detail shows why leaks due to ice dams happen so often.

Usually, the rafters are low to the top of the outside bearing wall for reasons of economy or aesthetics, bringing the roof sheathing very close to the ceiling edge below. This means a restriction

in the insulation that can be fitted between the ceiling and the sloping roof, resulting in excessive heat loss into the roof at that point. In addition, there is seldom a full ventilation space between the rafters above the insulation, so a thermal bridge is created that allows the heat loss to warm the sheathing and shingles, and melt the snow which then freezes to cause the damming and leaking. Usually there is a lot of air leakage at the outside wall, adding to the heat concentrated under the roof at that point.
