ENVIRONMENTAL Health Review

Vol. 29, No. 3

September 1985

SICK BUILDINGS: Case Studies of Tight Building Syndrome and Indoor Air Quality Investigations in Modern Office Buildings

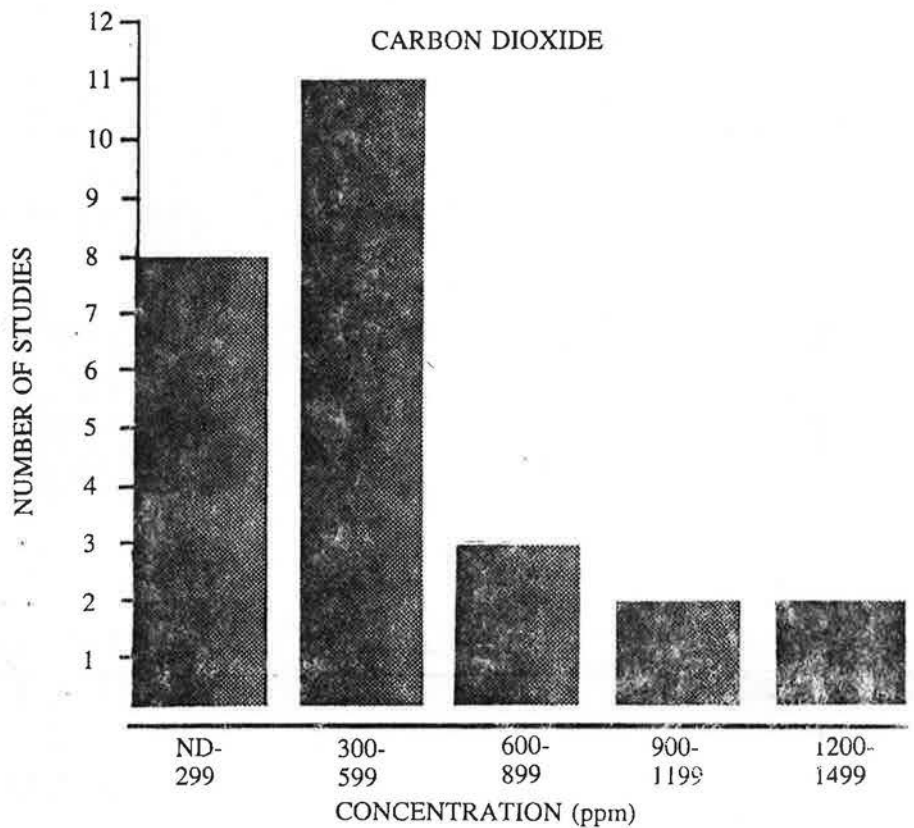
FIGURE 1: Graph of Carbon Dioxide Ranges Measured in 26 Building Studies

Carbon dioxide concentrations measured at selected locations on all occupied office floors are presented in Table 4. Carbon dioxide levels are higher than those normally found in similar air conditioned office buildings. For example Figure 1 is a graph of the distribution of CO2 levels measured in 26 office buildings contained in the Building Performance Database (Sterling *et al.*, 1985b). The concentration of CO2 measured in Building A is higher than that found in the majority of buildings.*

The dramatic increase of CO2 concentrations measured in Building A over the workday indicates an inability of the mechanical ventilation system to control metabolic produced contaminants. Although CO2 concentrations are all below

the 2500 ppm level recommended by ASHRAE (1981a), all levels measures are above the concentration of 600 ppm at which sensitive individuals begin to feel discomfort (Rajhans, 1984, Sterling *et al.*, 1984a).
