IABSE – ECCS SYMPOSIUM LUXEMBOURG 1985

Steel Buildings with Low Annual Energy Consumption

Arne ELMROTH

Carl Michael JOHANNESSON

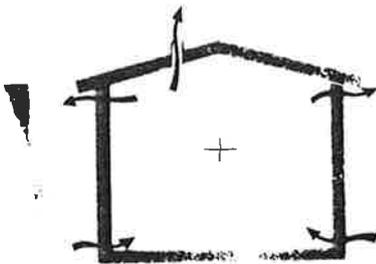
Air pressure on a calm day
Air leakage
Cold outside - warm inside

Fig 1 An insufficiently air-tight building where cold air seeps in at floor level and warm air leaks out at roof level due to thermal forces, wintertime. The pressure gradient is for temperature related pressures on a calm day and fore evenly distributed air leakage.

The governing force for air-leakage and ventilation in buildings is the difference in pressure of the air inside and outside the building. The forces affecting the air adjacent to and inside the building (excluding ventilation fans) and setting it in motion are wind and temperature. On a calm winters day the air pressure in the lower part of a building is lower inside the building than outside, and in the upper part of the building the air pressure on the inside is higher than that outside. The result is that cold air will seep in at floor level and that warm air will leak through the upper walls and the roof, fig 1, giving rise to, apart from the increased energy consumption, uncomfortable draughts at floor level. Such draughts are unacceptable in a quality building. At roof level, and especially in the eaves area, warm air leaks out which, when cooled, may even give rise to condensation and moisture problems in the roof itself. In order to reduce the seepage of cold air at floor level and the leakage of warm air at roof level it is necessary that the climate shield of the building be air-tight.

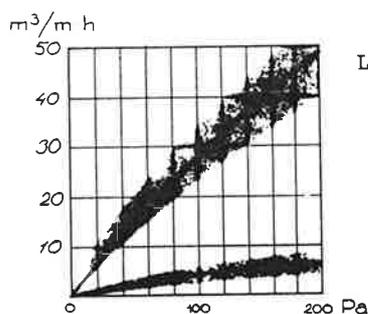
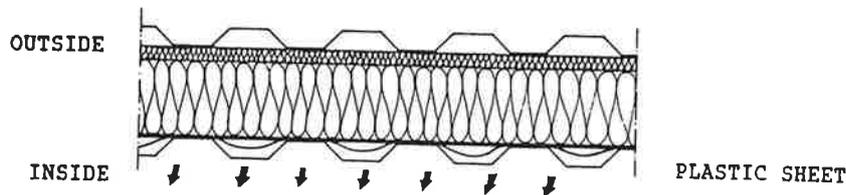
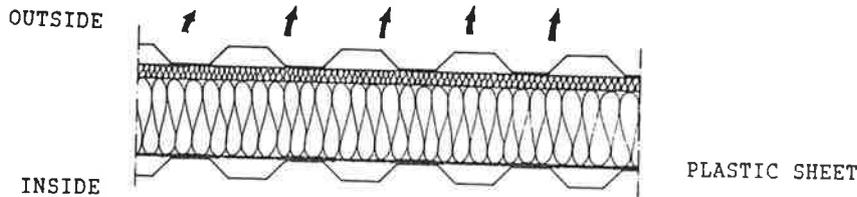
Lower pressure inside than outside

Higher pressure inside than outside.

Lower inside air pressure: the plastic sheet is pressed against the ground plate and against the thermal insulation.

Higher inside air pressure: the plastic sheet is pulled towards the profiled sheet wall causing leakage

Fig 2 If the plastic sheet is fixed to the ground plate only by means of a profiled steel sheet the air pressure at floor level will pull the sheet away from the ground plate and allow air leakage. If the air pressure is higher inside than outside the sheet will be pulled against the ground plate and reduce leakage. The latter case is however not the most usual one.

The air-tight membrane in walls constructed with cold formed sheet steel studs and sheet steel cladding is a plastic sheet between the inside surface of the thermal insulation and the inside wall finish. This form of construction creates no problems on undisturbed walls. If the wall is punctured by vents, adjoining walls, joints, windows etc great care must be taken in the design of these details. For example where the bottom edge of the plastic sheet is free - when the plastic sheet is fixed in place with a profiled steel sheet - air will seep in easily if the inside air pressure is lower than that outside. If the air pressure inside is higher then that outside the plastic sheet is pressed against the ground plate, reducing air leakage. It is most common to find lower air pressure at floor level which makes it necessary to find a better method of construction to avoid the free edge of the plastic sheet which is found today. Figure 2.

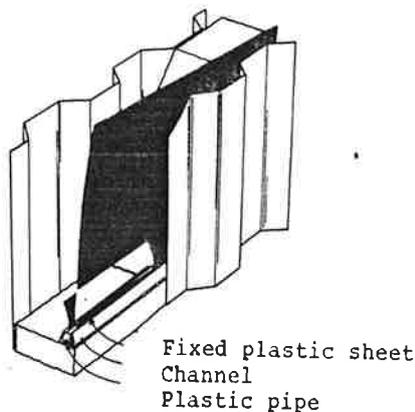
Fig 3 If the plastic sheet is fixed in a channel with a plastic pipe, electric conduit for example, excellent air tightness is achieved.

There are several methods of ensuring good air-tightness in the ground plate detail, one of which is a sheet steel channel in which the plastic sheet is clamped by means of a plastic pipe as shown in fig 3. When tested, this detail gave 100 times less leakage than that of a free sheet edge. Another version of the same detail which also gives a low leakage value is to fasten the plastic sheet between a fixing strip and sealant as shown in fig 4. These details cost very little but are essential; the extra cost being very quickly repaid.

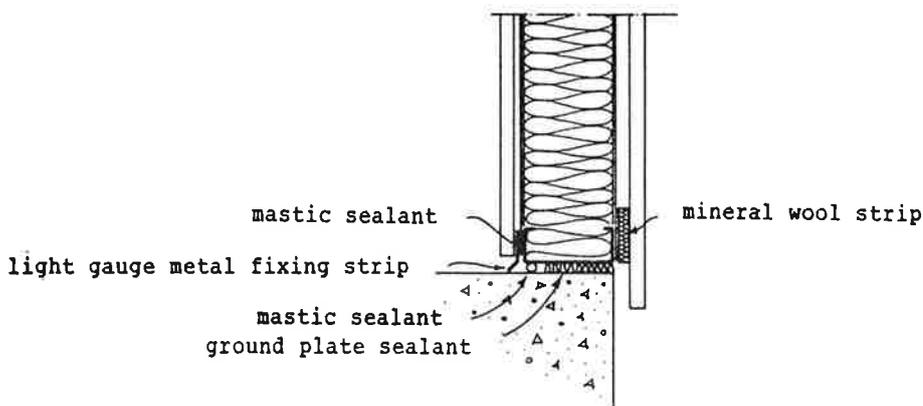
Fig 4 An alternative method of achieving good air-tightness in the ground plate detail is to fasten the plastic sheet with a special light gauge metal fixing strip. A mastic sealant or sealing strip placed between the plate and the sheet will ensure air-tightness. The joint between the ground-plate and the concrete foundation slab must be well sealed; mineral wool with a joint sealant on the inside gives an acceptable result.

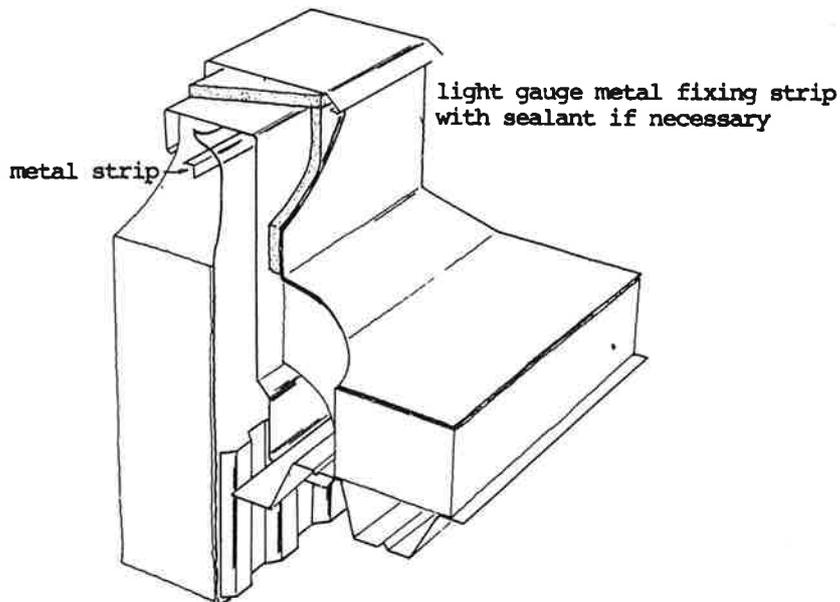
Fig 5 If the plastic sheet at the roof eaves is placed round the outside of the eaves beam there is a risk for air leakage being as the air pressure is often higher inside the building than outside. The sheet is drawn away from the beam and leakage occurs. The sheet must therefore be fixed with, for example, a fixing strip and mastic sealant in order to obtain sufficient air-tightness.

There is normally some kind of special light gauge sheet steel eaves beam which causes the plastic sheet to be led round it in some way, usually on the outside. The internal excess air pressure presses the sheet away from the eaves beam creating a gap for leakage. This is an unsatisfactory detail which is simple to resolve. Here again all that is required is a light gauge metal fixing-strip which fixes the plastic sheet to the eaves beam, with a sealant between if necessary, as shown in fig 5. Again the cost per metre is very low. Minor adjustments in detailing can give greatly improved air tightness.

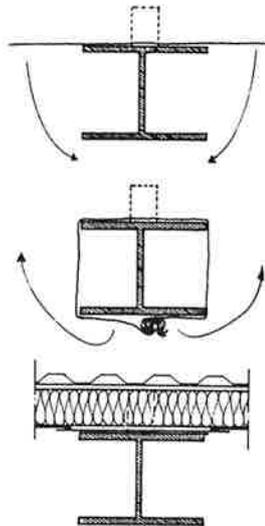
Strip of sheet plastic fixed to inside of column during frame construction

The plastic strip is folded out and fixed in place using U-channels and plastic conduct

The plastic strip is folded out after the thermal insulation is pitted and the main plastic sheeting pitted and overlapped using a sealing strip

Fig. 6 It can be difficult to place the plastic sheeting when steel columns are placed inside the facade. A strip of plastic sheet is therefore fitted directly after the completion of the frame and carefully fastened so as to avoid wind damage during construction. When the thermal insulation and the plastic vapour barrier are in place the strip is folded out to give a good overlap joint with the main plastic sheet.

The method of jointing the plastic sheet in the external walls is also of consequence to air-tightness. One method used which gives good joint tightness is to wrap a 0.5 m wide strip of plastic sheet round the column before the horizontal studs are fixed in place. Sealant is applied to the support details and the strip of sheet kept wrapped around the column. When the plastic sheet in the wall has been fitted in place after the completion of the thermal insulation, the wrapped around strip is folded out and sealed in the overlaps with a sealing strip as shown in fig 6. Overlapping edges in the plastic sheet without any form of sealing strip or the pressing together of the overlap will not give satisfactory air-tightness. This detail is not costly but does require thorough workmanship. The wrapped around strip of sheet must be carefully fastened during construction to avoid wind damage.

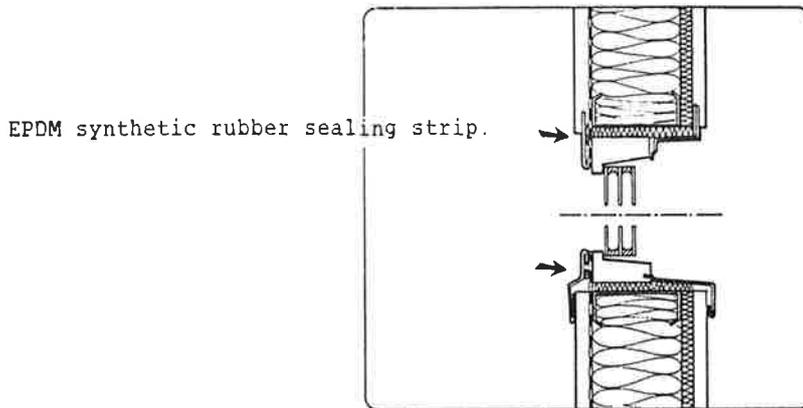
Fig 7 Window detailing. The plastic sheet in the wall is drawn over the window frame and fastened with a special sealing strip. An EPDM synthetic rubber sealing strip between the plastic sheet and the window frame considerably reduces the risk for air-leakage.

It is of great importance from the point of view of air-tightness that the air-tight membrane is not punctured by ducts, electric conduit etc. Improved detailing and instruction is required here. It is of great importance that all services are planned in detail while the building is still on the drawing board and that ducts are avoided as far as possible. Fig 7 shows an example of a window-wall detail. Note the thermal insulation and the positioning of the air-tight sealant against the air-tight sheet in the wall.

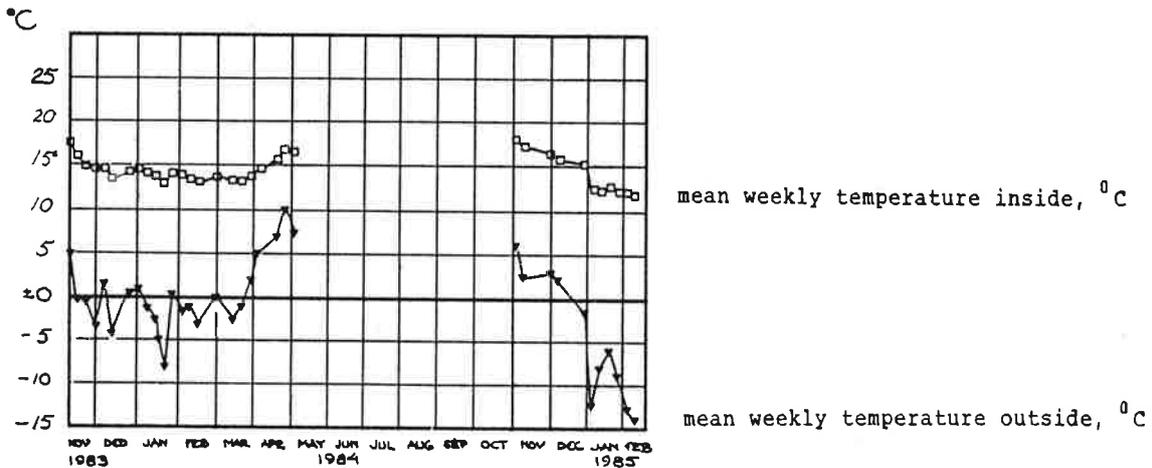
Fig 7 Mean weekly temperature outside and inside respectively recorded at the Ekerö Tennis Centre during Nov. 1983 to Feb. 1985

The mean weekly temperature inside and outside the building has been continuously recorded during the heating seasons 1983/84 and 84/85. The temperature inside the building has never been below a mean weekly value of +12°C. During the period Nov. 83 to March 84 the mean weekly temperature was +14°C, see fig 8. During the winter of 1983/84, which was relatively mild, the building was never heated with the installed heating system. The heat produced by the lighting system was sufficient to keep the building at a suitable temperature in which to play tennis. It was first during the extreme winter of 1984/85 when the mean weekly temperature fell to -10°C for 6-8 weeks (which is 6-8°C below the mean monthly average for Stockholm) that the infra-red roof panels were used.

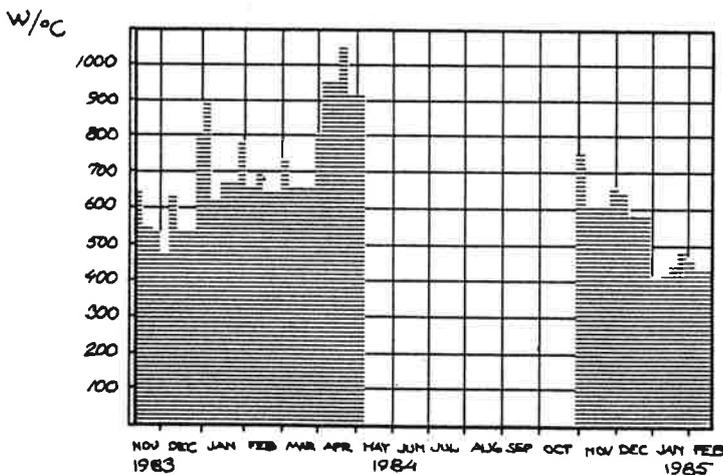
Fig 8 Energy consumption for the Ekerö Tennis Centre during Nov. 1983-Feb. 1985. No recording during May 1984-Oct. 1984.

The total annual energy consumption, which is almost totally used for lighting is 70 000 kWh.
