## INFILTRATION IN NORWEGIAN BUILDINGS

Jørn T. Brunsell	M.Sc.	Norwegian Building Research Institute	Norway
Sverre Fossdal	Dr.ing.	Norwegian Building Research Institute	Norway

Air infiltration in Norwegian buildings has been an unknown parameter. This paper is based on results from measurements in 9 different buildings in Norway. The measured parameters have been:

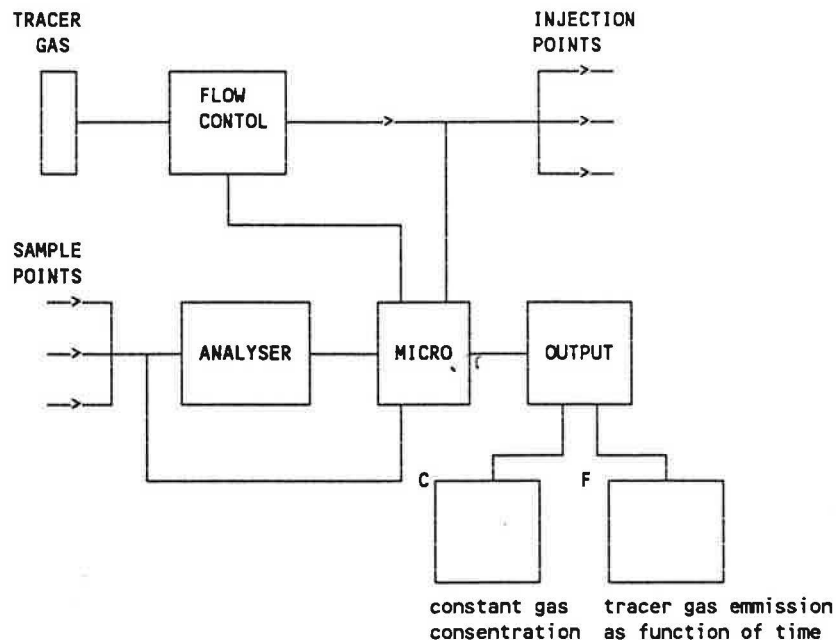
Figure 2.1. Schematic of constant concentration equipment

The measuring equipment used in this report can do measurement at ten different rooms at the same time with an accuracy of  $\pm 10\%$ . The measurements are controlled by a computer and parallel pressure differences, temperatures, wind speed and direction and relative humidity are measured. The equipment calculates the air change rate and collects all analog data every 3 minutes. Any possible connections between the analog data and the change in air change rate can be found.

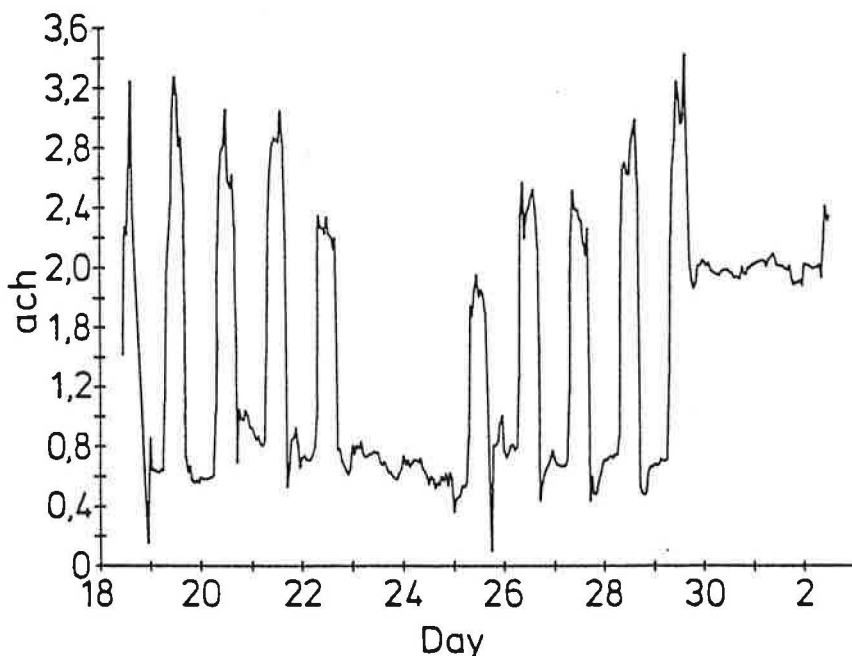
Figure 3.1.1. The average ventilation rate measured in the office building on the 7th floor. The measurement was carried out for a period of two weeks. During the first week the internal doors were closed and during the second week all internal doors were kept open.

#### 3.1 Office building

All the offices were occupied during daytime on weekdays but not on Saturdays and Sundays. The ventilation system was turned on at 7 a.m. and shut off at 4 p.m. on weekdays. Usually the ventilation system is off during the weekends, but during the last weekend it was running.

There were big differences from one zone to another in airing through the windows. The total air change rate rise, in one zone, 6 ach in average because of airing through windows.

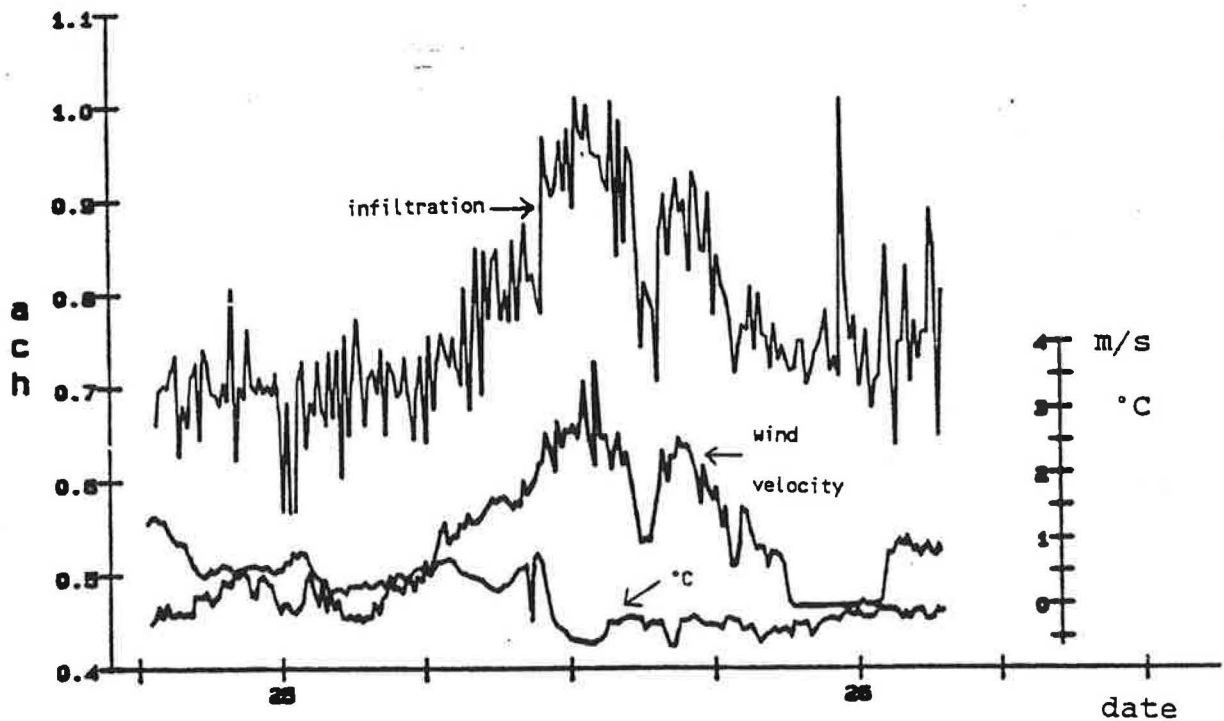
Figure 3.2.1. The influence of the wind velocity on the infiltration rate (the whole house). Inlets and outlets were shut and the occupants came home late in the evening the 25th.

When the occupants were not at home we can observe the immediate reaction in the infiltration rate caused by changes in the weather conditions, see fig 3.2.1.

During the first 10 days all the ventilation inlets and outlets were shut. The measured air change value for this periode is the same as the infiltration rate. In average the figure was 0.7 ach which is more than needed for ventilation purposes. The outside temperature was higher than normal and the wind velocity was lower.
