BEST PRACTICE PROGRAMME

Good Practice Case Study

1970's Civic offices designed and managed for low energy consumption

Hereford and Worcester County Hall, Spetchley Road, Worcester

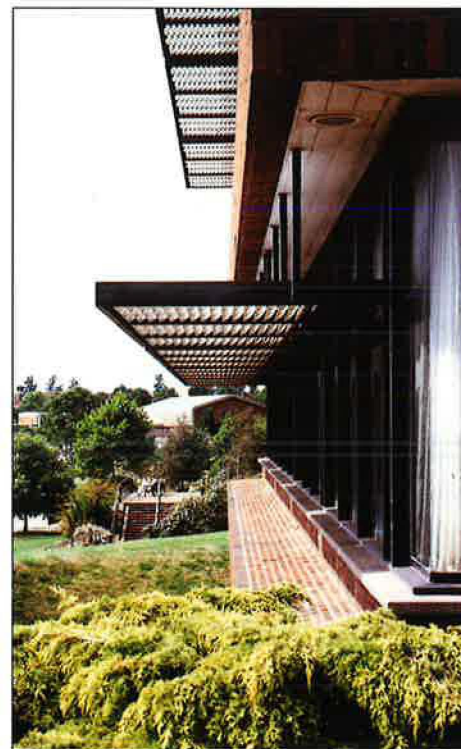
Typical office windows with overhangs and sunscreens.

The windows are solar-protected by overhangs and projecting louvres and the brick-clad concrete structure has thermal capacity. This combination delays the entry of summertime solar heat gains until after the occupied period, and reduces the need for mechanical cooling. The roof is steel-framed with zinc covering over 200 mm aerated concrete slabs, which provide thermal mass (delaying the arrival of solar heat gains) and insulation.

- The overhangs and sunscreens are deliberately designed to admit winter sun and help reduce space heating requirements. However, since no internal blinds are fitted, problems arise from glare and low sun.

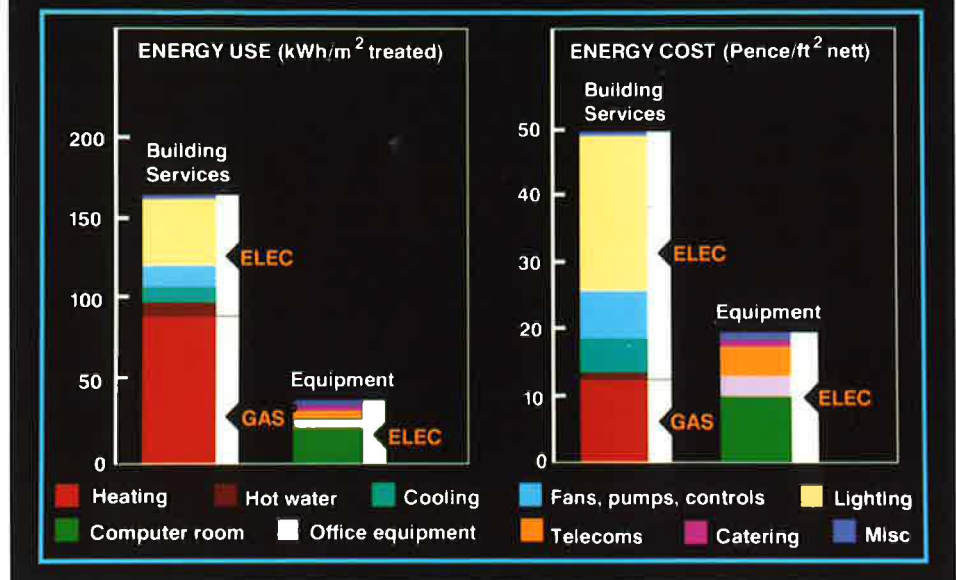
Annual energy use and cost for Hereford and Worcester County HQ

From May 1987 to April 1988 (2433 degree days) 1,952,500 kWh of gas and 2,062,500 kWh of electricity were consumed. Excluding the computer room's electricity consumption, the total of 183 kWh/m² of treated area is well within the CIBSE Energy Code 4's "good" category of less than 195 kWh/m² for a naturally-ventilated office of this size and only two-thirds of the level for air-conditioned office.

The diagram above gives a detailed breakdown of energy use and cost. Although consumptions are similar, the annual cost of electricity dominates: £93,500 as against £21,750 for gas, or 56 and 13 pence/ft² nett respectively.

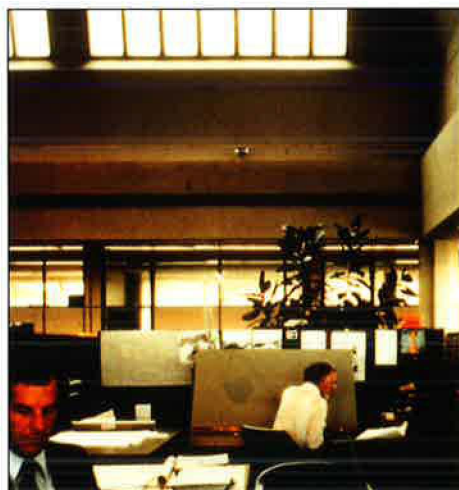
Rooflit top floor office core.

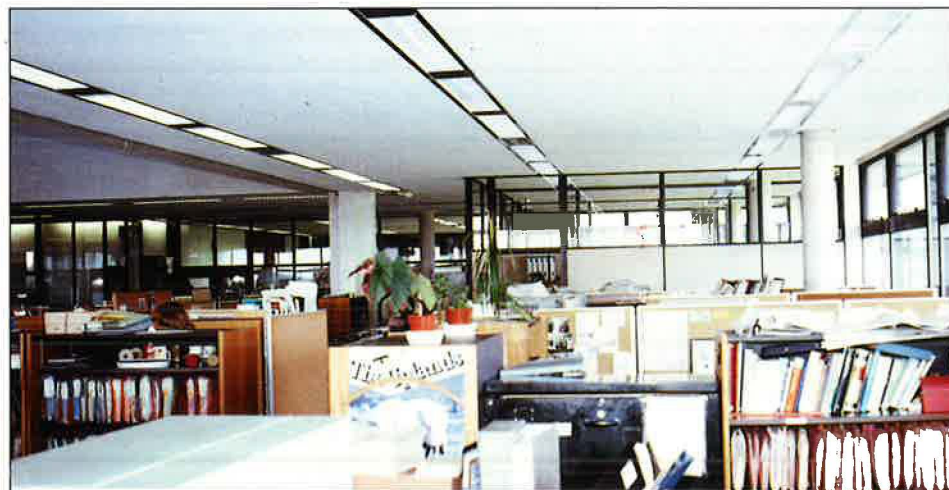
Perimeter offices. Note that the band of lights towards the window is off under automatic control.

The automatic control has under-performed partly because the continuous perimeter windows create an expectation of high levels inside, and partly because the lights are switched in groups — with all switches for each area in one panel — so there is a long walk when the lights go off. Although the switches are now labelled, people tend to switch everything on but are much less likely to switch anything off for fear of inconveniencing others.
