Longevity of Duct Tape in Residential Air Distribution Systems: 1-D, 2-D, and 3-D Joints

Energy Performance of Buildings Group
Indoor Environment Department
Lawrence Berkeley National Laboratory
One Cyclotron Road
Berkeley, CA 94720

December 2002

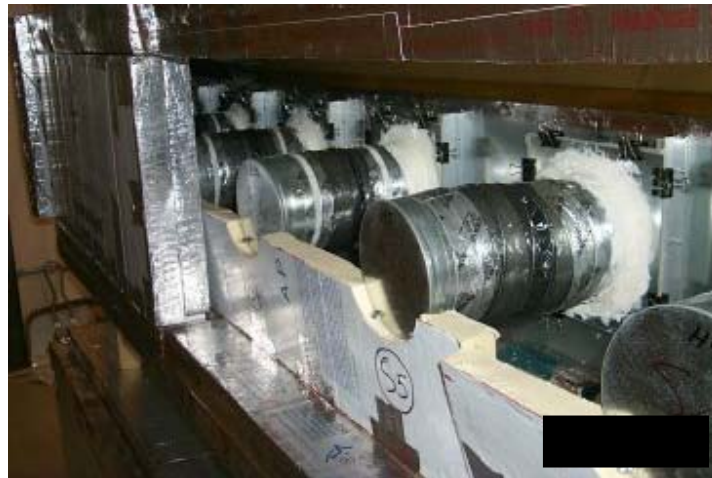
Figure 1. One chamber of the high temperature aging test apparatus.

Figure 1 shows samples mounted on the aging test apparatus. Heated air is continuously circulated through the test apparatus to both heat and pressurize the leakage sites. The apparatus is divided into an upper and lower chamber that each contains nine (eight?) samples. The inside of the test samples are exposed to high pressure heated air and the outside (shown in Figure 1) is in an insulated chamber that also becomes heated during the experiments by conduction through the test samples. This means that there is little temperature gradient across the samples. The hot air temperature is controlled using electric resistance heaters mounted directly in the air stream. The surface temperatures of each sample, the air temperature and the pressure across the leaks are continuously monitored using a computer based data acquisition system. The actual leakage measurements are conducted periodically (typically on a monthly or weekly basis) by removing the samples from the test machine. They are then allowed to cool to room temperature before being placed in a separate testing device that pressurizes the samples to 25 Pa and measures the air flow rate required to maintaining this 25 Pa pressure difference. This 25 Pa air flow is the leakage of the sample that is then recorded and compared to initial 25 Pa air flow measurements of the connections before and after initial sealing.

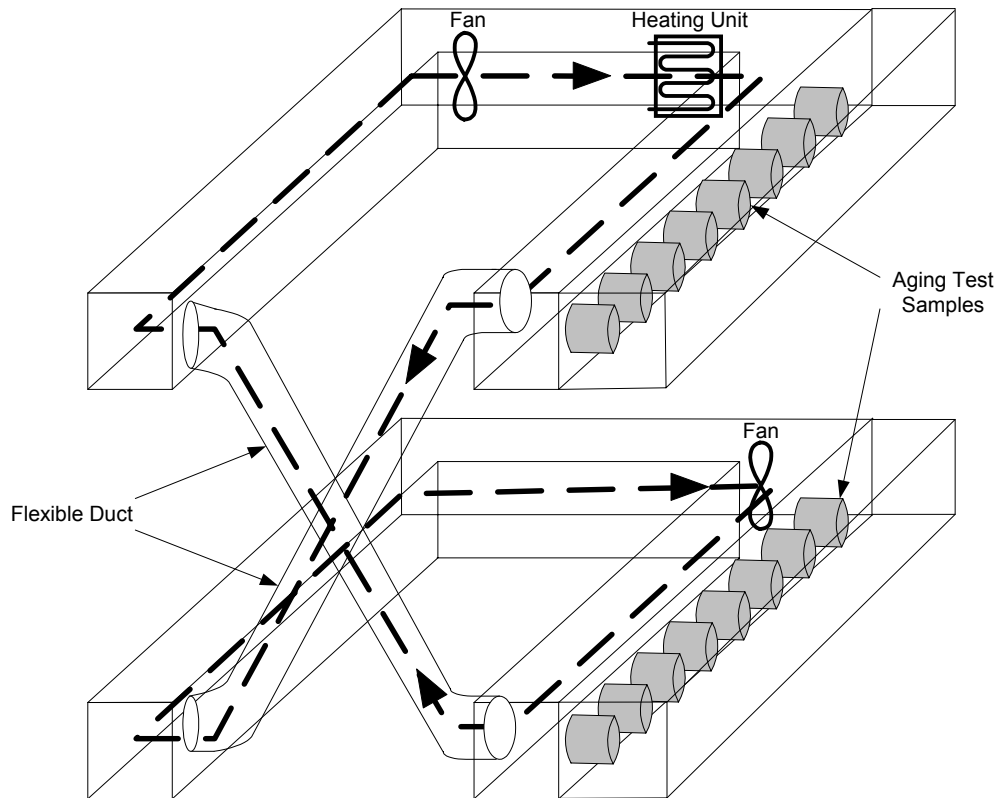
Figure 2. The hot air circulation in the modified aging test apparatus.

Figure 2 shows a schematic of the hot air circulation path in the aging test apparatus. The upper and lower test chambers are connected by insulated ducting so that the same air flows through both chambers and only one heater is required. In the previous phase of

testing, the lower chamber had cold air circulating through it. This apparatus conforms to proposed ASTM test requirements in order to develop an industry standard test method.

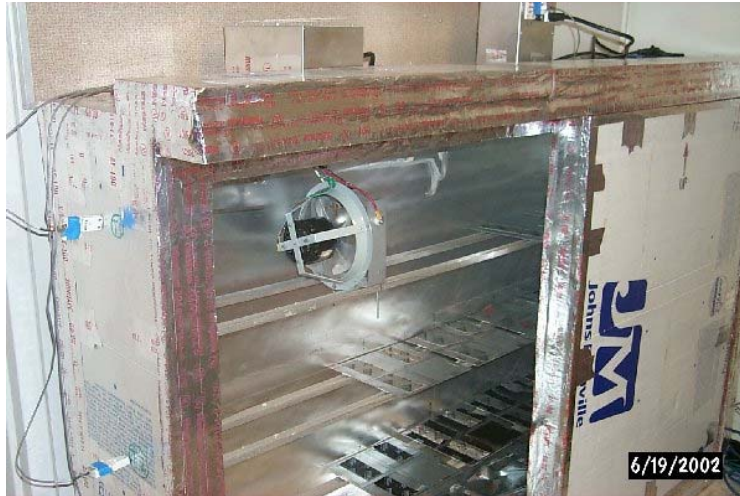
Figure 3. The high temperature baking apparatus.

Figure 3 shows the baking test oven that provides constant circulating air temperature of 212°F (100°C) for the baking specimens following the UL 181B “temperature test” protocol. All walls of the oven are made with 4” (100 mm) thick foil-faced foam sheathing. The bottom of the oven, sitting on the floor, is made thicker (6” (150 mm)) for added insulation. The oven is 44” (112 cm) high, 72” (183 cm) wide, and 10” (25 cm) deep. It contains four racks made of two strips of aluminum that hold the testing specimens. Six temperature sensors equidistantly placed on both sides of the oven provide readings of the temperature profile inside the oven. Measured results show that the temperatures do not vary by more than 5°F (2.5°C) from the average temperature of 212±5°F (100±3°C). The oven has an electric heating unit controlled by a relay box to turn off at 214°F (101°C) and on at 210°F (99°C), and also protected by a safety snap thermostat rated at 250°F (121°C). The temperature values are recorded at a one-minute interval. The air circulation inside the oven is insured by a thermally-protected fan.

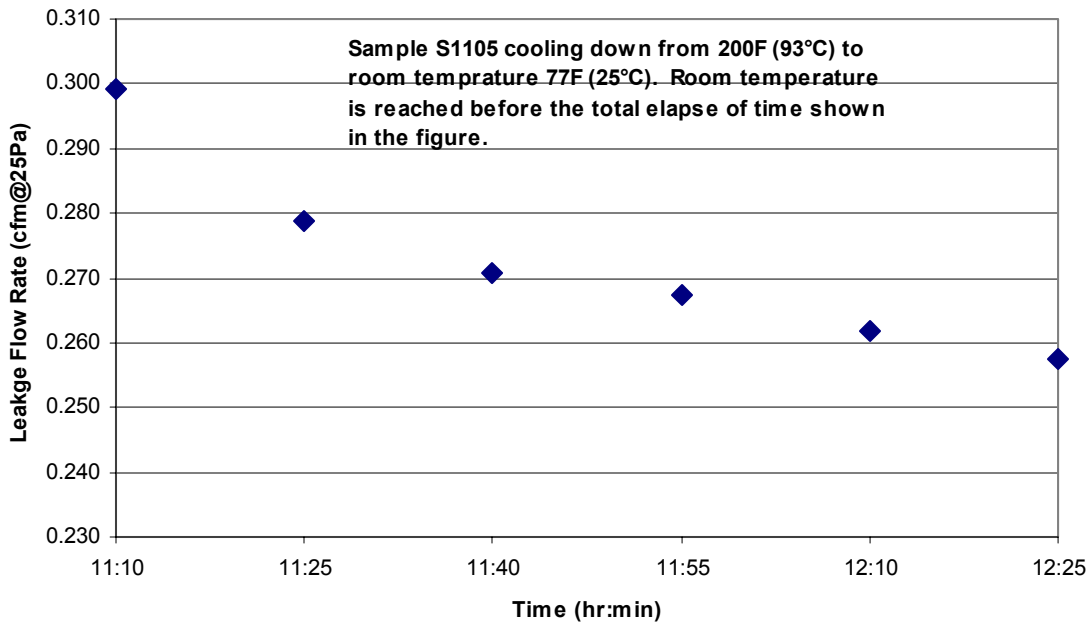
Figure 4. Decay in the measured leakage as the specimen cools down from 200F (93°C) to room temperature.

Because the aging test involves heating the specimens continuously at 200°F (93°C), it takes some time for the specimens to return to room temperature. Therefore the elapsed time between removal from the test chamber and measurement of leakage could have an effect on the results. To examine this effect, a specimen was tested six times at 15-minute intervals, with the first measurement taken at its highest temperature (200°F (93°C)). The experiment took place in the laboratory where room temperature is 77°F (25°C). Figure 4 shows the decay in the leakage flow as a function of cool-off time. The leakage flow at the highest temperature is 16% higher than the last value taken 1 hour and 15 minutes later. The difference in leakage is attributed to the “re-sealing” of the joint as it shrinks and hardens at lower temperatures. For consistent results the samples need to cool to room temperature before being leakage tested. However, for some of the results discussed here we did not wait a uniform time, which resulted in additional uncertainty in measured sample leakage.

stabilization and tested the samples at some intermediate temperature, thus leading to higher measured leakage. The magnitude of the changes in leakage with time and therefore sample temperature shown in Figure 4 indicate that the negative leakage shown in Figures 13a and b is of a similar magnitude to this effect. In addition, a general observation of the core-to-collar joints undergoing an aging test is that the shrinkage of the duct tape can have a positive effect as it tightens up around the joint, unlike the case of a collar-to-plenum joint where the shrinkage of the duct tape makes it peel off and pull away from the surface it is applied to, thus exposing the leaks.

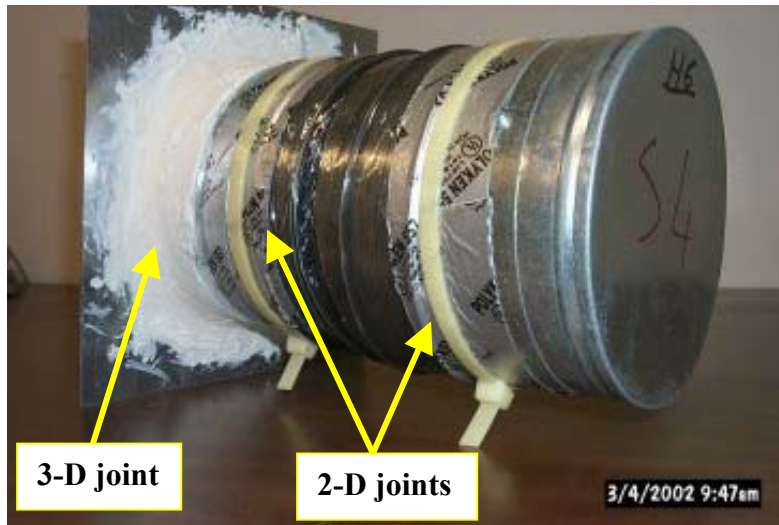
Figure 5. Example of test sample showing the two taped connections and the mechanical clamps.

Flexible ducts consist of three layers: inner membrane called “core”, a layer of insulation and an outer layer acting as a moisture barrier called a “jacket”. The test samples were sealed with two layers (one continuous piece) of duct tape applied to the core of the duct with the insulation and outer moisture barrier removed. The taped joint is reinforced with a mechanical plastic clamp installed over the tape as required for UL 181 B-FX installations. Figure 5 shows a laboratory construction of the 6” (150 mm) flexible core-to-collar joint aging test specimens, which contains two core-to-collar joints (the joint being tested) and one collar-to-plenum joint (not tested and sealed with mastic). The white irregular ring of material at the back (left) is mastic that has been applied over the collar-to-plenum joint. The end of the duct is capped with a metal cap that is sealed before testing. Figure 6 shows a schematic of the flexible duct core-to-collar joint as it fits on the aging test apparatus. Figure 6 shows how the whole specimen is enclosed in insulation that forms a test chamber.

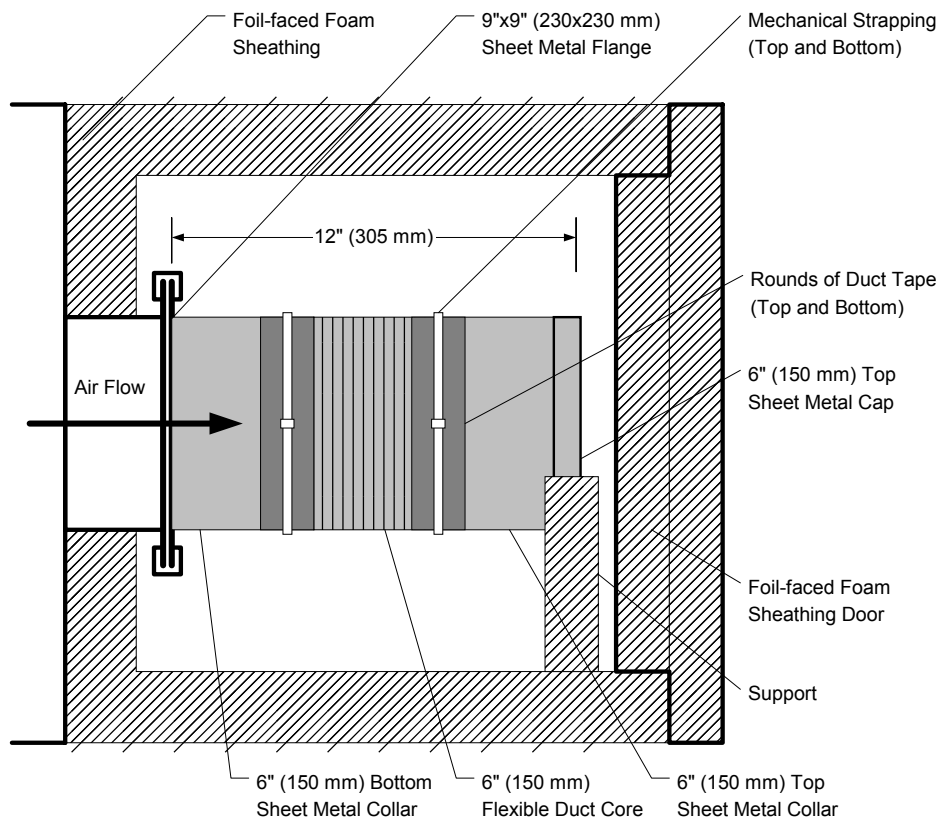
Figure 6. A side-view schematic of a flexible duct core to sheet metal collar joint specimen positioned on the aging test apparatus.

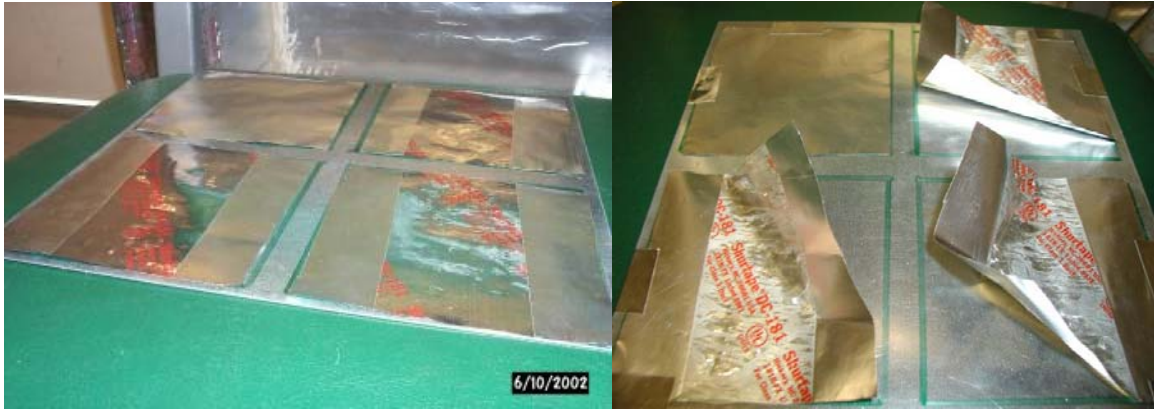
Figure 7. A baking specimen following the UL 181B temperature test protocol consisting of three samples of tape (Tape 3) and one control sample of the substrate (Aluminum Foil) before testing and after four weeks of testing.

For each duct tape (Tape 1, Tape 2, Tape 3, and Tape 4), twelve specimens were made by applying a strip of tape to three 4 by 4 inch (100 by 100 mm) samples of each of the following materials: aluminum foil, polyethylene, polyethylene terephthalate (PET), and sheet metal (steel). Another 4 by 4 inch (100 by 100 mm) control sample of each of the substrate materials is included in the specimen without applying the tape to it. The control sample serves as a means to quantify the deterioration attributed to the substrate in isolation from the duct tape. A specimen set in the baking test, therefore consists of three similar samples and one control sample, all carried by a sheet metal tray in the oven (Figure 7). Since the substrates used in this test are very thin and light weight, they are

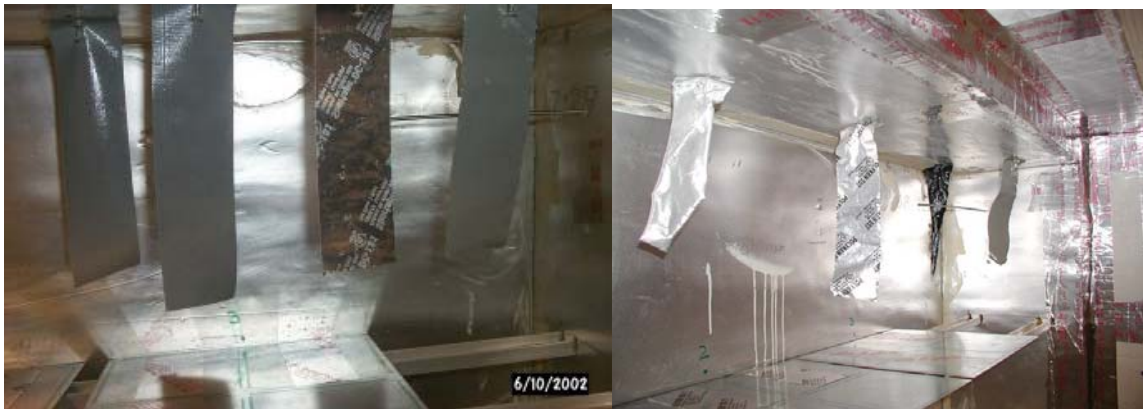
Figure 8. Hanging specimens of Tapes 1 to 4 in the high temperature baking apparatus before testing and after three weeks of testing.

In addition to the specimens following the UL 181B temperature test protocol, we included “hanging specimens” (Figure 8) of all four tapes in the oven to examine their deterioration in isolation from the substrate they are applied to.

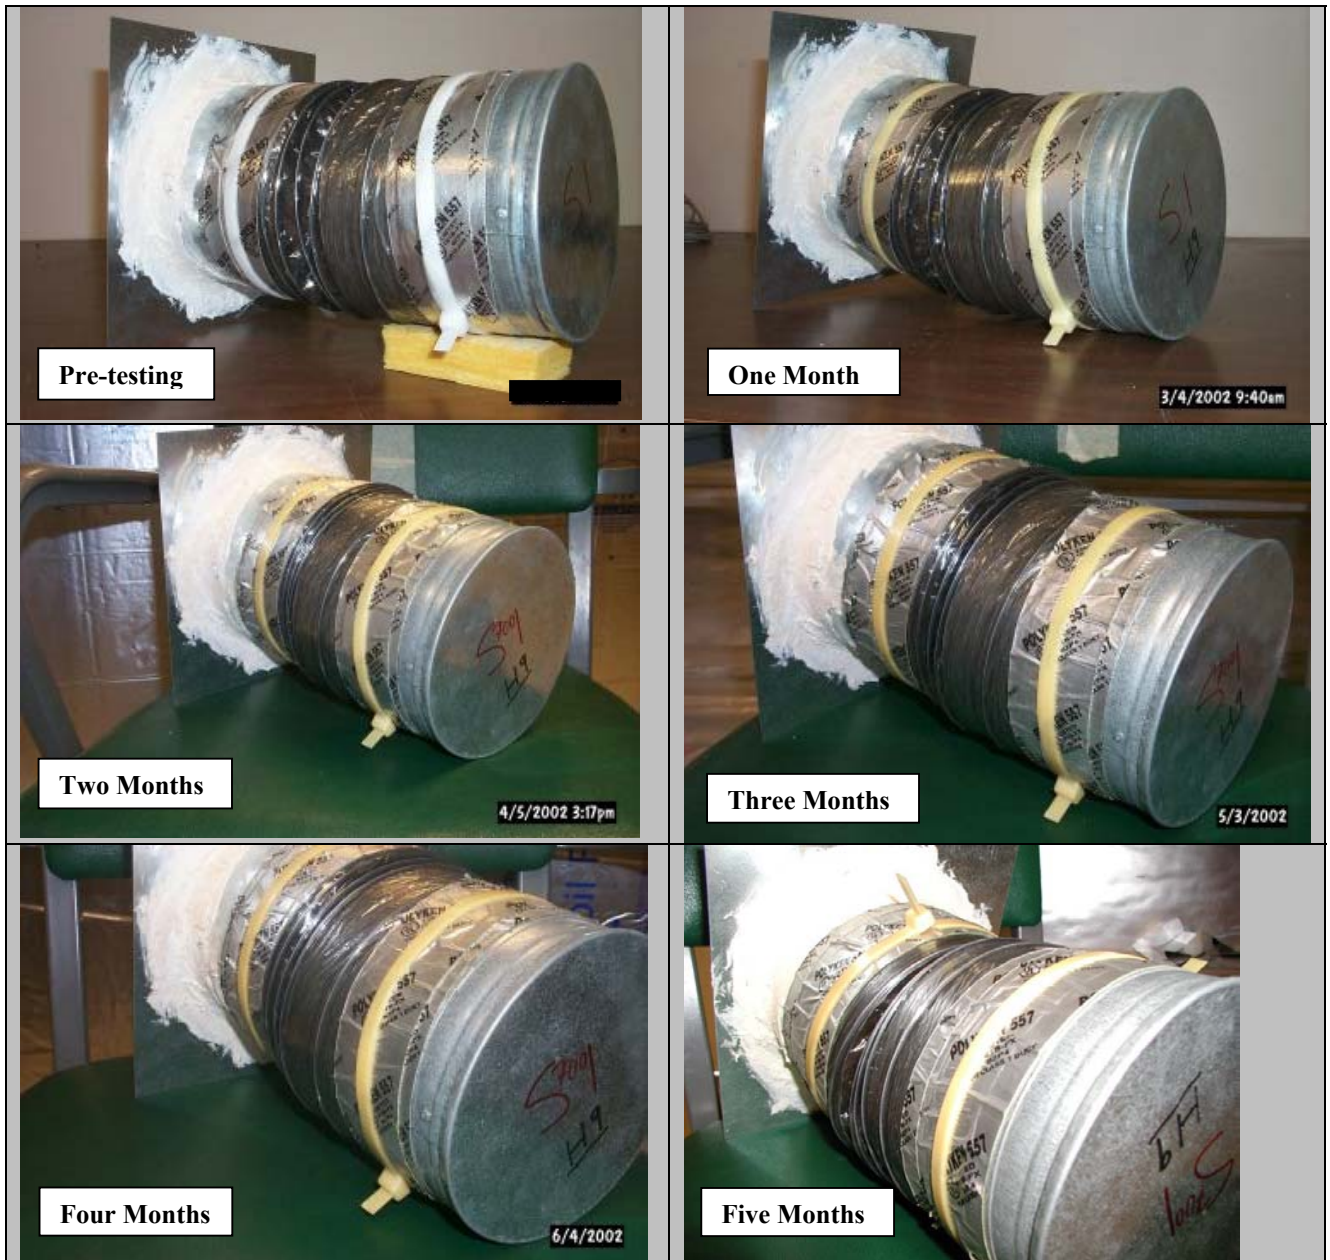
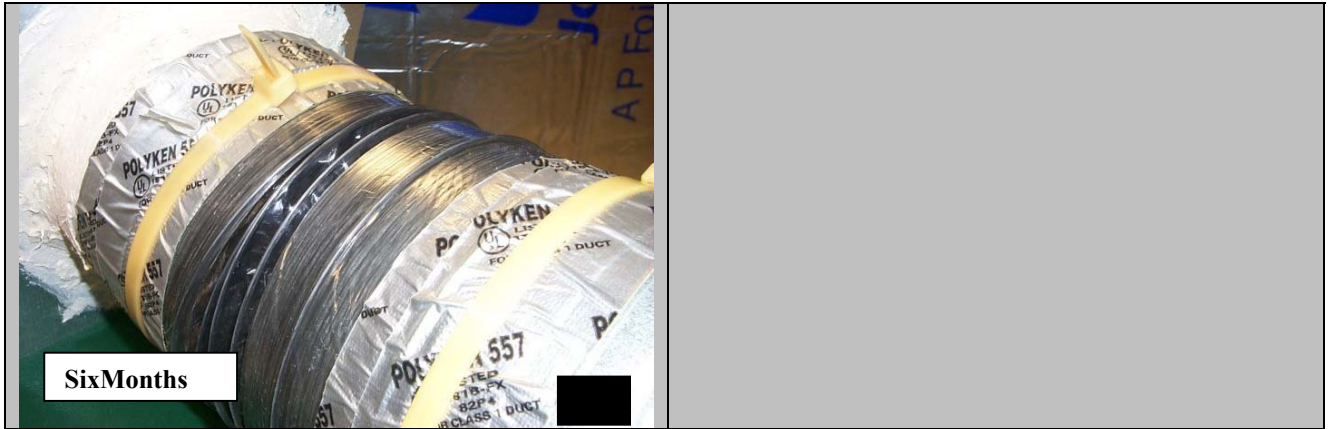
Figure 9. Deterioration of flexible duct core-to-sheet metal collar joint during the six months of the aging test at 200 F (93°C) temperature.

In order to systematically record the visual deterioration of the samples, monthly pictures of all 18 specimens were taken. Typical minor deteriorations were observed as discoloration, wrinkling, and oozing, and major deteriorations were shrinking, peeling, delamination, and cracking. Figure 9 shows the deterioration of one of the specimens with clamping, and 2 continuous wraps of duct tape.

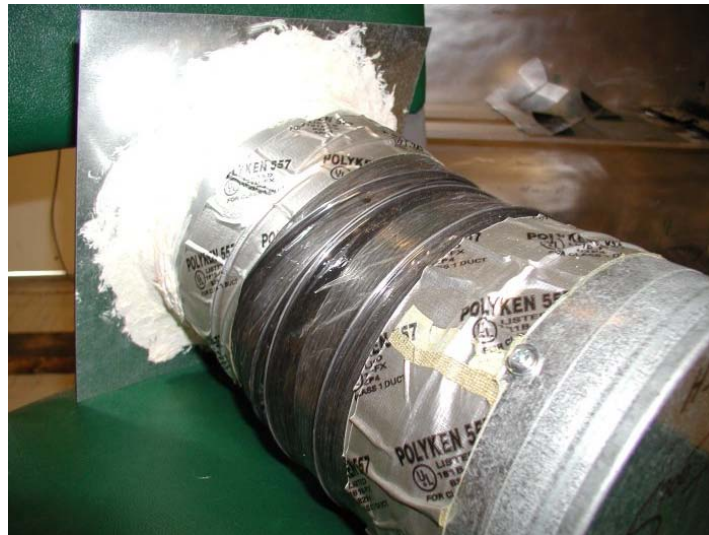
Figure 10. Shrinkage and delamination among the unclamped specimens (showing here result of 5 months of aging)

- shrinkage and delamination among the unclamped specimens (Figure 10)
- oozing of the adhesive layer in the foil-butyl tape (Tape 4) specimens (Figure 11)
- little shrinkage and delamination in the strapped specimens
- discoloration of the plastic strapping in the clamped specimens

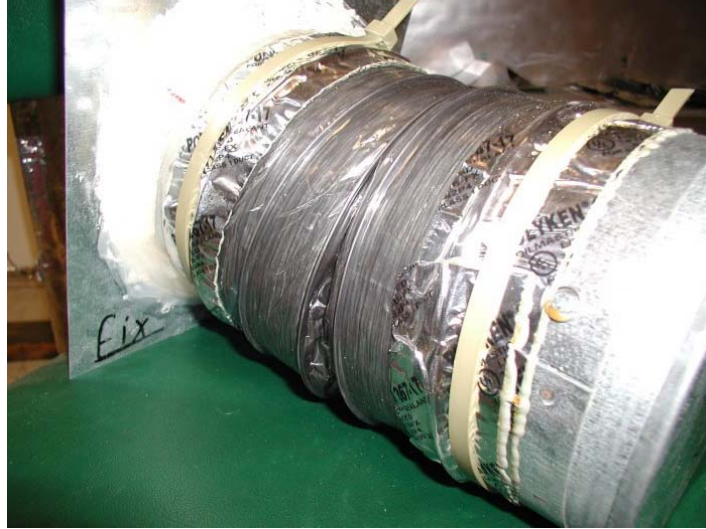
Figure 11. Oozing of the adhesive layer in the foil-butyl tape (Tape 4) specimens (showing result of 5 months of aging).

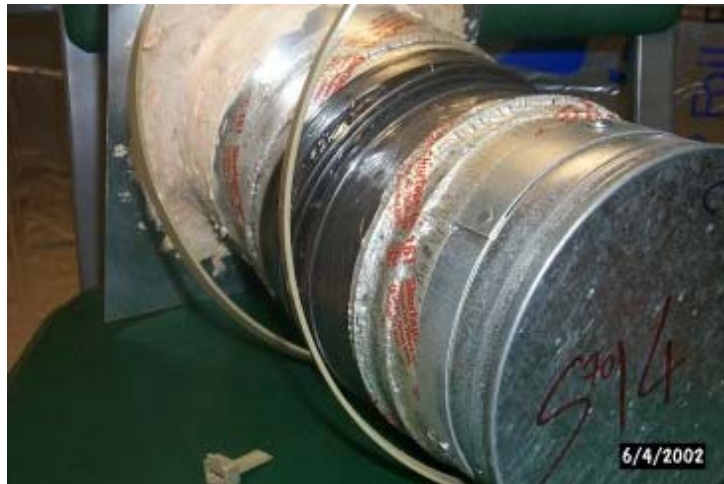
Figure 12. The failed plastic strapping on one of the flexible core to sheet metal collar specimens after four months of aging.

The discoloration of the plastic strapping was an indication of its deterioration which basically lead to a total failure afterward in one case (specimen S7014) after four months of aging. The plastic clamp cracked open due to the increased brittleness of the plastic (Figure 12).

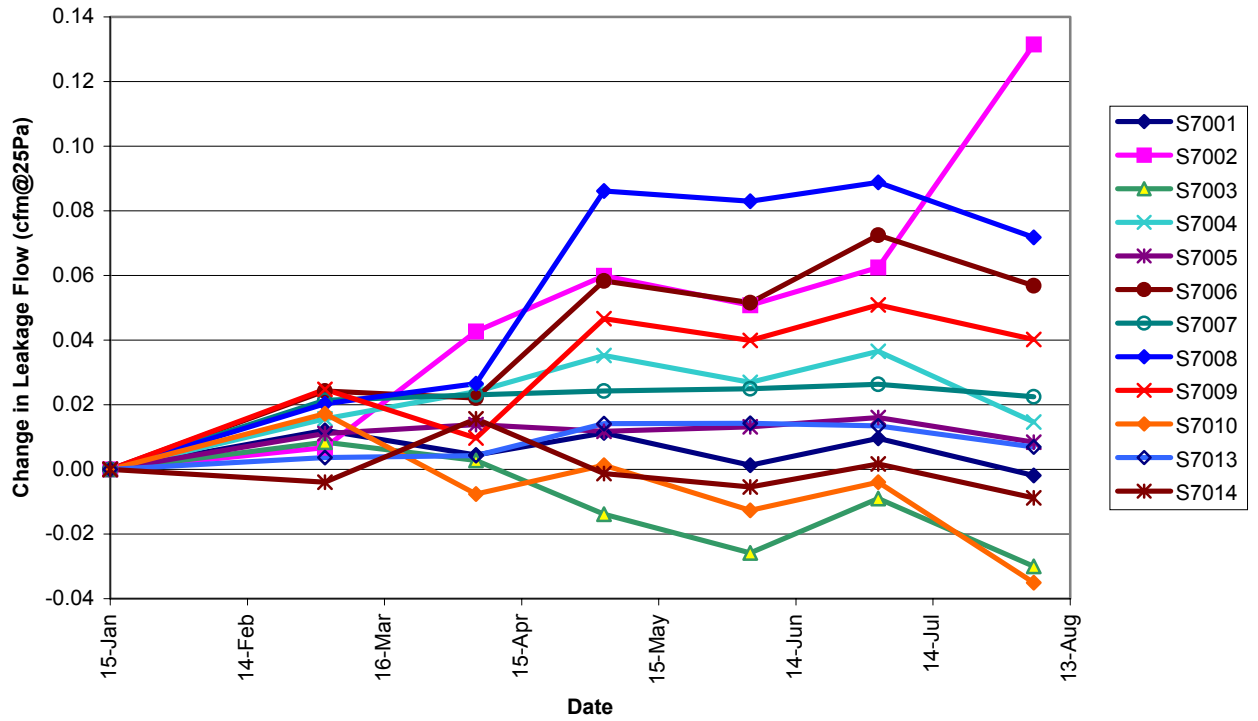
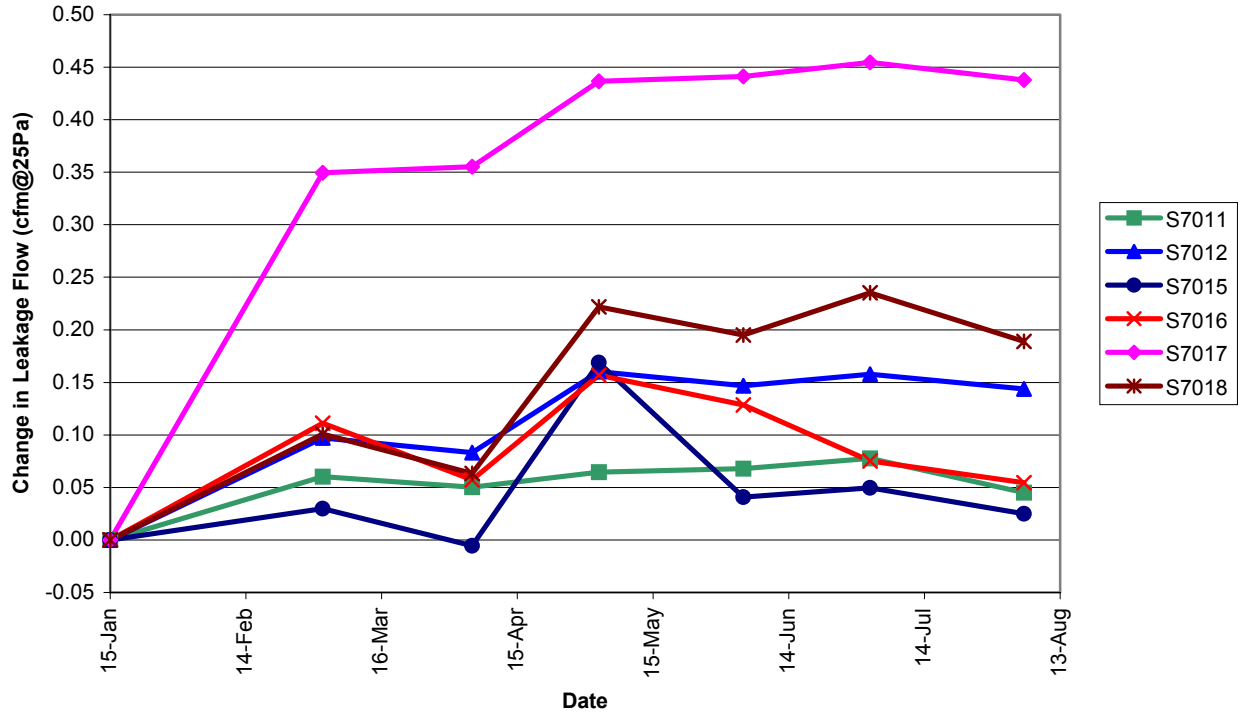
Figure 13 (a and b). The measured change in leakage flow of the flexible core to sheet metal collar joint specimens during the six-month period of the aging test.

The results are separated in two figures (13 a and b) for clarity. These results show all but one of the samples having an increase in leakage after the first month of testing. After this first month there are no clear universal trends with both increases and decreases in leakage of different magnitudes for different samples. The cases of decreases in leakage illustrate some of the limitations of our test procedure in terms of the resolution of the leakage tests and other issues, such as the changes due to temperature of the test sample during leakage testing (discussed earlier). For example, for the most recent tests, we waited until the samples were cool before testing, which leads to lower measured leakage. In the earlier measurements we did not consider waiting for temperature

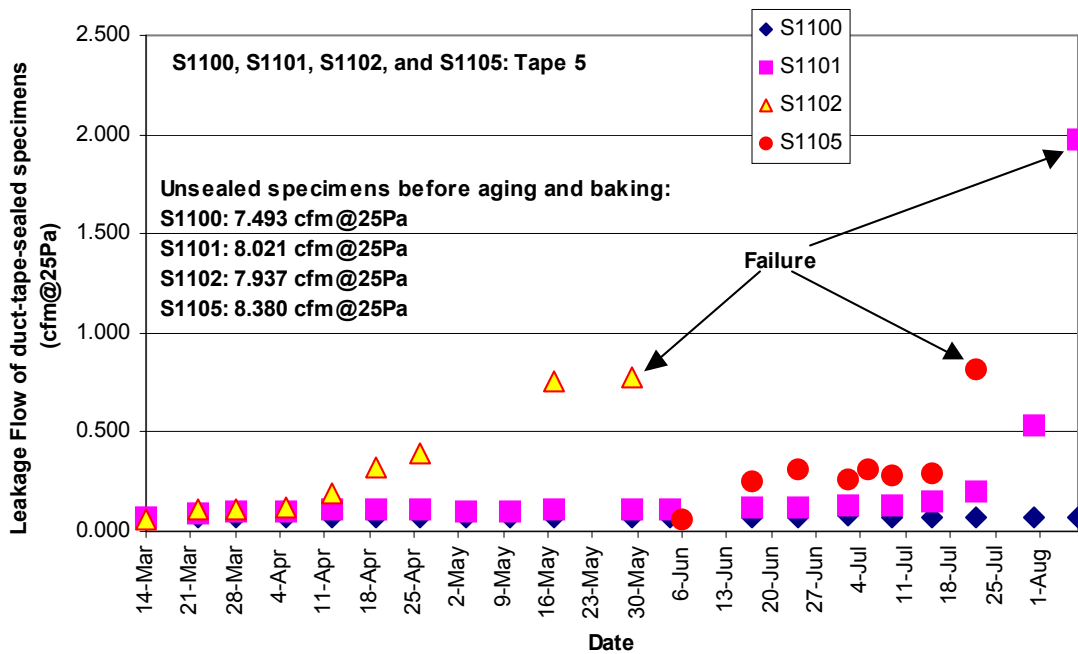
Figure 14. The measured leakage of the collar-to-plenum joint Tape-5 specimens.

Collar-to-plenum joints aging test. In addition to the aging tests of the flexible duct, core-to-collar joints, we also repeated the tests of the collar-to-plenum joints aging tests that were conducted in previous studies. These tests were performed for a new duct tape product that has been developed to have improved high temperature performance (Tape 5) as well a sample of Tape 1. The tape new failed in 9 days (using the >10% of unsealed leakage criteria), showing shrinkage and pulling away from the sheet metal plenum. Figures 14 and 15 show the results of these tests. Because they were mounted in a different location on the test apparatus, these collar-to-plenum were exposed to different temperatures than the core to collar samples. These samples were placed between the left and right chambers (shown in Figure 2) where in previous phases of longevity testing the samples experienced cycling temperatures. Table 4 shows the temperatures the specimens were exposed to during the test, and the corresponding elapsed time before failure. Specimen S1102 failed after 2.5 months, and was replaced with specimen S1105. Specimen S1105 appeared to leak at a faster rate at the beginning, then leveled off, then showed a catastrophic (sudden) failure, contrary to the gradual failure of S1002). It took specimen S1105 only one month and three weeks to fail.

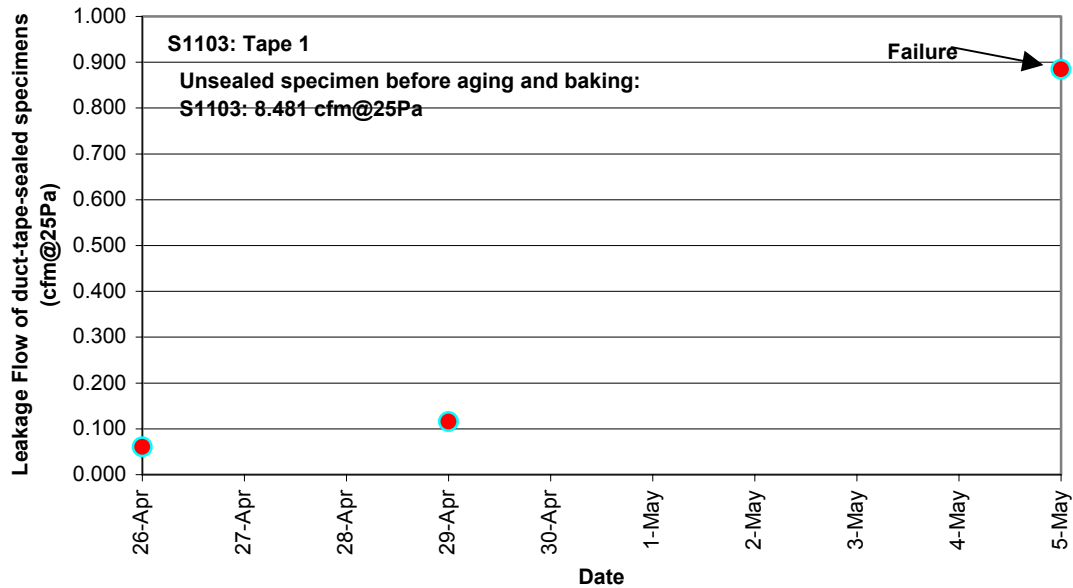
Figure 15. The measured leakage of the collar-to-plenum joint Tape-1 specimen.

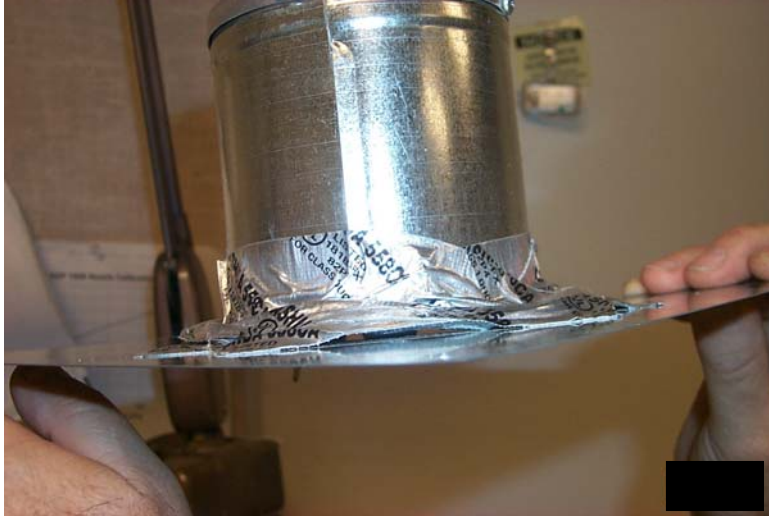
Figure 16. A typical failure of the 3-D collar-to-plenum joint.

Figure 16 shows the failure of the 3-D joint as the duct tape tends to pull away from the sheet metal, thus uncovering the series of overlapping fin-joints.
